Report: TAB REPORT
Function: Test, Adjust, & Balance
Date: 07/24/2023

07-10-23 WALGREENS #1769 - DENVER, CO

Project: 07-10-23 WALGREENS #1769 - DENVER, CO

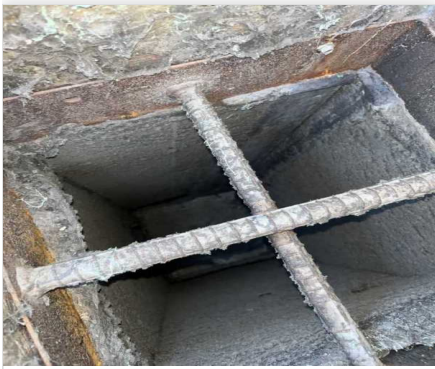
EF2_DROP
07/25/2023

Issue Name : EF2 No Backdraft Damper
Description : No backdraft damper was found in the EF2 ductwork. Recommend installing to prevent drafting into the restrooms when the fan is not running.
Created By : National TAB **Assigned To :** National TAB - Will Turnbough
Status : Open
Originated Date : 07/25/2023 - Stephen Tassinaro - National TAB

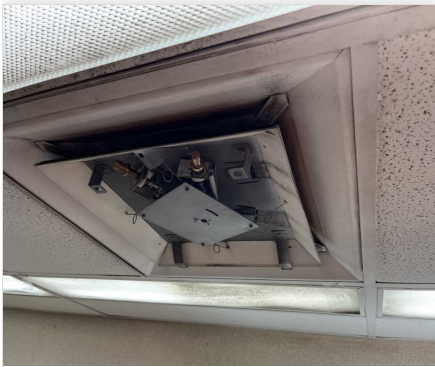
OFFICE_SUPPLY
07/25/2023

Issue Name : Office Supply Diffuser Missing Cover
Description : The supply diffuser in the Manager's Office is missing its cover. This does not appear to be causing performance issues but is unsightly. Recommend installing cover and cleaning diffuser.
Created By : National TAB **Assigned To :** National TAB - Will Turnbough
Status : Open
Originated Date : 07/25/2023 - Stephen Tassinaro - National TAB

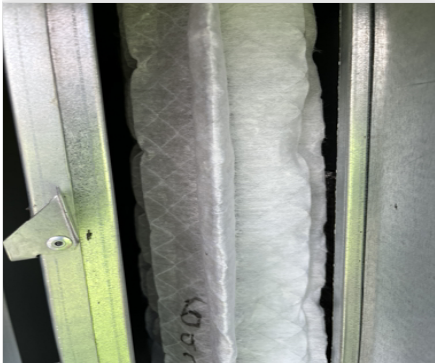
CurrentFilters
07/20/2023

Issue Name : RTU Final Filters
Description : Recommended to install the appropriate sized MERV 8 or better throwaway filters in the RTUs for improved filtration.
Created By : National TAB **Assigned To :** National TAB - Will Turnbough
Status : Open
Originated Date : 07/20/2023 - Stephen Tassinaro - National TAB

Verify filters are installed, clean and of proper size. Verify there is no air by-pass around filters.	Fail
--	------

RECOMMEND MERV 8 (OR BETTER) THROWAWAY FILTERS TO BE INSTALLED.

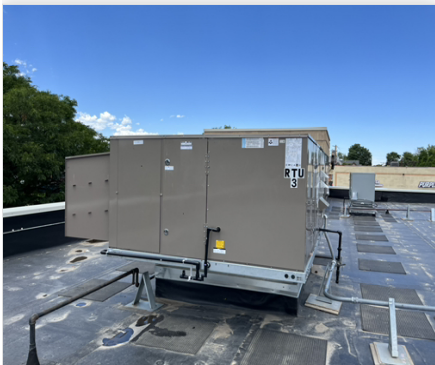
RTU2(1)
07/20/2023

Issue Name : RTU Labeling
Description : The current RTU labeling does not match that of the RTU submittals. NTi reported units per the submittal numbering.
Created By : National TAB **Assigned To :** National TAB - Will Turnbough
Status : Open
Originated Date : 07/20/2023 - Stephen Tassinaro - National TAB

Units are labeled correctly Fail

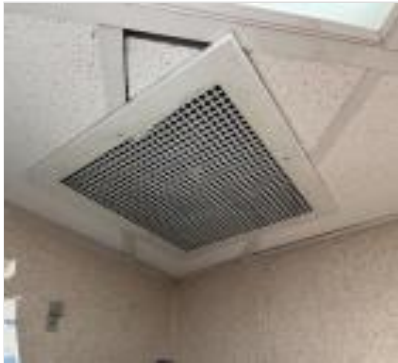
EF1
07/25/2023

Issue Name : EF1 Not Functional
Description : EF1 in the manager's office is not functional. The thermostat on the wall appears to be working as it sends 120V to the fan when needed, however the fan motor does not respond. Appears motor replacement is necessary, cleaning also recommended.
Created By : National TAB **Assigned To :** National TAB - Will Turnbough
Status : Open
Originated Date : 07/20/2023 - Stephen Tassinaro - National TAB

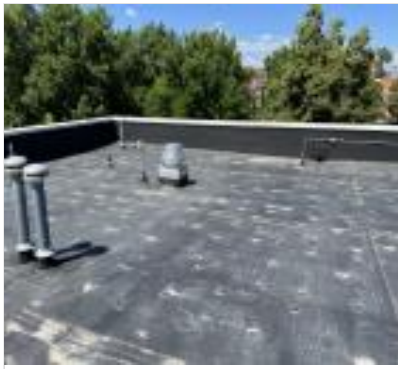
EF2
07/25/2023

Back draft damper is installed and functional Fail

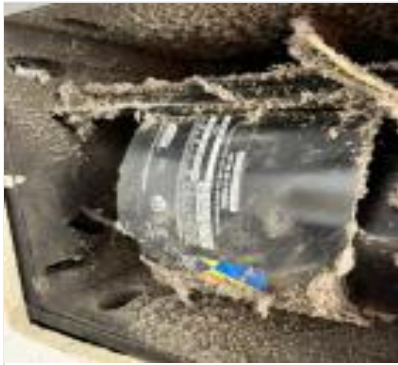
EF3(1)
07/25/2023

Issue Name : EF3 Dirty and Low Flow
Description : EF3 in the employee room is exhausting 30CFM out of 100CFM design. Fan found to be functional but clogged with dirt and debris. Thorough cleaning recommended.
Created By : National TAB **Assigned To :** National TAB - Will Turnbough
Status : Open
Originated Date : 07/24/2023 - Stephen Tassinaro - National TAB

Notes:
FAN RUNNING BUT DIRTY AND IN NEED OF CLEANING.
