Report: TAB REPORT
Function: Test, Adjust, & Balance
Date: 07/24/2023

06-24-24 WALGREENS #1769 - DENVER, CO

Project: 06-24-24 WALGREENS #1769 - DENVER, CO

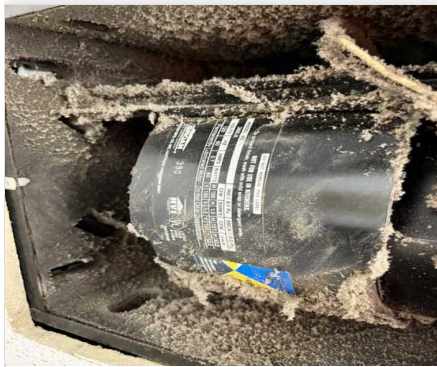
EF3
07/25/2023

Issue Name : EF3 Dirty and Low Flow
Description : EF3 in the employee room is exhausting 30CFM out of 100CFM design. Fan found to be functional but clogged with dirt and debris. Thorough cleaning recommended.
Created By : National TAB **Assigned To :** National TAB - Stephen Tassinaro
Status : Open
Priority : Urgent **Asset Tag :**
Originated Date : 07/24/2023 - Stephen Tassinaro - National TAB

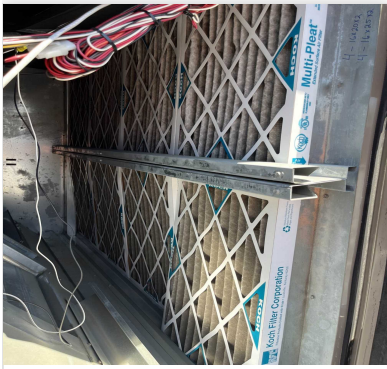
Dirty_Filters
06/19/2024

- **06/17/2024 National TAB - Stephen Tassinaro**
 - MERV 8 filters now installed in all units, but they are dirty and due for replacement.

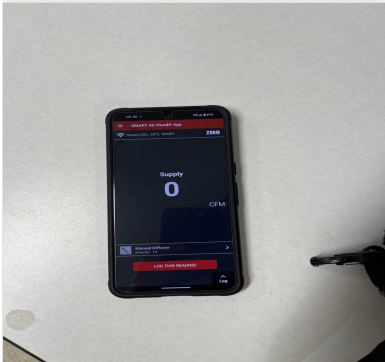
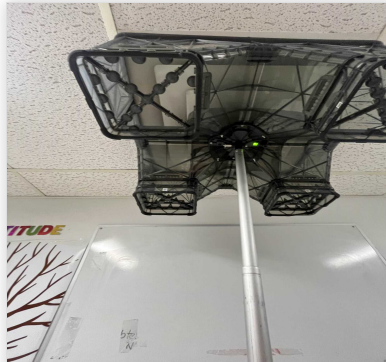
Issue Name : SGRD2-17 Low Flow
Description : SGRD2-17 airflow below design (15CFM out of 100CFM Design). NTAB inspected duct from within employee room and where possible on the first floor and did not see any restrictions. Recommend ensuring take-off is secure and damper is open to increase airflow to downstairs employee room.
Created By : National TAB **Assigned To :** National TAB - Stephen Tassinaro
Status : Open
Priority : Urgent **Asset Tag :**
Originated Date : 07/24/2023 - Stephen Tassinaro - National TAB

- **06/19/2024 National TAB - Stephen Tassinaro**
 - NTi measured no improvement at the supply grille in the employee room.
