**Report: TAB REPORT**  
**Function: Test, Adjust, & Balance**  
**Date: 07/24/2023**

## 06-24-24 WALGREENS #1769 - DENVER, CO

Project: 06-24-24 WALGREENS #1769 - DENVER, CO

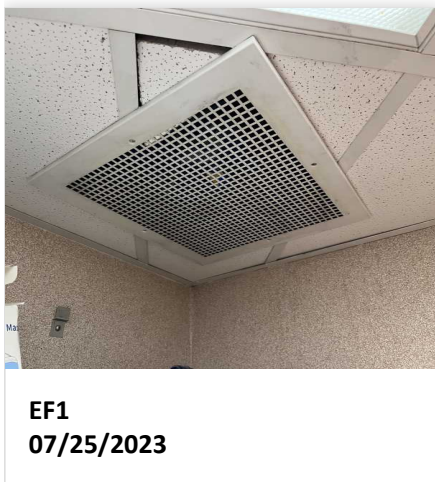
**Issue Name :** EF1 Not Functional  
**Description :** EF1 in the manager's office is not functional. The thermostat on the wall appears to be working as it sends 120V to the fan when needed, however the fan motor does not respond. Appears motor replacement is necessary, cleaning also recommended.  
**Created By :** National TAB                      **Assigned To :** National TAB - Stephen Tassinaro  
**Status :** Open  
**Priority :** Urgent                                      **Asset Tag :**  
**Originated Date :** 07/20/2023 - Stephen Tassinaro - National TAB

- **06/19/2024 National TAB - Stephen Tassinaro**
  - Fan is still not operational. NTi tech confirmed the thermostat switch is still working as intended. Fan is receiving 120v but does not function. NTi left fan unplugged.
    1. [Open](#) EF1\_Issues.mp4  
06/19/2024

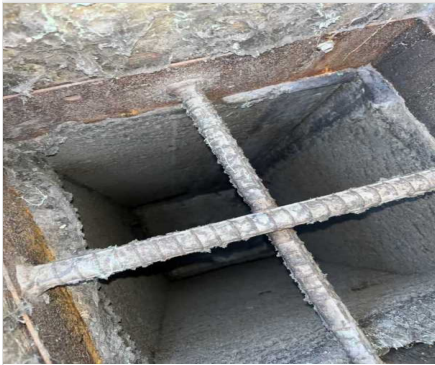
EF2\_DROP  
07/25/2023

**Issue Name :** EF2 No Backdraft Damper  
**Description :** No backdraft damper was found in the EF2 ductwork. Recommend installing to prevent drafting into the restrooms when the fan is not running.  
**Created By :** National TAB                      **Assigned To :** National TAB - Stephen Tassinaro  
**Status :** Open  
**Priority :** Medium                                      **Asset Tag :**  
**Originated Date :** 07/25/2023 - Stephen Tassinaro - National TAB

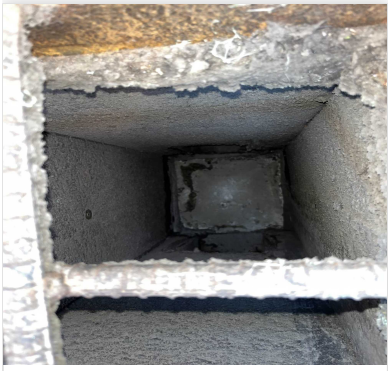
IMG\_3249  
06/17/2024

- **06/17/2024 National TAB - Stephen Tassinaro**
  - No damper installed.

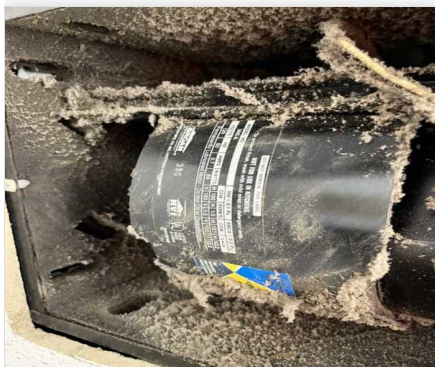
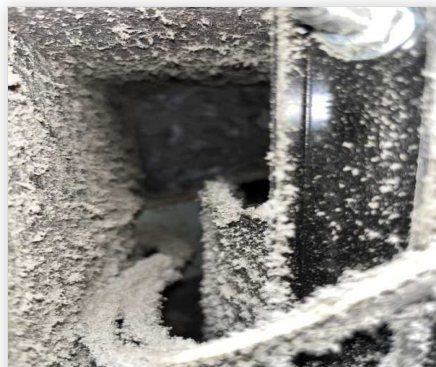
**Issue Name :** EF3 Dirty and Low Flow  
**Description :** EF3 in the employee room is exhausting 30CFM out of 100CFM design. Fan found to be functional but clogged with dirt and debris. Thorough cleaning recommended.  
**Created By :** National TAB                      **Assigned To :** National TAB - Stephen Tassinaro  
**Status :** Open  
**Priority :** **Urgent**                                      **Asset Tag :**  
**Originated Date :** 07/24/2023 - Stephen Tassinaro - National TAB

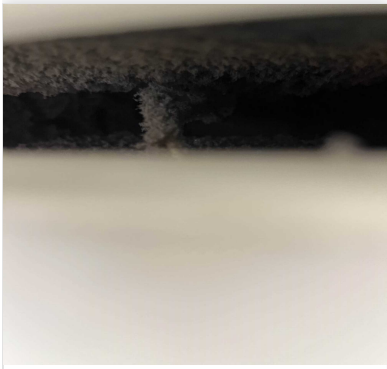
- **06/19/2024 National TAB - Stephen Tassinaro**
  - Airflow is now reduced to 0CFM, fan is still operating but flow hood is unable to detect any airflow. Fan is very dirty. It is possible a larger fan need be installed to overcome to rise to the rooftop from the basement, as well as thoroughly cleaning the duct.

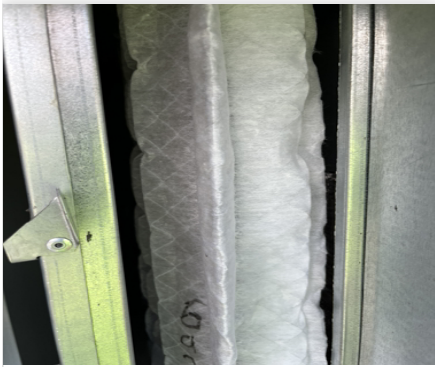
**CurrentFilters**  
**07/20/2023**

**Issue Name :** RTU Final Filters  
**Description :** Recommended to install the appropriate sized MERV 8 or better throwaway filters in the RTUs for improved filtration.  
**Created By :** National TAB                      **Assigned To :** National TAB - Stephen Tassinaro  
**Status :** Open  
**Priority :** Medium                                      **Asset Tag :**  
**Originated Date :** 07/20/2023 - Stephen Tassinaro - National TAB

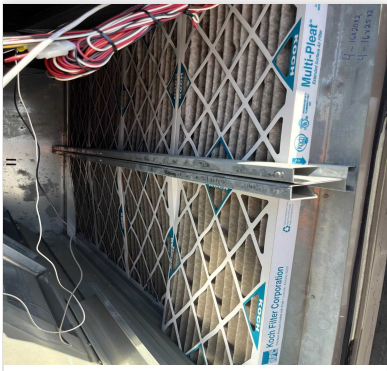
**Dirty\_Filters**  
**06/19/2024**

- **06/17/2024 National TAB - Stephen Tassinaro**
  - MERV 8 filters now installed in all units, but they are dirty and due for replacement.

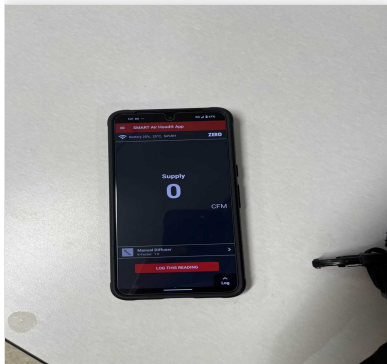
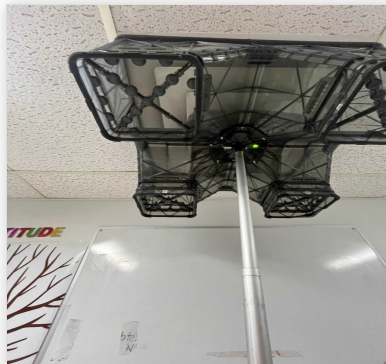
**Issue Name :** SGRD2-17 Low Flow  
**Description :** SGRD2-17 airflow below design (15CFM out of 100CFM Design). NTAB inspected duct from within employee room and where possible on the first floor and did not see any restrictions. Recommend ensuring take-off is secure and damper is open to increase airflow to downstairs employee room.  
**Created By :** National TAB                      **Assigned To :** National TAB - Stephen Tassinaro  
**Status :** Open  
**Priority :** Urgent                                      **Asset Tag :**  
**Originated Date :** 07/24/2023 - Stephen Tassinaro - National TAB

- **06/19/2024 National TAB - Stephen Tassinaro**
  - NTi measured no improvement at the supply grille in the employee room.
