Report: TAB REPORT
Function: Test, Adjust, & Balance
Date: 07/24/2023

07-10-23 WALGREENS #1769 - DENVER, CO

Project: 07-10-23 WALGREENS #1769 - DENVER, CO

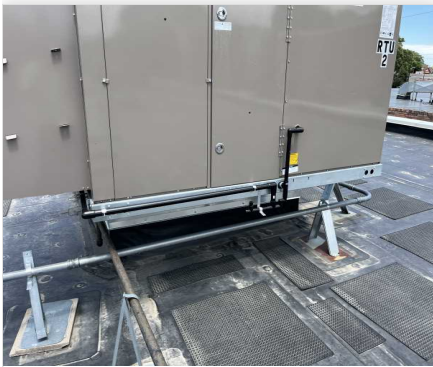
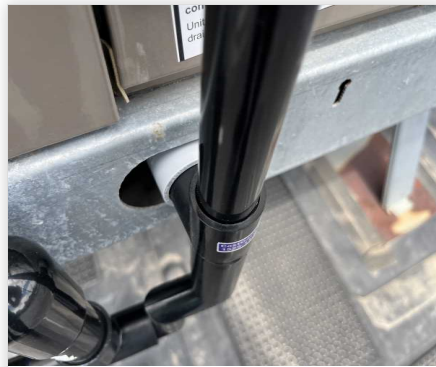
Issue Name : Costguard Unions Are Not Cemented
Description : All unions in the Costguard were found to be loose and not cemented. The condensate drains also terminate at the units, there is no drainage beyond the Costguard systems.

UNIONS ARE NOT CEMENTED

CONDENSATE PIPING TERMINATES AT RTUS

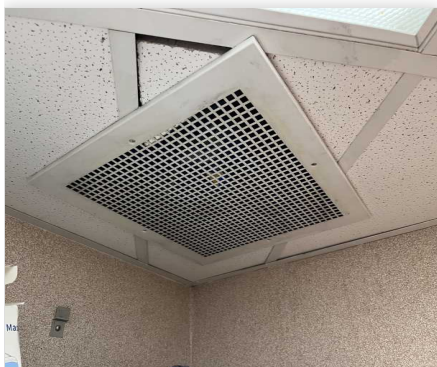
EF1
07/25/2023

Issue Name : EF1 Not Functional
Description : EF1 in the manager's office is not functional. The thermostat on the wall appears to be working as it sends 120V to the fan when needed, however the fan motor does not respond. Appears motor replacement is necessary, cleaning also recommended.
Created By : National TAB **Assigned To :** National TAB - Will Turnbough
Status : Open
Originated Date : 07/20/2023 - Stephen Tassinaro - National TAB

Existing fans have issues. EF1 motor is not functional. EF3 is extremely dirty resulting in no airflow.

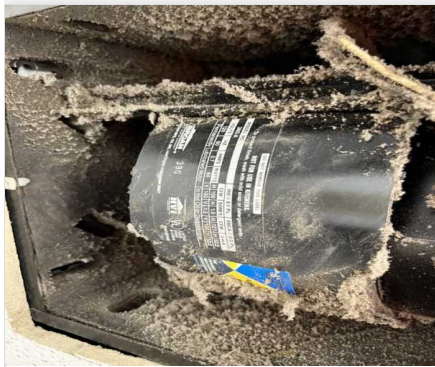
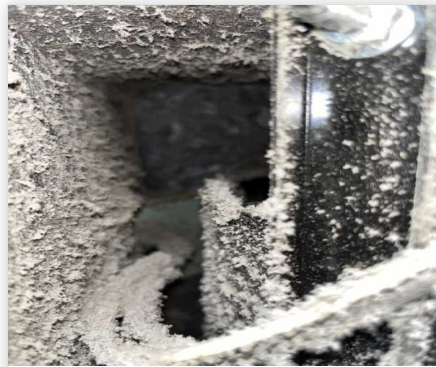
Issue Name : EF3 Dirty and Low Flow
Description : EF3 in the employee room is exhausting 30CFM out of 100CFM design. Fan found to be functional but clogged with dirt and debris. Thorough cleaning recommended.
Created By : National TAB **Assigned To :** National TAB - Will Turnbough
Status : Open
Originated Date : 07/24/2023 - Stephen Tassinaro - National TAB

Notes:
FAN RUNNING BUT DIRTY AND IN NEED OF CLEANING.

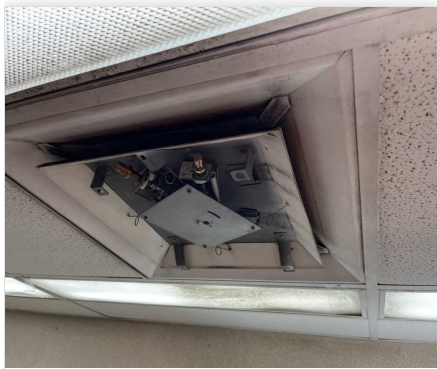
OFFICE_SUPPLY
07/25/2023

Issue Name : Office Supply Diffuser Missing Cover
Description : The supply diffuser in the Manager's Office is missing its cover. This does not appear to be causing performance issues but is unsightly. Recommend installing cover and cleaning diffuser.
Created By : National TAB **Assigned To :** National TAB - Will Turnbough
Status : Open
Originated Date : 07/25/2023 - Stephen Tassinaro - National TAB

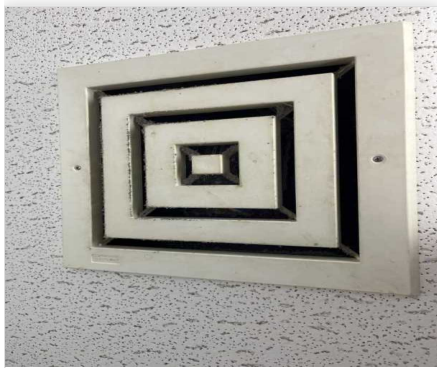
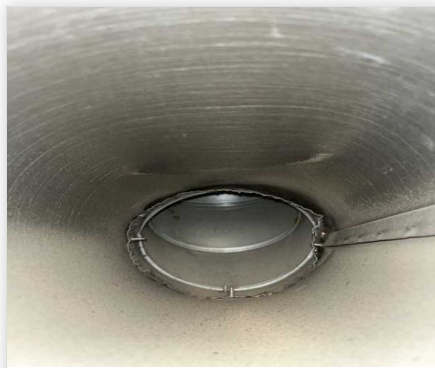
Issue Name : SGRD2-17 Low Flow
Description : SGRD2-17 airflow below design (15CFM out of 100CFM Design). NTAB inspected duct from within employee room and where possible on the first floor and did not see any restrictions. Recommend ensuring take-off is secure and damper is open to increase airflow to downstairs employee room.
Created By : National TAB **Assigned To :** National TAB - Will Turnbough
Status : Open
Originated Date : 07/24/2023 - Stephen Tassinaro - National TAB
