Report: TAB REPORT
Function: Test, Adjust, & Balance
Date: 07/24/2023

06-24-24 WALGREENS #1769 - DENVER, CO

Project: 06-24-24 WALGREENS #1769 - DENVER, CO

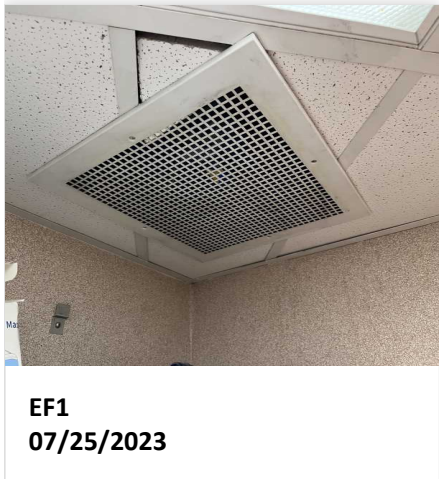
Issue Name : EF1 Not Functional
Description : EF1 in the manager's office is not functional. The thermostat on the wall appears to be working as it sends 120V to the fan when needed, however the fan motor does not respond. Appears motor replacement is necessary, cleaning also recommended.
Created By : National TAB **Assigned To :** National TAB - Stephen Tassinaro
Status : Open
Priority : Urgent **Asset Tag :**
Originated Date : 07/20/2023 - Stephen Tassinaro - National TAB

- **06/19/2024 National TAB - Stephen Tassinaro**
 - Fan is still not operational. NTi tech confirmed the thermostat switch is still working as intended. Fan is receiving 120v but does not function. NTi left fan unplugged.
 1. [Open](#) EF1_Issues.mp4
06/19/2024

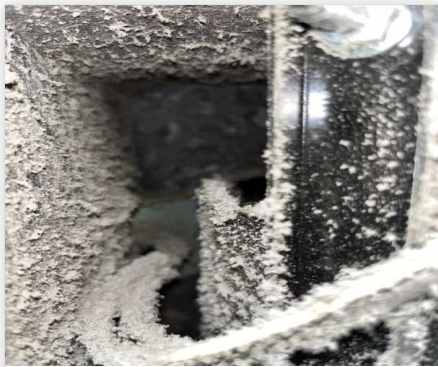
Issue Name : EF3 Dirty and Low Flow
Description : EF3 in the employee room is exhausting 30CFM out of 100CFM design. Fan found to be functional but clogged with dirt and debris. Thorough cleaning recommended.
Created By : National TAB **Assigned To :** National TAB - Stephen Tassinaro
Status : Open
Priority : **Urgent** **Asset Tag :**
Originated Date : 07/24/2023 - Stephen Tassinaro - National TAB

EF3
07/25/2023

EF3_DEBRIS
07/25/2023

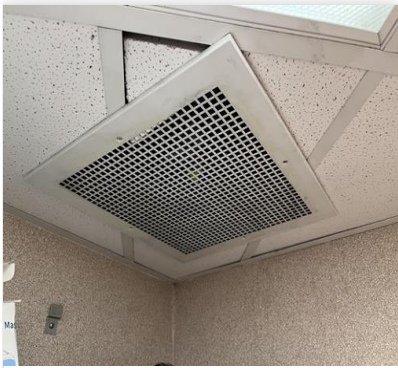
EF1
07/25/2023

Existing fans have issues. EF1 motor is not functional. EF3 is extremely dirty resulting in no airflow.
