Report: TAB REPORT
Function: Test, Adjust, & Balance
Date: 07/24/2023

07-10-23 WALGREENS #1769 - DENVER, CO

Project: 07-10-23 WALGREENS #1769 - DENVER, CO

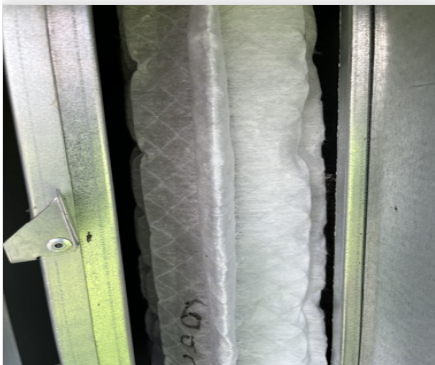
CurrentFilters
07/20/2023

Issue Name : RTU Final Filters
Description : Recommended to install the appropriate sized MERV 8 or better throwaway filters in the RTUs for improved filtration.
Created By : National TAB **Assigned To :** National TAB - Will Turnbough
Status : Open
Originated Date : 07/20/2023 - Stephen Tassinaro - National TAB

RECOMMEND MERV 8 (OR BETTER) THROWAWAY FILTERS TO BE INSTALLED.

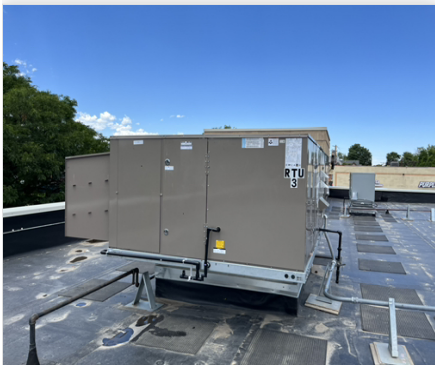
RTU2(1)
07/20/2023

Issue Name : RTU Labeling
Description : The current RTU labeling does not match that of the RTU submittals. NTi reported units per the submittal numbering.
Created By : National TAB **Assigned To :** National TAB - Will Turnbough
Status : Open
Originated Date : 07/20/2023 - Stephen Tassinaro - National TAB
