**National TAB  
1329 E. KEMPER ROAD  
SUITE 4210  
CINCINNATI, OH 45246**

**Report: TAB REPORT  
Function: Test, Adjust, & Balance  
Date: 06/08/2023**

**PROJECT  
05-29-23 CULVERS - APPLETON, WI**

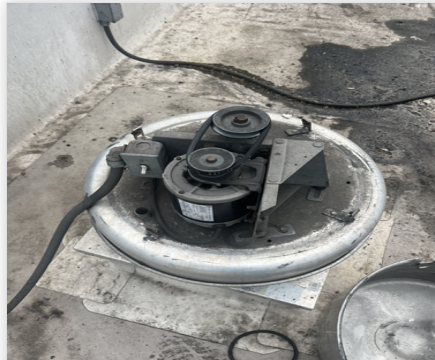
**Issue Name :** PRV-1 (customer RR) Rotation Incorrect  
**Description :** PRV-1 was initially found off, with a broken belt. Belt was replaced but fan is rotating the incorrect direction. Instructions for correcting rotation are on motor label. Recommend this is corrected.  
**Created By :** National TAB                      **Assigned To :** National TAB - Michael McDonnell  
**Status :** Open  
**Originated Date :** 06/07/2023 - Michael McDonnell - National TAB

PRV-1: PRV-1 serves the customer restrooms and was not operating on arrival. The belt was found damaged and the electrical disconnect turned off. A new belt was installed, and the fan runs but is spinning in the incorrect direction. Recommend rotation is corrected and the fan powered on. The building was balanced positive enough that once the fan is operational, it should not have a significant impact on the net pressure.

Rotation is correct?	Rotation is incorrect on PRV-1 (customer restroom). Correct on all others.
Belts are tight?	Yes
Grease cup installed on hood fan?	Yes
Hinge kit installed installed on hood fan?	Yes

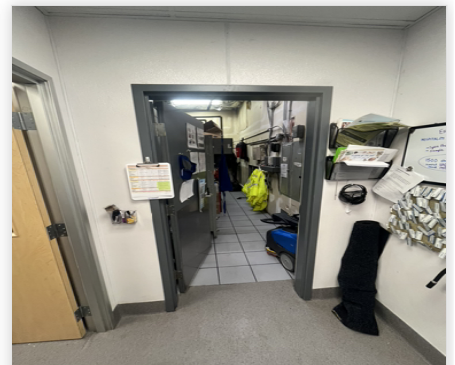
**Issue Name :** PRV-5 Mechanical Room Exhaust  
**Description :** PRV-5 serves the back mechanical room where the walk-in cooler is located. The fan is activated by temperature setpoint and when activated, powers on and opens a relief louvre in the mechanical room. Recommend the door to the mechanical room is kept closed so PRV-5 operation doesn't impact store balance and pulls exhaust from the louvre and not the store.

PRV-5: This fan serves the back mechanical room where the walk-in cooler is located. It operates based on a thermostat and activates when the room reaches a certain temperature. When the fan is activated, a louvre in the room opens to bring fresh air into the space and reduce the temperature. Once the thermostat is satisfied, the fan turns off and the louvre closes. When PRV-5 is operational, most often on warmer days, it pulls from the store space and causes the store to go negative. We recommend that the door to this room is kept shut so that when PRV-5 is activated, it only pulls from the louvre and not the store. This will prevent already treated air from being exhausted and prevent the store from becoming negatively pressurized and pulling untreated air into the store space.

Notes: [1] AIRFLOW NOT MEASURED. DOES NOT IMPACT BUILDING PRESSURE AS LONG AS DOOR TO MECHANICAL ROOM IS KEPT CLOSED. RECOMMEND DOOR IS KEPT CLOSED.

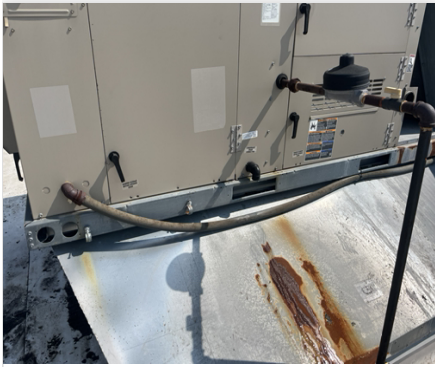
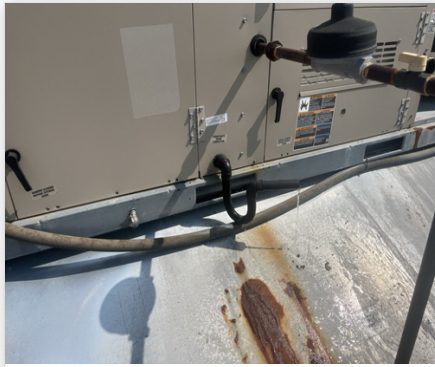
**Issue Name :** RESOLVED: RTU-3 (dining) Condensate Drain Not installed  
**Description :** RTU-3 did not have a condensate drain installed on arrival. Drain was found laying on roof and reattached. Recommend drain is secured.  
**Created By :** National TAB                      **Assigned To :** National TAB - Michael McDonnell  
**Status :** Open  
**Originated Date :** 06/07/2023 - Michael McDonnell - National TAB
