**National TAB
1329 E. KEMPER ROAD
SUITE 4210
CINCINNATI, OH 45246**

**Report: TAB REPORT
Function: Test, Adjust, & Balance
Date: 06/08/2023**

**PROJECT
05-29-23 CULVERS - APPLETON, WI**

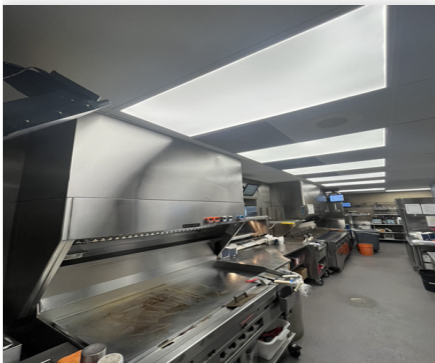
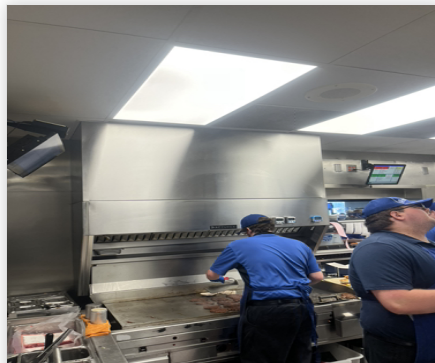
Issue Name : MAU Cookline Diffuser Locations
Description : The MAU serves 4 diffusers along the cookline that are positioned directly above the hood cooking surface. This is disrupting hood capture and cooling the griddle cooking surface in the summer. Typically these diffusers are positioned further back from the hoods to avoid hood disruption.

The store has a make-up-air unit (MAU) that is conditioned (provides both heating and cooling) and serves 4 diffusers located along the cookline. These diffusers are positioned directly above the cooking equipment. Typically, the cookline diffusers are installed further back from the hoods to condition the air but not disrupt hood capture. This is also why perforated grilles and 2' straight necks are usually used on these diffusers (so air blows straight down and not at the hood). These diffusers are perforated but do not have the straight necks installed. As installed, the MAU diffusers were significantly impacting hood capture, specifically on the griddle. Because the MAU provides a significant portion of the kitchen supply airflow, we did not want to turn it off or slow it down. The diffusers directly above the cooking equipment were dampened down, with the diffuser above the griddle closed significantly. This slightly lowered the total MAU supply airflow, but greatly improved hood capture.

| Is space free of drafting? | No, position of cookline diffusers directly above hoods was causing smoke capture issues, especially on the griddle. |

- **06/07/2023 National TAB - Michael McDonnell**
 - Diffuser directly above griddle dampened closed, hood capture significantly improved.

| If deviations from design were necessary to resolve 1-3 what were they? Otherwise put "NA". | MAU cookline supply diffuser positioned directly above griddle was dampened shut. Hood capture much improved. |

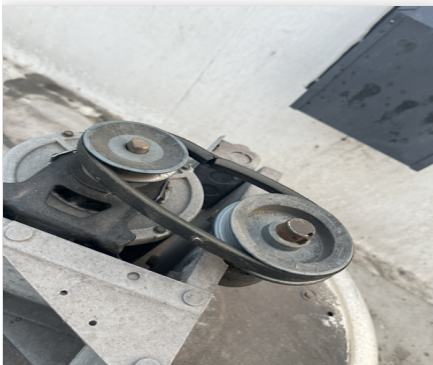
Issue Name : PRV-1 (customer RR) Rotation Incorrect
Description : PRV-1 was initially found off, with a broken belt. Belt was replaced but fan is rotating the incorrect direction. Instructions for correcting rotation are on motor label. Recommend this is corrected.
Created By : National TAB **Assigned To :** National TAB - Michael McDonnell
Status : Open
Originated Date : 06/07/2023 - Michael McDonnell - National TAB

PRV-1: PRV-1 serves the customer restrooms and was not operating on arrival. The belt was found damaged and the electrical disconnect turned off. A new belt was installed, and the fan runs but is spinning in the incorrect direction. Recommend rotation is corrected and the fan powered on. The building was balanced positive enough that once the fan is operational, it should not have a significant impact on the net pressure.

| Rotation is correct? | Rotation is incorrect on PRV-1 (customer restroom). Correct on all others. |

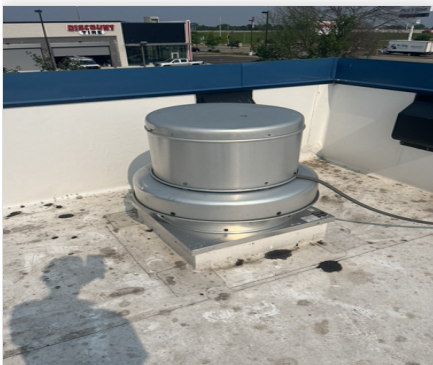
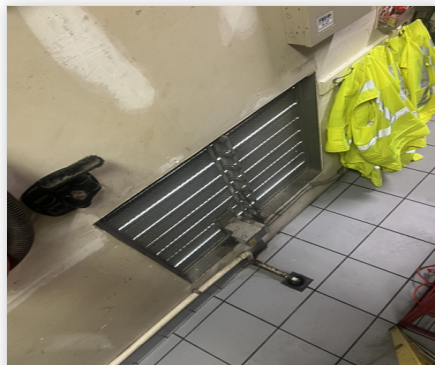
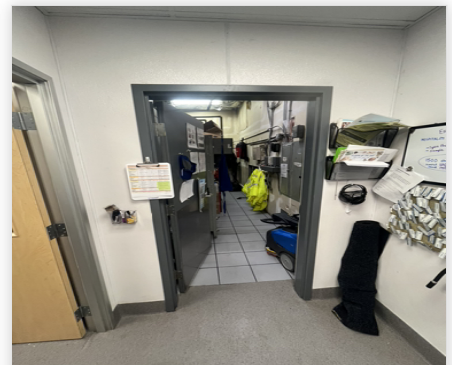
Issue Name : PRV-5 Mechanical Room Exhaust
Description : PRV-5 serves the back mechanical room where the walk-in cooler is located. The fan is activated by temperature setpoint and when activated, powers on and opens a relief louvre in the mechanical room. Recommend the door to the mechanical room is kept closed so PRV-5 operation doesn't impact store balance and pulls exhaust from the louvre and not the store.

PRV-5: This fan serves the back mechanical room where the walk-in cooler is located. It operates based on a thermostat and activates when the room reaches a certain temperature. When the fan is activated, a louvre in the room opens to bring fresh air into the space and reduce the temperature. Once the thermostat is satisfied, the fan turns off and the louvre closes. When PRV-5 is operational, most often on warmer days, it pulls from the store space and causes the store to go negative. We recommend that the door to this room is kept shut so that when PRV-5 is activated, it only pulls from the louvre and not the store. This will prevent already treated air from being exhausted and prevent the store from becoming negatively pressurized and pulling untreated air into the store space.

Notes: [1] AIRFLOW NOT MEASURED. DOES NOT IMPACT BUILDING PRESSURE AS LONG AS DOOR TO MECHANICAL ROOM IS KEPT CLOSED. RECOMMEND DOOR IS KEPT CLOSED.

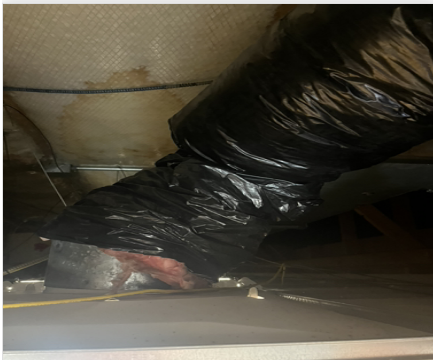
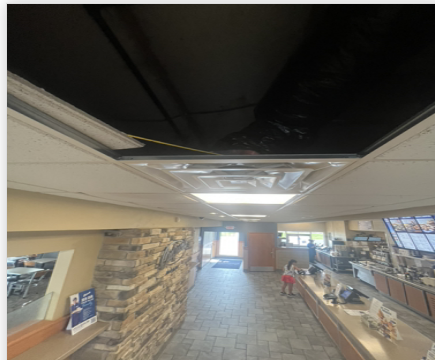
Issue Name : RTU-3 Diffuser Duct pinched, no airflow.
Description : An RTU-3 diffuser to the right of the serving counter (when facing menu) has its duct pinched due to disconnected hard duct wrapped in flex. The diffuser has no airflow. Recommend the pinched duct is resolved.
Created By : National TAB **Assigned To :** National TAB - Michael McDonnell
Status : Open
Originated Date : 06/07/2023 - Michael McDonnell - National TAB

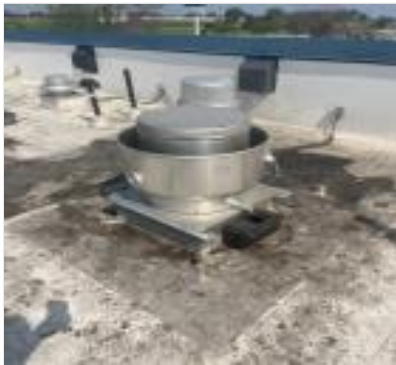
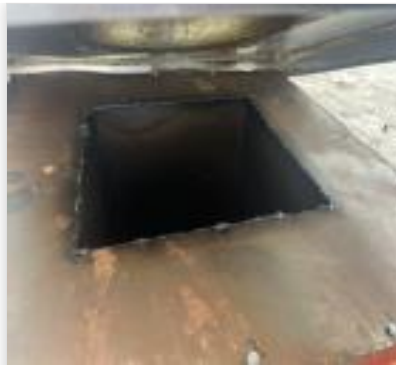
PRV-2
06/07/2023

PRV-2 and PRV-3: These fans serve HD-1 and HD-2 respectively. They are installed properly, and airflow is at design. There is some significant grease staining surrounding PRV-2 but we assume this was caused by the previous fan as the new fan appears clean and the grease drain/trap is properly installed.
