Report: TAB REPORT
Function: Test, Adjust, & Balance
Date: 06/08/2023

PROJECT
05-29-23 CULVERS - APPLETON, WI

3631 E CALUMET ST

APPLETON, WI 54915

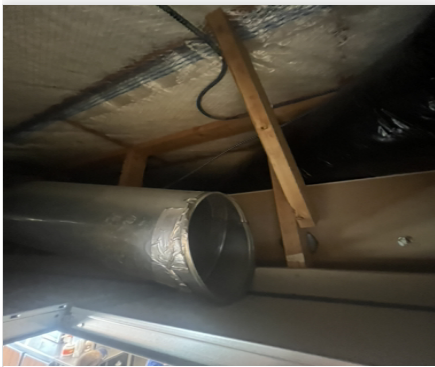
Deletedduct
06/07/2023

Issue Name : INFO ONLY: Unused Duct Laying in Ceiling Space
Description : Several deleted/ unused ducts were found laying in the ceiling space, specifically above the serving/drive-thru area. Recommend these are removed.
Created By : National TAB **Assigned To :** National TAB - Michael McDonnell
Status : Open
Originated Date : 06/07/2023 - Michael McDonnell - National TAB

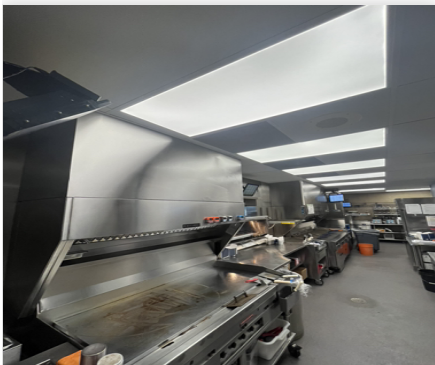
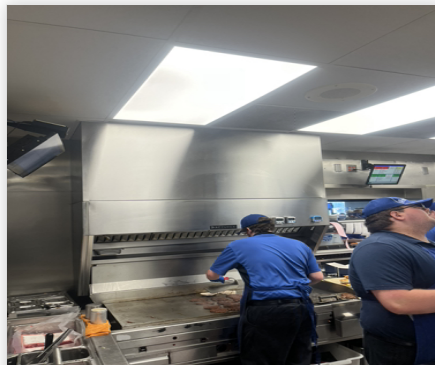
Issue Name : MAU Cookline Diffuser Locations
Description : The MAU serves 4 diffusers along the cookline that are positioned directly above the hood cooking surface. This is disrupting hood capture and cooling the griddle cooking surface in the summer. Typically these diffusers are positioned further back from the hoods to avoid hood disruption.

The store has a make-up-air unit (MAU) that is conditioned (provides both heating and cooling) and serves 4 diffusers located along the cookline. These diffusers are positioned directly above the cooking equipment. Typically, the cookline diffusers are installed further back from the hoods to condition the air but not disrupt hood capture. This is also why perforated grilles and 2' straight necks are usually used on these diffusers (so air blows straight down and not at the hood). These diffusers are perforated but do not have the straight necks installed. As installed, the MAU diffusers were significantly impacting hood capture, specifically on the griddle. Because the MAU provides a significant portion of the kitchen supply airflow, we did not want to turn it off or slow it down. The diffusers directly above the cooking equipment were dampened down, with the diffuser above the griddle closed significantly. This slightly lowered the total MAU supply airflow, but greatly improved hood capture.

- **06/07/2023 National TAB - Michael McDonnell**
 - Diffuser directly above griddle dampened closed, hood capture significantly improved.

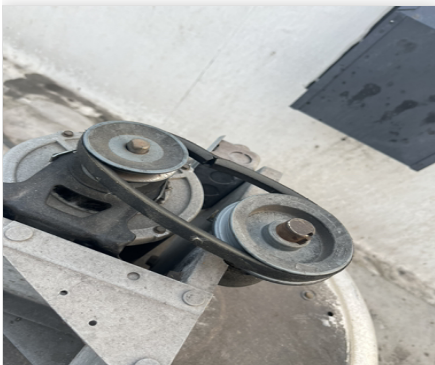
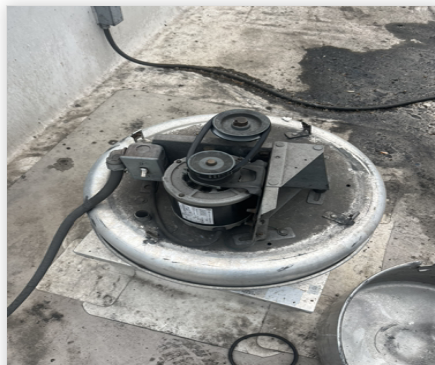
Issue Name : PRV-1 (customer RR) Rotation Incorrect
Description : PRV-1 was initially found off, with a broken belt. Belt was replaced but fan is rotating the incorrect direction. Instructions for correcting rotation are on motor label. Recommend this is corrected.
Created By : National TAB **Assigned To :** National TAB - Michael McDonnell
Status : Open
Originated Date : 06/07/2023 - Michael McDonnell - National TAB

PRV-1: PRV-1 serves the customer restrooms and was not operating on arrival. The belt was found damaged and the electrical disconnect turned off. A new belt was installed, and the fan runs but is spinning in the incorrect direction. Recommend rotation is corrected and the fan powered on. The building was balanced positive enough that once the fan is operational, it should not have a significant impact on the net pressure.

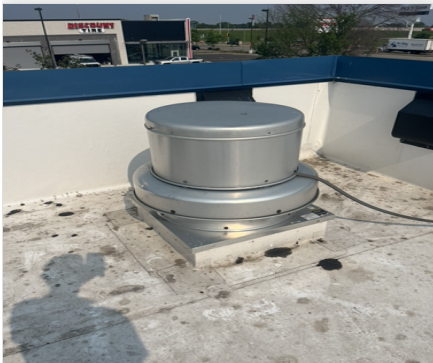
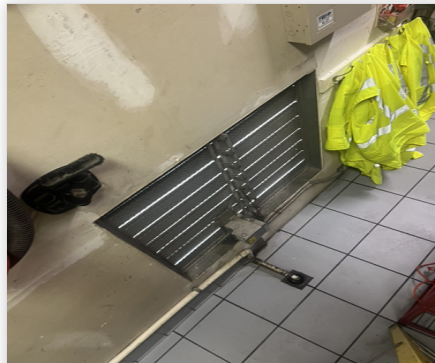
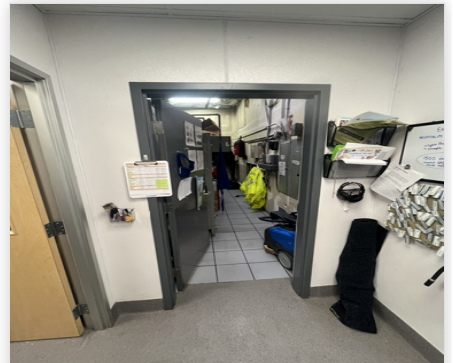
Issue Name : PRV-5 Mechanical Room Exhaust
Description : PRV-5 serves the back mechanical room where the walk-in cooler is located. The fan is activated by temperature setpoint and when activated, powers on and opens a relief louvre in the mechanical room. Recommend the door to the mechanical room is kept closed so PRV-5 operation doesn't impact store balance and pulls exhaust from the louvre and not the store.

PRV-5: This fan serves the back mechanical room where the walk-in cooler is located. It operates based on a thermostat and activates when the room reaches a certain temperature. When the fan is activated, a louvre in the room opens to bring fresh air into the space and reduce the temperature. Once the thermostat is satisfied, the fan turns off and the louvre closes. When PRV-5 is operational, most often on warmer days, it pulls from the store space and causes the store to go negative. We recommend that the door to this room is kept shut so that when PRV-5 is activated, it only pulls from the louvre and not the store. This will prevent already treated air from being exhausted and prevent the store from becoming negatively pressurized and pulling untreated air into the store space.

Notes: [1] AIRFLOW NOT MEASURED. DOES NOT IMPACT BUILDING PRESSURE AS LONG AS DOOR TO MECHANICAL ROOM IS KEPT CLOSED. RECOMMEND DOOR IS KEPT CLOSED.

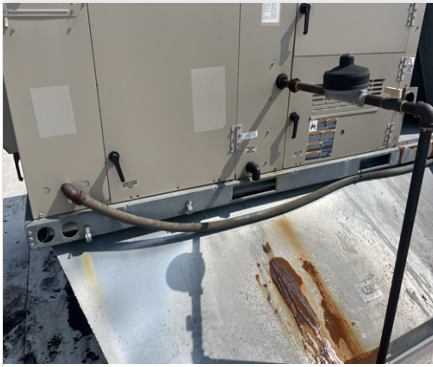
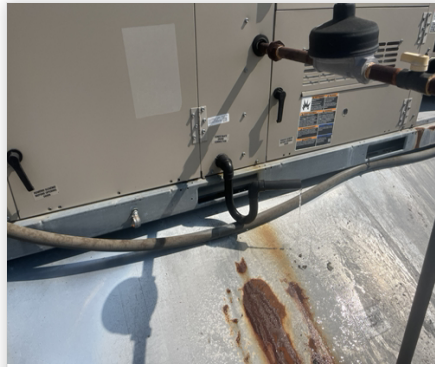
Issue Name : RESOLVED: RTU-3 (dining) Condensate Drain Not installed
Description : RTU-3 did not have a condensate drain installed on arrival. Drain was found laying on roof and reattached. Recommend drain is secured.
Created By : National TAB **Assigned To :** National TAB - Michael McDonnell
Status : Open
Originated Date : 06/07/2023 - Michael McDonnell - National TAB

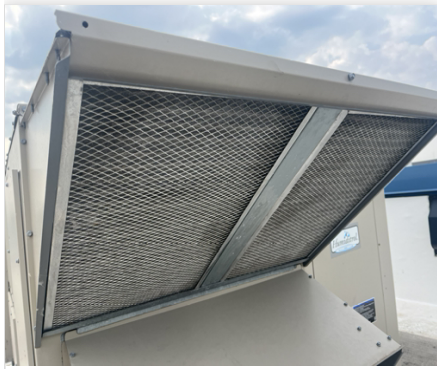
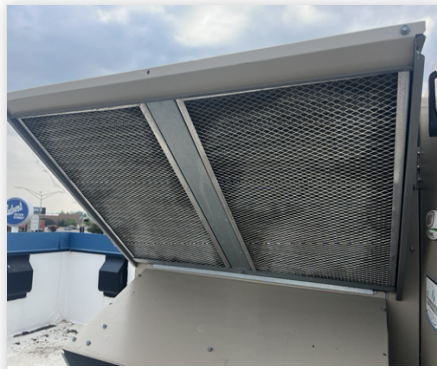
Issue Name : RTU OA filters installed backwards.

Description : OA filters are installed backwards in the units. Metal support grate should be on the inside of the filter.

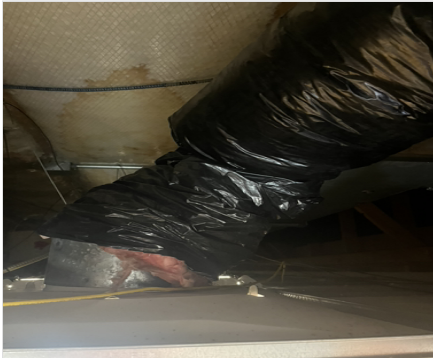
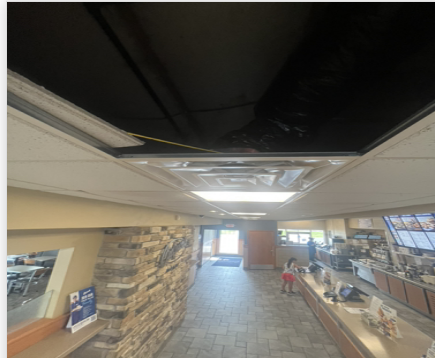
Issue Name : RTU-3 Diffuser Duct pinched, no airflow.
Description : An RTU-3 diffuser to the right of the serving counter (when facing menu) has its duct pinched due to disconnected hard duct wrapped in flex. The diffuser has no airflow. Recommend the pinched duct is resolved.
Created By : National TAB **Assigned To :** National TAB - Michael McDonnell
Status : Open
Originated Date : 06/07/2023 - Michael McDonnell - National TAB

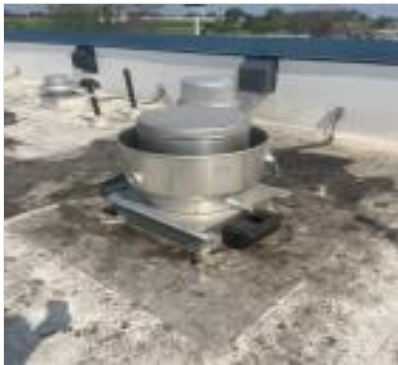
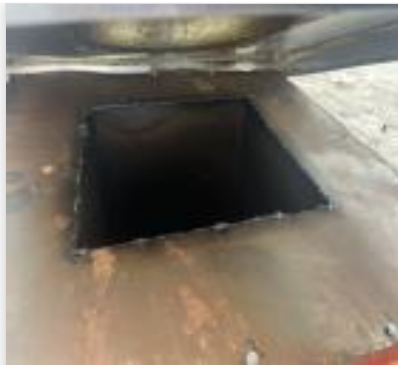
PRV-2 and PRV-3: These fans serve HD-1 and HD-2 respectively. They are installed properly, and airflow is at design. There is some significant grease staining surrounding PRV-2 but we assume this was caused by the previous fan as the new fan appears clean and the grease drain/trap is properly installed.
