Report: TAB Report
Function: Test, Adjust, & Balance
Date: 10/22/2025
Completed By: National TAB

PROJECT
01-12-26 QT #0585 OMAHA, NE

Project: 01-12-26 QT #0585 OMAHA, NE

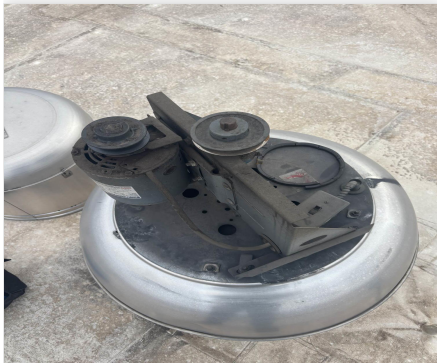
Issue Name : EF-1: Missing Belt
Description : The drive belt for EF-1 is missing. No airflow.
Created By : National TAB **Assigned To :** National TAB - Dan Hertenstein
Status : Open
Priority : Urgent **Asset Tag :** EF1
Originated Date : 01/15/2026 - Kalen Kemp - National TAB

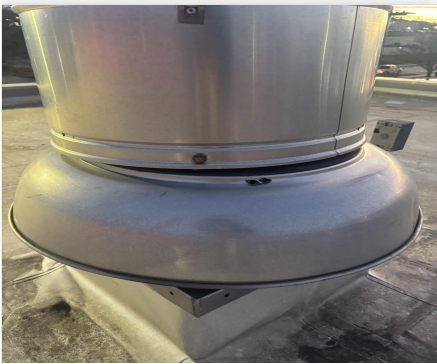
Issue Name : EF-1: Motor Cover/Housing
Description : The motor cover/housing is not securely fastened to the base of the fan.
Created By : National TAB **Assigned To :** National TAB - Dan Hertenstein
Status : Open
Priority : Low **Asset Tag :** EF1
Originated Date : 01/15/2026 - Kalen Kemp - National TAB

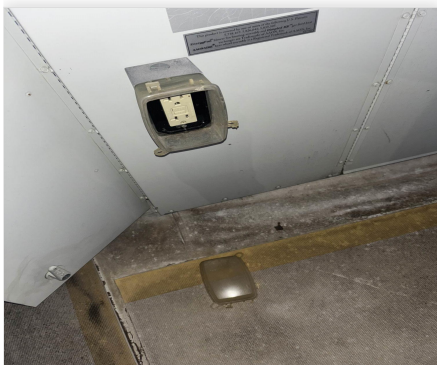
Issue Name : RT-1: GFI Outlet Cover
Description : The GFI outlet cover for RT-1 is not securely attached to the unit. Placed Cover over GFI outlet. Plastic tabs are broken and cover was found laying on the roof upon arrival.
Created By : National TAB **Assigned To :** National TAB - Dan Hertenstein
Status : Open
Priority : Low **Asset Tag :** RT-1
Originated Date : 01/15/2026 - Kalen Kemp - National TAB

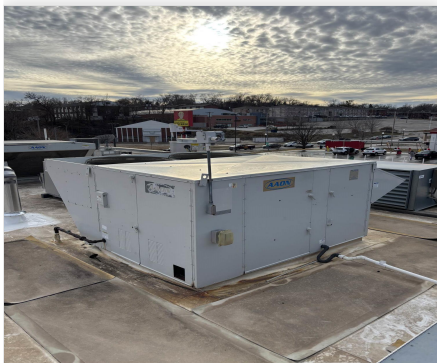
Issue Name : RT-2: Low Airflow
Description : RT-2 is low on airflow. Measured 3228 CFM. Design is 4,000 CFM. Adjusted motor sheave as far as possible. Set OA proportional to Supply airflow.
Created By : National TAB **Assigned To :** National TAB - Dan Hertenstein
Status : Open
Priority : High **Asset Tag :** RT-2
Originated Date : 01/15/2026 - Kalen Kemp - National TAB

RT-2 LOW ON AIRFLOW . MEASURED AT 3228 CFM. SET OA PROPORTIONAL TO SUPPLY. EF-1 MISSING DRIVE BELT. NO AIRFLOW.

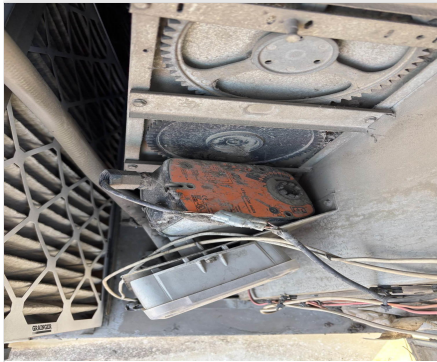
Issue Name : RT-2: OA Damper Actuator
Description : The OA damper actuator is not attached to the damper blades. OA damper position set manually.
Created By : National TAB **Assigned To :** National TAB - Dan Hertenstein
Status : Open
Priority : Medium **Asset Tag :** RT-2
Originated Date : 01/15/2026 - Kalen Kemp - National TAB

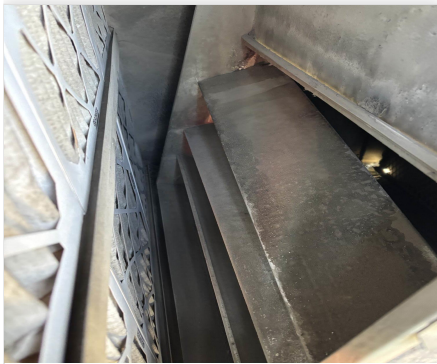
Issue Name : RT-2: Return Damper Blade
Description : A return damper blade is broken. Blade is detached from side wall.
Created By : National TAB **Assigned To :** National TAB - Dan Hertenstein
Status : Open
Priority : **Medium** **Asset Tag :** RT-2
Originated Date : 01/15/2026 - Kalen Kemp - National TAB

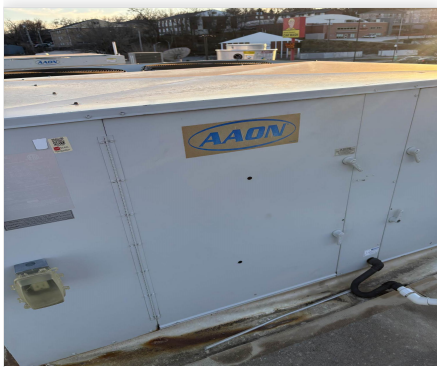
Issue Name : RT-2: Whistling Sound
Description : RT-2 has loud whistling sound coming from blower compartment door. Issue seems to be cause by bad seal.
Created By : National TAB **Assigned To :** National TAB - Dan Hertenstein
Status : Open
Priority : Low **Asset Tag :** RT-2
Originated Date : 01/15/2026 - Kalen Kemp - National TAB

RT-2 HAS WHISTLING SOUND AT BLOWER COMPARTMENT DOOR.

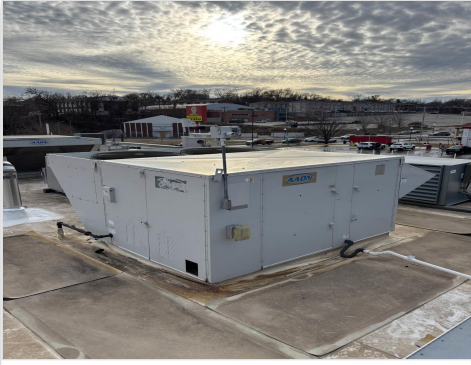
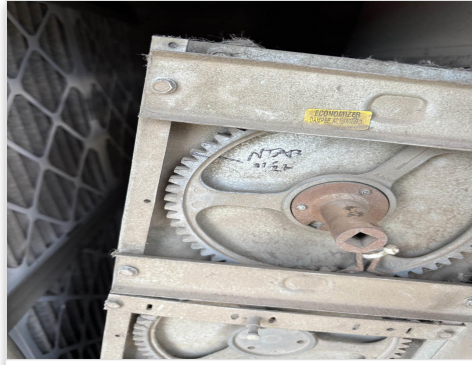
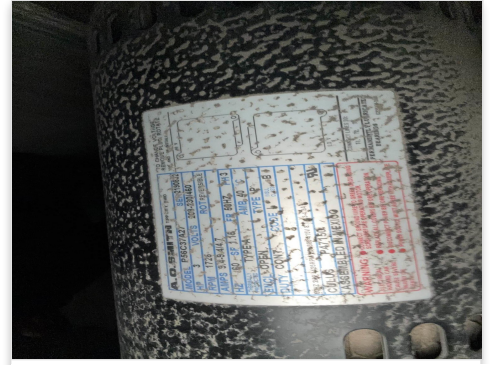
- UNIT IS LOW ON AIRFLOW. SET OA PROPORTIONAL TO SUPPLY.
- RETURN DAMPER BLADE BROKEN IN MA COMPARTMENT.
- ECONOMIZER ACTUATOR IS NOT ATTACHED TO DAMPER BLADES. DAMPER POSITION SET MANUALLY.

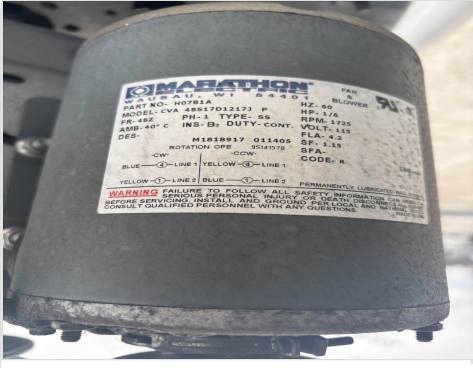
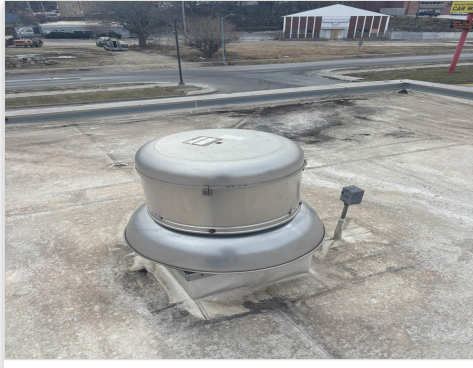
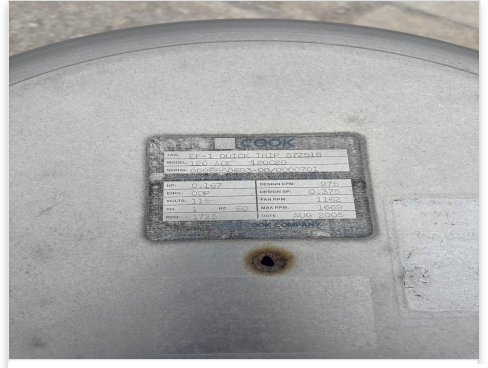
- FAN IS MISSING BELT. NO AIRFLOW.
- MOTOR COVER NOT SECURELY FASTENED.
