Report: TAB Report
Function: Test, Adjust, & Balance
Date: 10/22/2025
Completed By: National TAB

PROJECT
01-12-26 QT #0585 OMAHA, NE

4720 HAMILTON STREET

QUIKTRIP
4705 SOUTH 129TH EAST AVENUE
TULSA, OK 74134

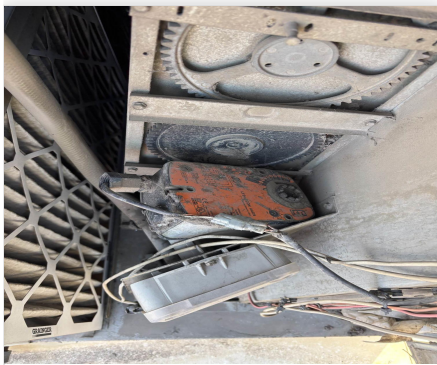
Issue Name : RT-2: OA Damper Actuator
Description : The OA damper actuator is not attached to the damper blades. OA damper position set manually.
Created By : National TAB **Assigned To :** National TAB - Dan Hertenstein
Status : Open
Priority : Medium **Asset Tag :** RT-2
Originated Date : 01/15/2026 - Kalen Kemp - National TAB

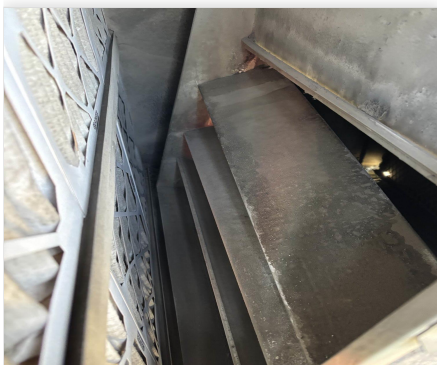
Issue Name : RT-2: Return Damper Blade
Description : A return damper blade is broken. Blade is detached from side wall.
Created By : National TAB **Assigned To :** National TAB - Dan Hertenstein
Status : Open
Priority : Medium **Asset Tag :** RT-2
Originated Date : 01/15/2026 - Kalen Kemp - National TAB

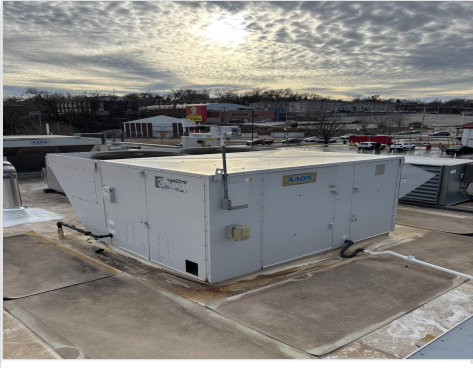
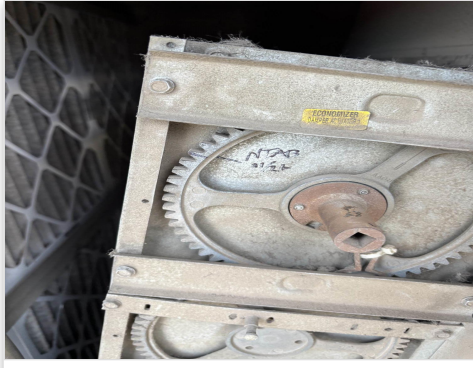
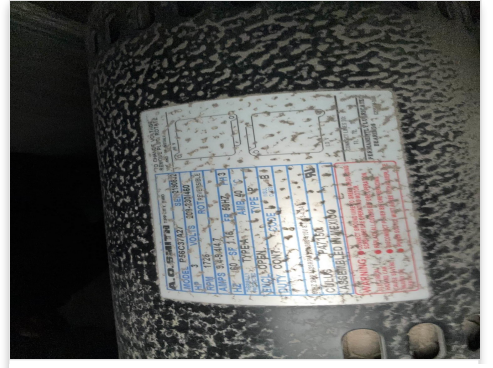
Asset: RT-2

- UNIT IS LOW ON AIRFLOW. SET OA PROPORTIONAL TO SUPPLY.
- RETURN DAMPER BLADE BROKEN IN MA COMPARTMENT.
- ECONOMIZER ACTUATOR IS NOT ATTACHED TO DAMPER BLADES. DAMPER POSITION SET MANUALLY.

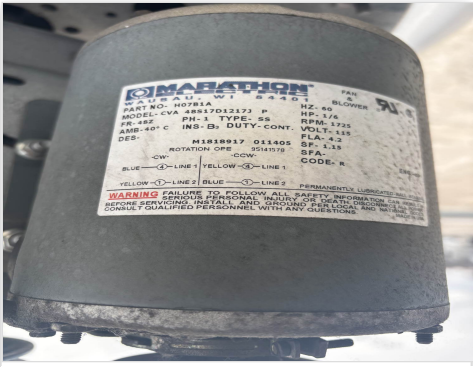
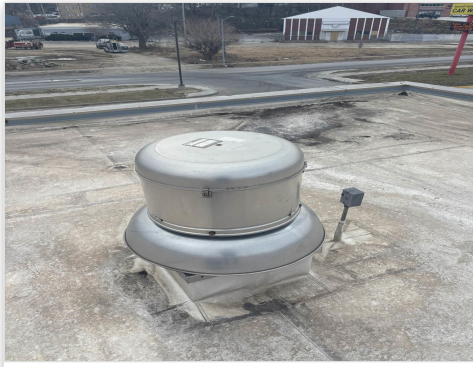
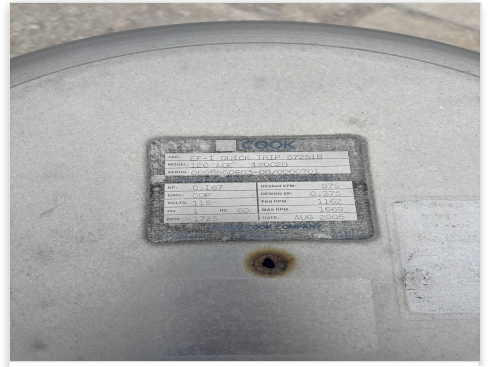
Asset: EF1

- FAN IS MISSING BELT. NO AIRFLOW.
- MOTOR COVER NOT SECURELY FASTENED.
