# PlanGrid Task Report - Dec 6, 2024

**L05162\_Walpole FSU (MA)**

Providence Highway, Walpole, Massachusetts

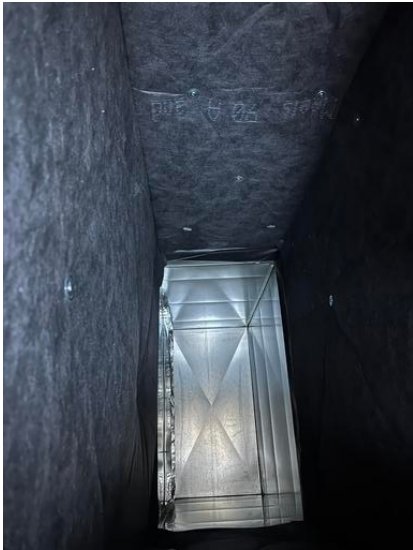
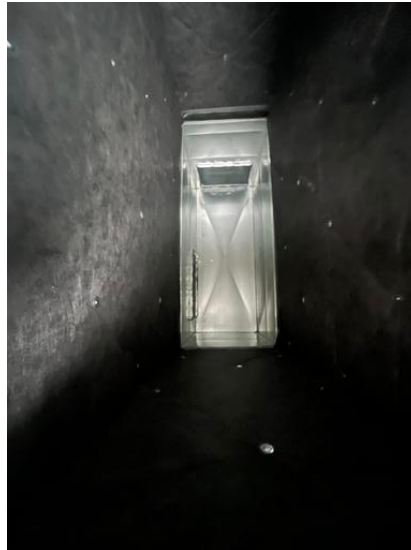
## #261 [DUCT 019] [NEW] CRITICAL – Incorrectly lined insulation.

AC Supply and Return Drops are internally lined. Liner is only allowed on rectangular restroom duct, and needs to be removed per specifications.

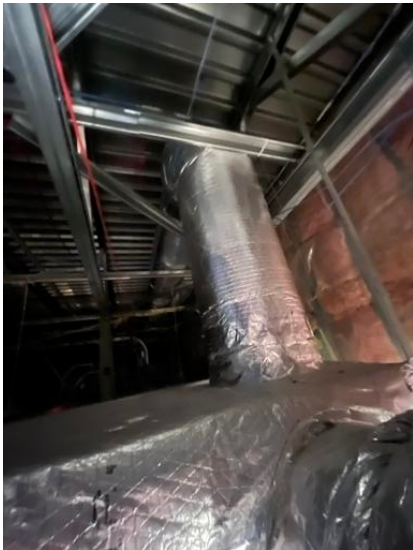
IMG\_2564

## #262 [DUCT 017] [NEW] CRITICAL – AC-4: Duct not installed per plans.

AC-4 takeoff for diffuser serving mechanical room comes off of the top of the duct. Deviation from plans, diffuser is low on airflow as a result. Recommend ductwork is corrected.

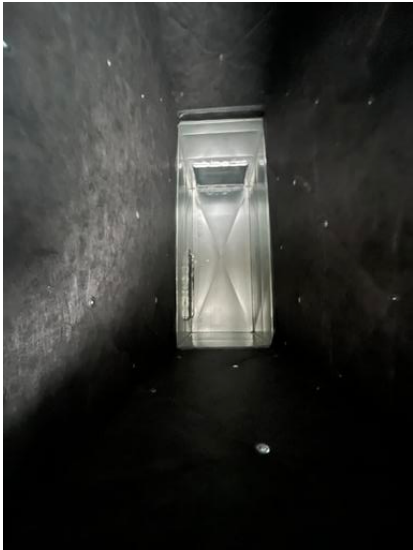
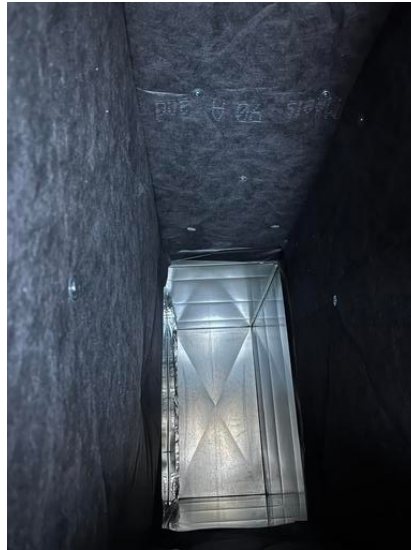
## #263 [DUCT 004] [NEW] CRITICAL – AC Duct drop transitions.

See key note 48 on M-101:  
Where duct offsets horizontally, provide elbow with single-thickenss vanes. Units that require, do not have vanes installed and drops are not radiused. Seek APPROVAL.

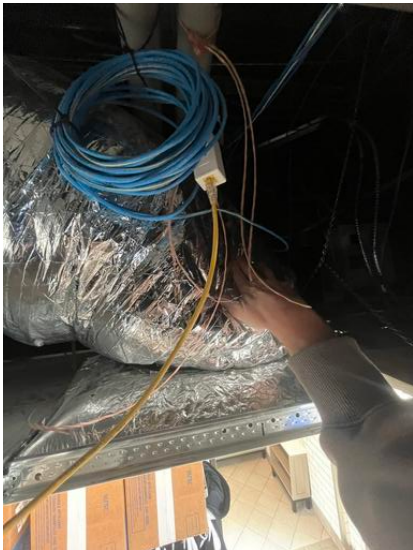
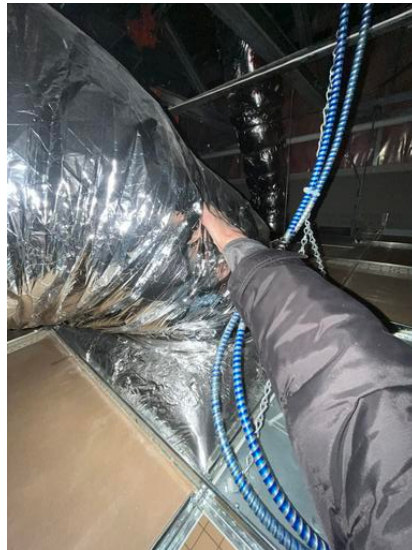
## #264 [DUCT 007] [NEW] CRITICAL – Diffuser rigid 90's.

Ensure rigid 90 degree fittings are secured to diffusers, with hard pipe risers adjusted to meet take off height elevation and connected to horizontal flex. No flex in drops allowed per details. Rigid 90s observed to be missing on all AC systems.

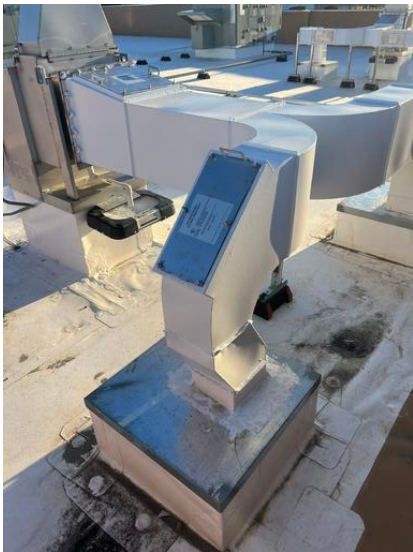
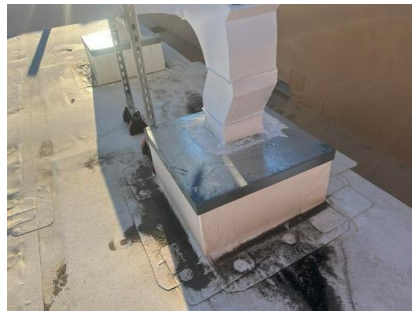
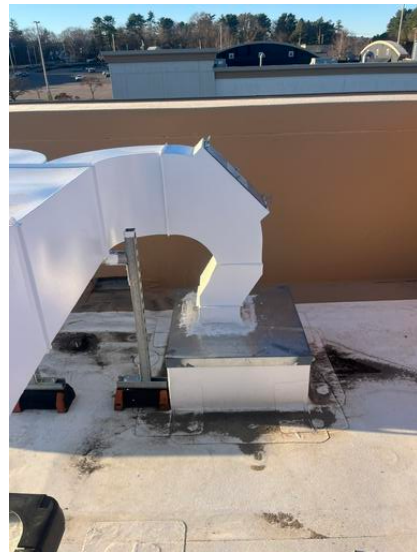
## #265 [EXHA 003] [NEW] CRITICAL – Incorrect grease exhaust duct ells.

EF-1 Grease ductwork not constructed with long radius centerline  $R=3W/2$  fittings per specification. Short radius, mitered ells, and offsets greater than 45 degrees are not allowed. Seek APPROVAL.

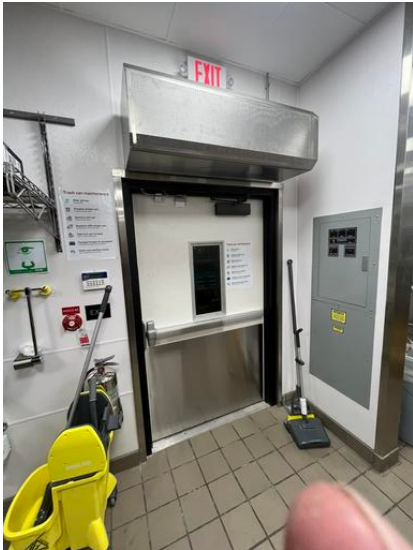
IMG\_2606

## #266 [CURT 999] [NEW] (MISC) Rear Kitchen Air Door not functional

Rear Air door in kitchen is not functional. Be sure timer is set to 0, so door shuts off immediately when closed (adjusted by internal blue potentiometer).

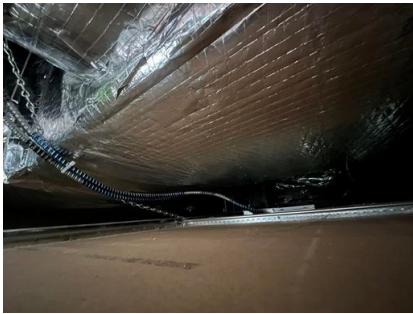
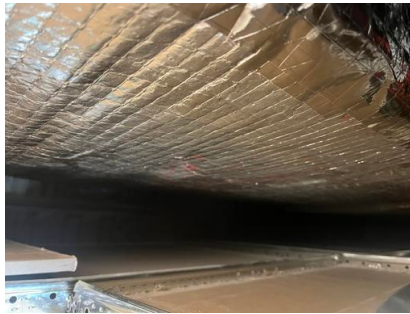
**#267 [DUCT 501] [NEW] Insulation stick pins.**

External insulation on bottom of ducts 24" or wider is to be supported by stick pins 18" on center. Cut pins and apply tape or mastic over stick pin washers. None observed on AC-2 ductwork.

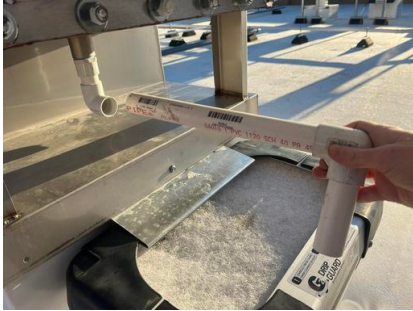
IMG\_2529

**#268 [EXHA 507] [NEW] Exhaust fan drain line.**

PVC drains need to be glued.

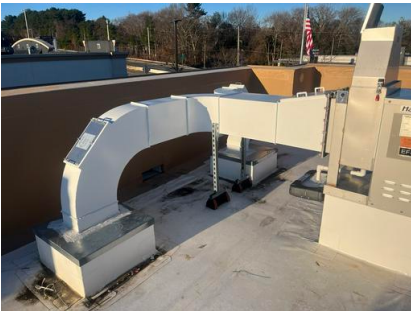
IMG\_2526

**#269 [EXHA 510] [NEW] Grease exhaust duct is not supported.**

EF-1: See key note 1 on exhaust fan detail on M-501. Support at each roof penetration.

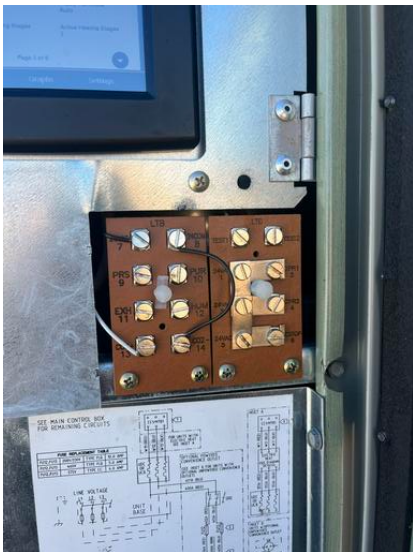
IMG\_2552

**#270 [CNTL 500] [NEW] AC-4: Humidistat terminations incorrect.**

Humidistat wiring not terminated correctly per control wiring detail. Appears landed at CO terminals. ESTOP wiring missing in this photo, this was already corrected.

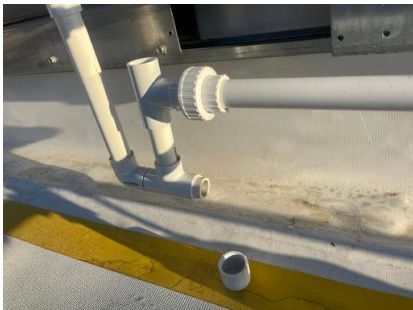
IMG\_2535

**#271 [UNIT 517] [NEW] Condensate piping construction.**

Equipment condensate piping or p-trap is not constructed per normal CFA specifications. Some ACs missing cleanout plug, end is capped.

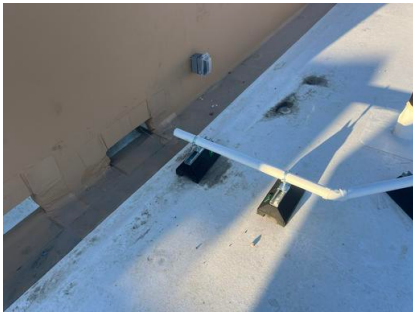
IMG\_2534

**#272 [UNIT 517] [NEW] Condensate piping termination.**

Condensate drains terminate on the roof. Recommend drain termination is extended and routed down into scupper per plans.

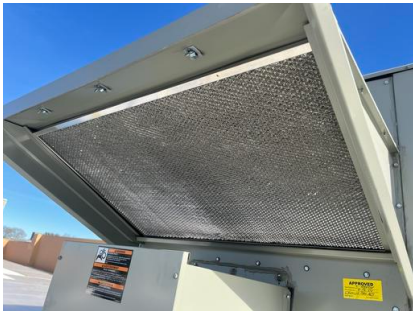
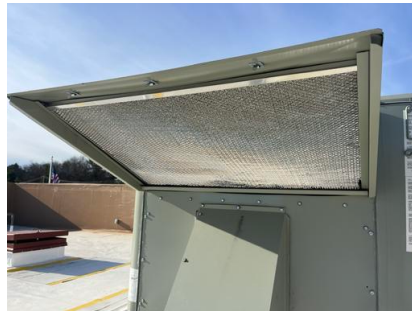
**#273 [UNIT 508] [NEW] AC Outdoor air intakes.**

AC outdoor intakes improperly assembled. OA filters must be able to be removed easily for cleaning.

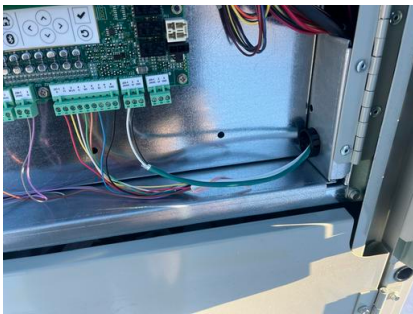
IMG\_2536

**#274 [CNTL 003] [NEW] CRITICAL – Wiring specifications.**

Sensor cable is not ConnectAir W221P-2003NT cable. Full spec and ordering at: [NetworkThermostat.com/CFA](http://NetworkThermostat.com/CFA)

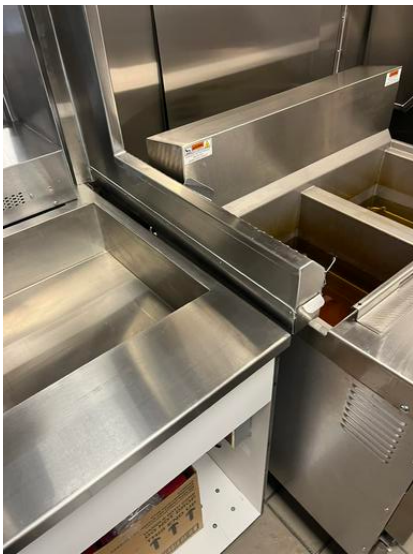
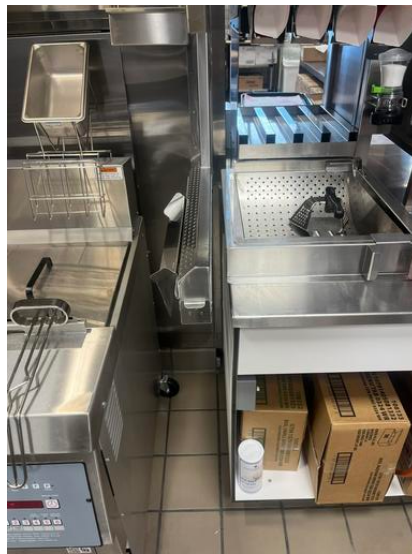
## #275 [HOOD 508] [NEW] Sidejet arm angle bracket.

The Halton supplied angle bracket that connects the integral sidejet arm to the counter is missing or not installed correctly. Secure bracket to arm and bracket to counter underneath removeable fry dump via stainless steel rivets.

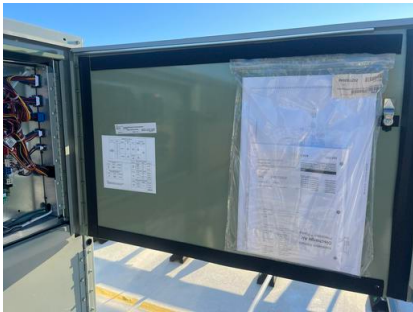
IMG\_2540

**#276 [UNIT 501] [NEW] Equipment low voltage diagrams**

Equipment missing laminated copy of controls detail low voltage wiring diagrams. Needs to be installed in each unit.

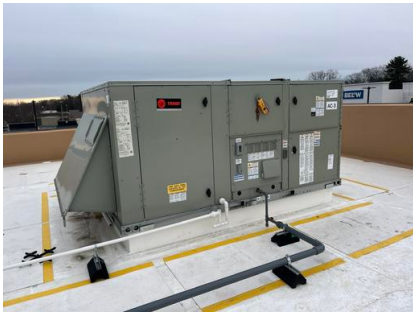
IMG\_2584

**#277 [UNIT 503] [NEW] Trane equipment missing field kits.**

Trane equipment does not have additional manufacturer supplied, field installed relays, delay timer, or discharge temperature controller with FAT scheduled in design. Unsure if Trane is still supplying FAT kits. RTU schedule calls for FAT, not installed.

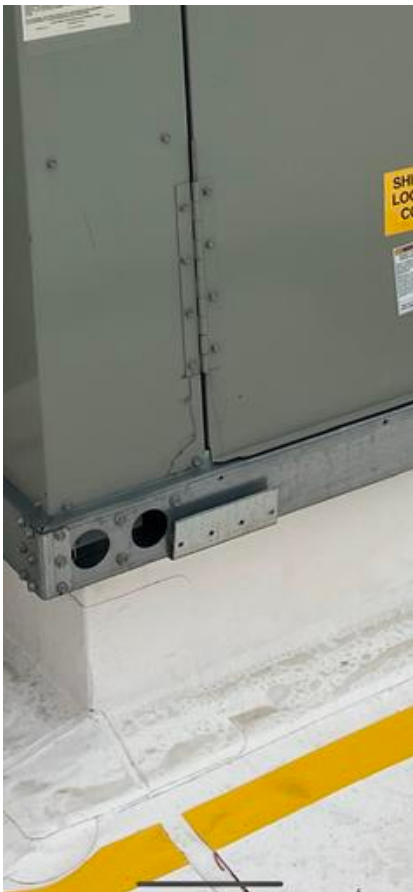
IMG\_2684

**#279 [UNIT 518] [NEW] Equipment not secured properly.**

Equipment not secured properly to curb, high wind/seismic clips not installed/secured correctly. Clips do not appear fastened.

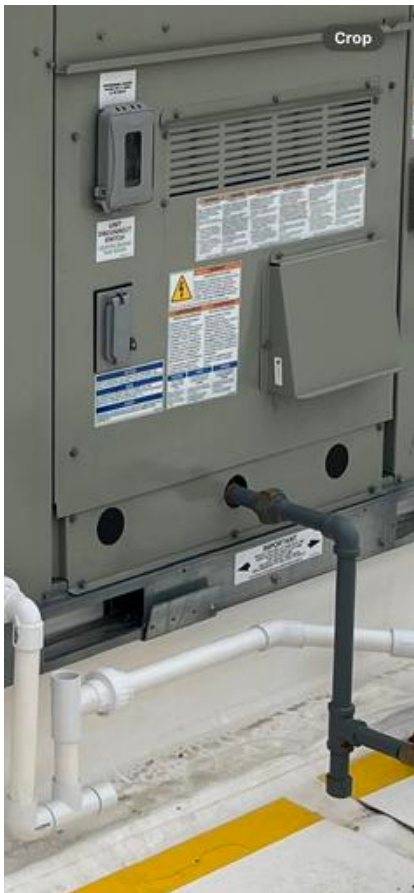
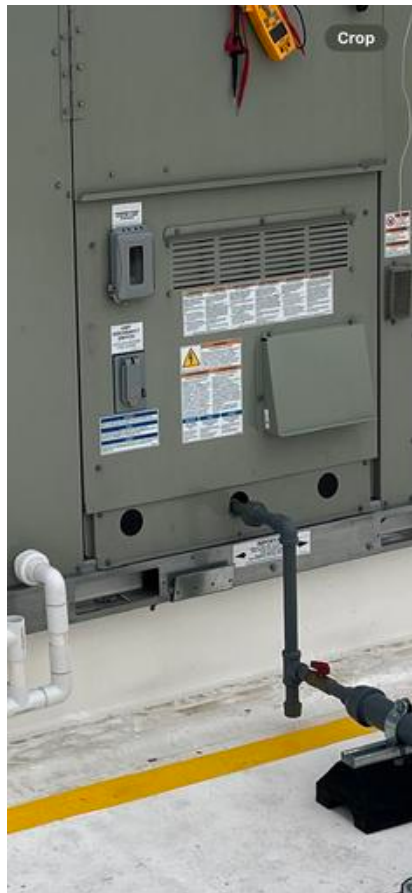
## #280 [UNIT 510] [NEW] Gas inlet grommet.

AC gas inlet grommet is missing at the gas line/RTU penetration point.
