Report: Punch List
Function: Test, Adjust, & Balance
Date: 09/30/2024
Completed By: National TAB

PROJECT
HomeSense (Knoxville, TN)

Project: HomeSense (Knoxville, TN)

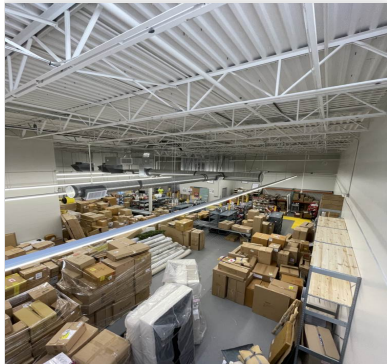
Issue Name : RTU-7 Dampers
Description : RTU-7 is missing all branch dampers except on trunk closest to back wall - that trunk has a damper installed but it is catching on a bolt and cannot move freely. Additionally, the mop closet diffuser will need a dedicated takeoff/neck/face damper installed to restrict its flow as there is currently no damper which only adjusts this diffuser.

- **10/21/2024 National TAB - Jordan Best**
 - Ductwork inaccessible due to inventory items in the warehouse. Dampers unable to be installed, diffusers unable to be balanced.
