Report: TAB Report
Function: Test, Adjust, & Balance
Date: 07/09/2024

07-08-24 ULTA #1708 HARTSDALE, NY

Rectenwald Brothers Construction

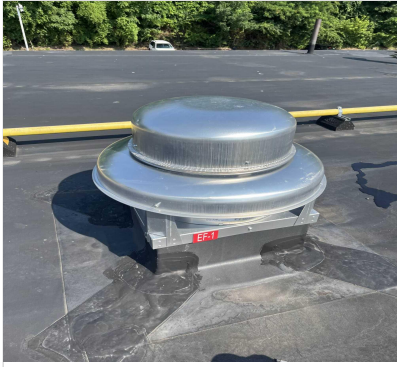
EF-1

NTi Found the backdraft damper sitting crooked and loosely in the curb. NTi secured the backdraft damper with screws to prevent it from moving.
