**Report: PunchList**  
**Function: Test, Adjust, & Balance**  
**Date: 03/11/2026**  
**Completed By: National TAB**

## 03-09-26 Culvers - Brooklyn, OH

5080 Tiedeman Rd

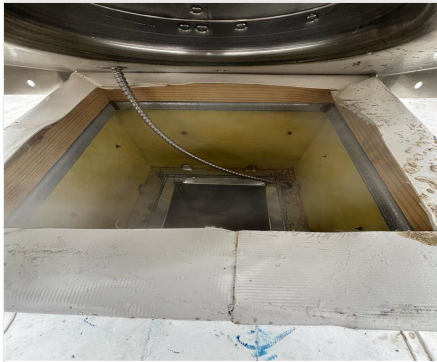
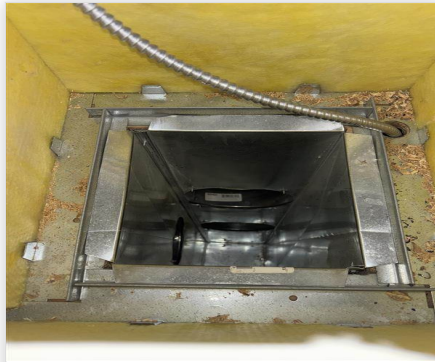
**Issue Name :** PRV-1 missing a backdraft damper  
**Description :** The backdraft damper was not found at the store. Recommend installing one and ensuring it fully opens to not impact airflow.  
**Created By :** National TAB                      **Assigned To :** National TAB - Brianna Biggs  
**Status :** Open  
**Priority :** Low                                      **Asset Tag :**  
**Originated Date :** 03/11/2026 - Aaron Cosby - National TAB

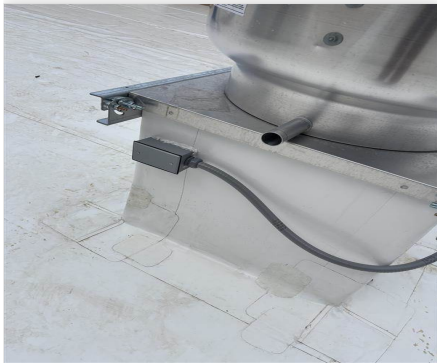
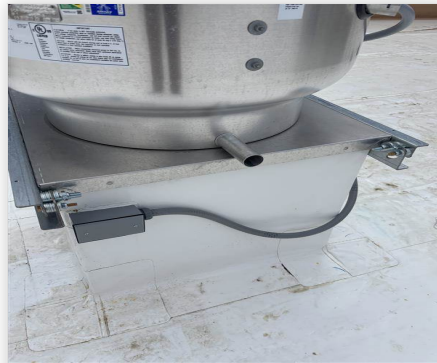
**Issue Name :** PRV-2 & PRV-3 missing grease cups  
**Description :** No grease cups found near units.  
**Created By :** National TAB                      **Assigned To :** National TAB - Brianna Biggs  
**Status :** Open  
**Priority :** Low                                      **Asset Tag :**  
**Originated Date :** 03/11/2026 - Aaron Cosby - National TAB

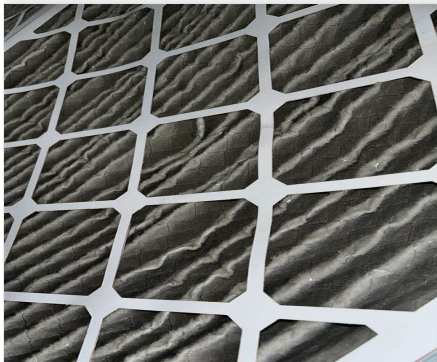
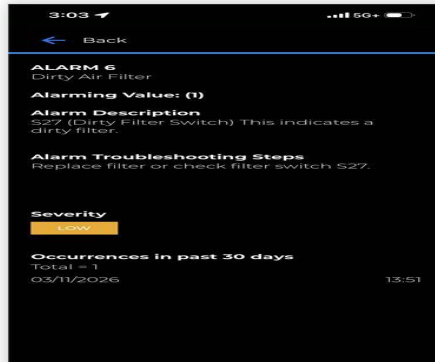
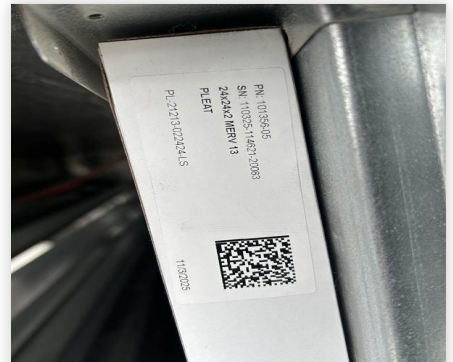
**Issue Name :** RTU-1 & RTU-2 dirty filters  
**Description :** Filters were not changed after construction. Recommend replacing (12x 24"X24"X2")  
**Created By :** National TAB                      **Assigned To :** National TAB - Brianna Biggs  
**Status :** Open  
**Priority :** Medium                                      **Asset Tag :**  
**Originated Date :** 03/11/2026 - Aaron Cosby - National TAB

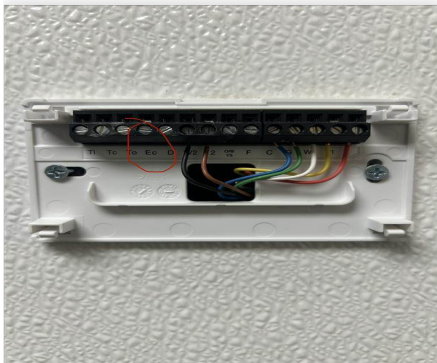
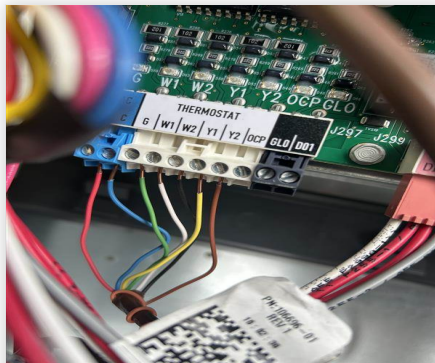
**Issue Name :** RTU-1 & RTU-2 missing occupancy wiring  
**Description :** Both RTUs need thermostat wire run from OCP on each RTU to their respective Ec terminal. Without it, economizing will be disrupted and Humiditrol reheat will not operate. This will cause negative building pressure and compromise the unit's ability to remove moisture from the air. A jumper was temporarily installed during balancing  
**Created By :** National TAB **Assigned To :** National TAB - Brianna Biggs  
**Status :** Open  
**Priority :** Medium **Asset Tag :**  
**Originated Date :** 03/11/2026 - Aaron Cosby - National TAB
