**Report: TAB Remarks**  
**Function: Test, Adjust, & Balance**  
**Date: 03/31/2026**  
**Completed By: National TAB**

## Moxies Restaurant (Fort Lauderdale, FL)

Project: Moxies Restaurant (Fort Lauderdale, FL)

## Issue List

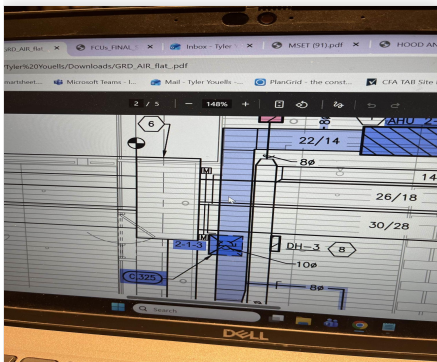
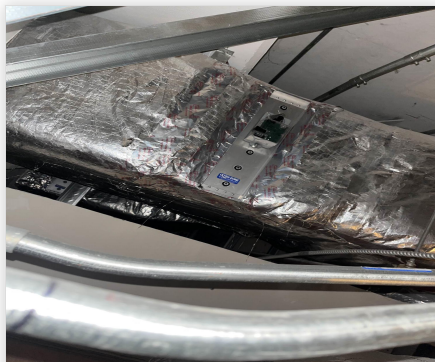
**Issue Name :** 2nd Floor Motorized dampers  
**Description :** Noticed high suction pressure/possible restriction in MUA/DOAS duct. Tracing back to motorized dampers on the second floor one of them is making a rattling noise. Suspect possible blockage or broken damper blades. Recommend MC install an access panel in the duct for inspection purposes. Dampers are not wired to anything but do appear to be open

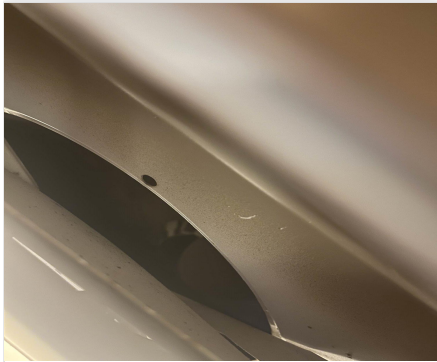
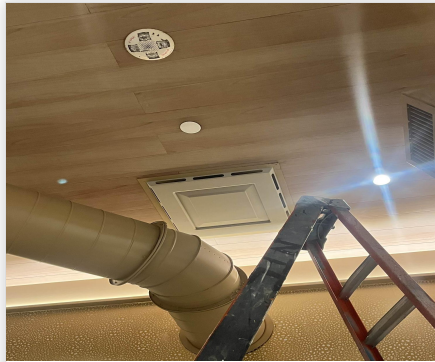
**Issue Name :** AHU 1-4 Diffuser not fully connected  
**Description :** Duct is not properly connected to the diffuser and leaking air above ceiling.  
**Created By :** National TAB                      **Assigned To :** National TAB - Joe Hertenstein  
**Status :** Open  
**Priority :** High                                      **Asset Tag :**  
**Originated Date :** 04/02/2026 - Tyler Youells - National TAB

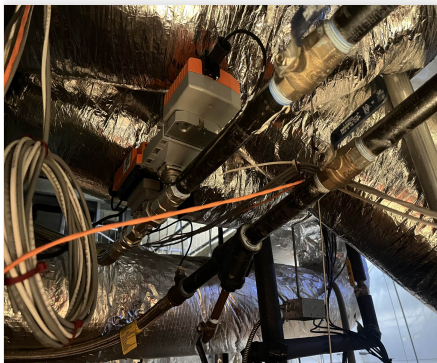
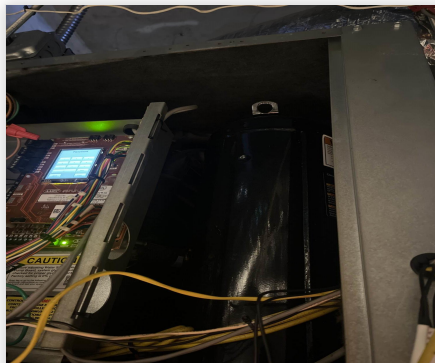
**Issue Name :** AHUs Note CW  
**Description :** Note that these units are not AHUs they are water source heat pumps they are not provided with chilled or Hot water they are provided with condenser water. Note that the water piping to units does not have any balance valve for flow to be measured by TAB technician.

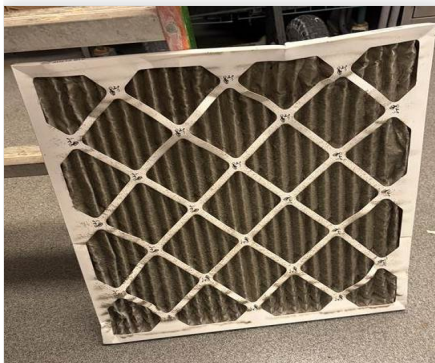
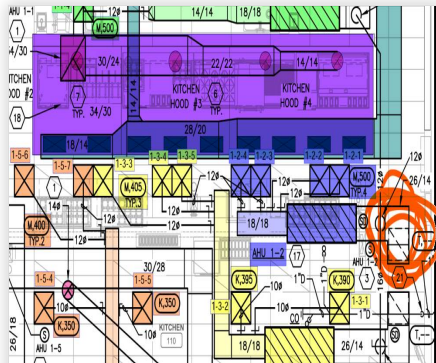
**Issue Name :** Air filters need to be changed  
**Description :** air filters are well pass the change date, particularly in the kitchen.  
Recommend replacing all filters  
**Created By :** National TAB      **Assigned To :** National TAB - Joe Hertenstein  
**Status :** Open  
**Priority :** Medium      **Asset Tag :**  
**Originated Date :** 03/31/2026 - LAURA CUESTA - National TAB

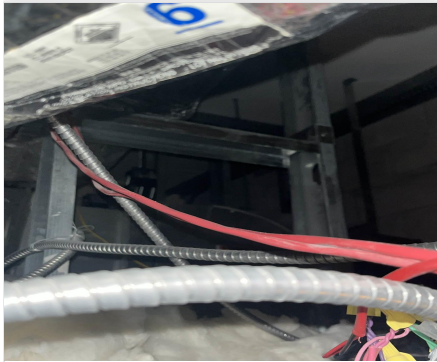
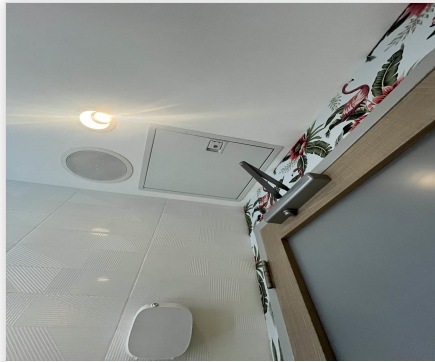
**Issue Name :** EF-2 not Accesible  
**Description :** Fan is not accessible for balancing. cannot open the access panel due to door strut.  
**Created By :** National TAB                      **Assigned To :** National TAB - Joe Hertenstein  
**Status :** Open  
**Priority :** InfoOnly                                      **Asset Tag :**  
**Originated Date :** 04/02/2026 - Tyler Youells - National TAB

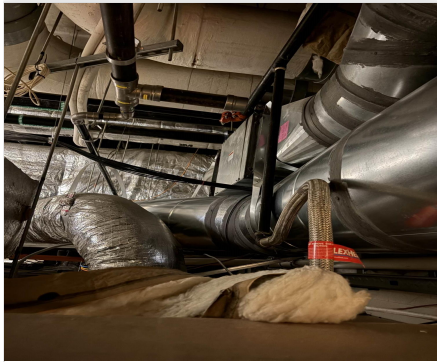
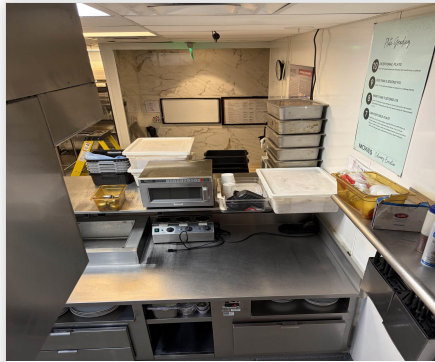
**Issue Name :** EF1 Inaccessible  
**Description :** EF1 is located directly above kitchen cooking line table that can not be moved, making EF1 fan difficult to reach and get data from.  
**Created By :** National TAB                      **Assigned To :** National TAB - Joe Hertenstein  
**Status :** Open  
**Priority :** Medium                                      **Asset Tag :**  
**Originated Date :** 04/02/2026 - LAURA CUESTA - National TAB

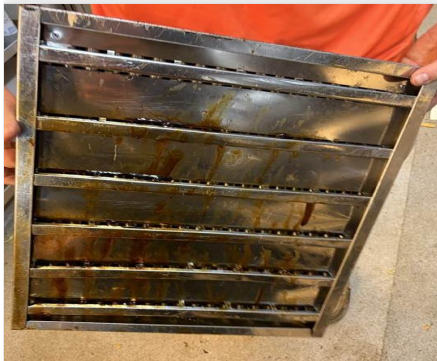
**Issue Name :** Hood grease filters need to be cleaned  
**Description :** For all of the hoods the filters have not been cleaned in a while, a lot of grease build up, would recommend a cleaning baffle filters And cleaning more regularly  
**Created By :** National TAB                      **Assigned To :** National TAB - Joe Hertenstein  
**Status :** Open  
**Priority :** Medium                                      **Asset Tag :**  
**Originated Date :** 03/31/2026 - LAURA CUESTA - National TAB

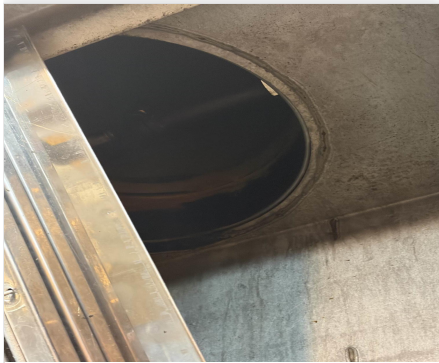
**Issue Name :** Hood out of design  
**Description :** Hoods Do not have balancing dampers installed in the risers. Hood 4 is well below design and a couple other hoods are high. Hood 4 has the most heat underneath it from cooking equipment and could benefit from an increased exhaust rate.  
**Created By :** National TAB                      **Assigned To :** National TAB - Joe Hertenstein  
**Status :** Open  
**Priority :** Medium                                      **Asset Tag :**  
**Originated Date :** 03/31/2026 - LAURA CUESTA - National TAB

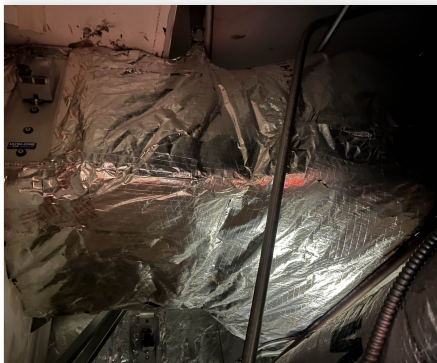
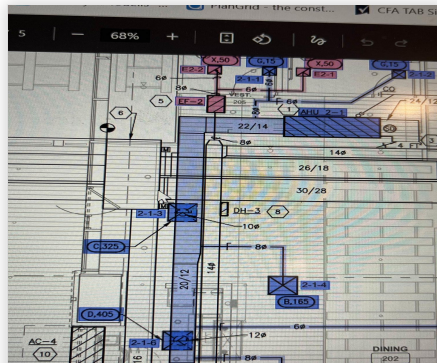
**Issue Name :** MUA-1 Flow/Choke Point  
**Description :** MUA total flow is 4850/8136CFM. Suction pressure at inlet of the unit is -2.30" indicating restriction. Tracing duct restriction is found at damper through demising wall. Duct goes from 30/28 down to 20/16 damper which is not even the free area. Prints were not followed in regards to Keynote 6

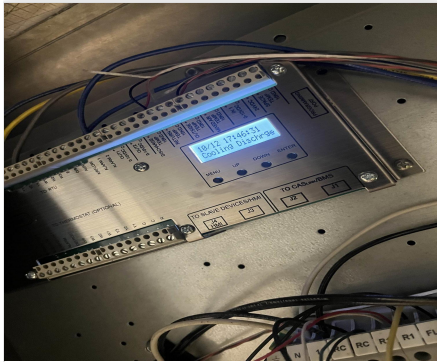
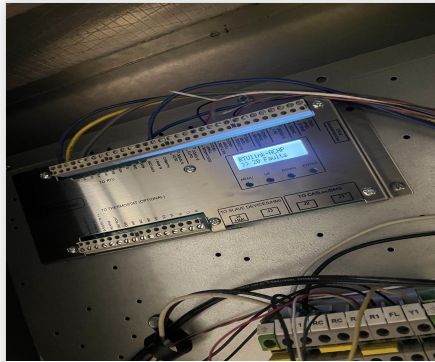
**Issue Name :** MUA-2 Cooling alarm  
**Description :** MUA-2 has 20 alarms all for cooling discharge. Recommend servicing cooling system of the unit.  
**Created By :** National TAB                      **Assigned To :** National TAB - Joe Hertenstein  
**Status :** Open  
**Priority :** Medium                                      **Asset Tag :**  
**Originated Date :** 04/01/2026 - Tyler Youells - National TAB
