Report: Punchlist
Function: Test, Adjust, & Balance
Date: 07/29/2025
Completed By: National TAB

PROJECT
07-21-25 ALBERTSONS #1948 MESA, AZ

441 N VAL VISTA DRIVE

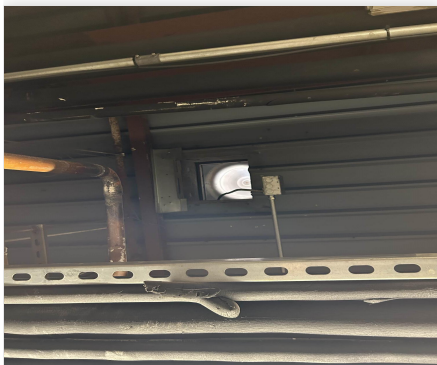
Issue Name : EF-10 & 11 LOW AIRFLOW
Description : Exhaust fans 10 & 11 low on airflow. Both units have been set to maximum speed on speed controller. Unable to further speed up the unit. No restriction found to ductwork.
Created By : National TAB **Assigned To :** National TAB - Dan Hertenstein
Status : Open
Priority : Low **Asset Tag :**
Originated Date : 07/29/2025 - David Nicolas Sanchez - National TAB

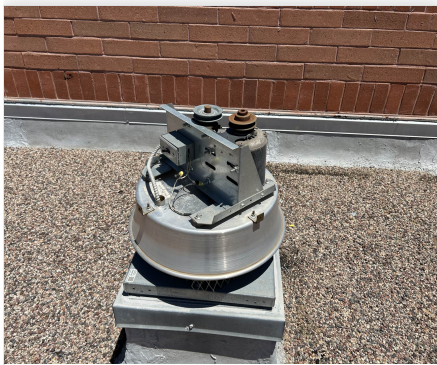
Issue Name : EF-9 NOT FUNCTIONAL
Description : EF-9 is not functional and appears to be abandoned. Recommend servicing or replacing unit.
Created By : National TAB **Assigned To :** National TAB - Dan Hertenstein
Status : Open
Priority : Low **Asset Tag :**
Originated Date : 07/29/2025 - David Nicolas Sanchez - National TAB

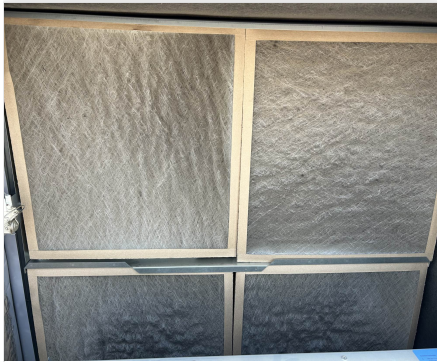
Issue Name : RTU-1 FILTER CHANGE REQUIRED
Description : Filter replacement required for RTU-1. Construction filter currently installed inside unit. Recommend replacing with MERV8 filters.
Created By : National TAB **Assigned To :** National TAB - Dan Hertenstein
Status : Open
Priority : Low **Asset Tag :**
Originated Date : 07/22/2025 - David Nicolas Sanchez - National TAB

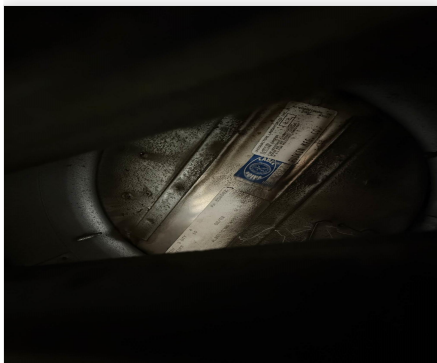
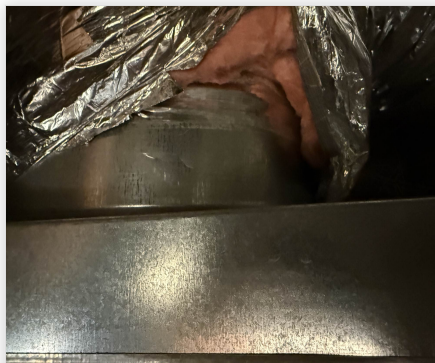
Issue Name : RTU-3 CLOSED DAMPER
Description : Damper is fully closed in Pharmacy area above sink. Unable to locate damper handle or mechanism to keep damper opened. Recommend cleaning duct from debris and opening damper for proper airflow.
Created By : National TAB **Assigned To :** National TAB - Dan Hertenstein
Status : Open
Priority : Medium **Asset Tag :**
Originated Date : 07/22/2025 - David Nicolas Sanchez - National TAB

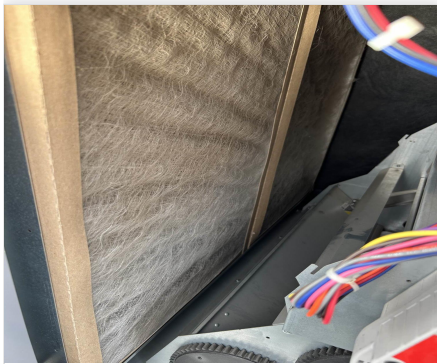
Issue Name : RTU-3 CONSTRUCTION FILTER INSTALLED
Description : Contruccion filter installed. Recommend replacing with MERV 8 filters.
Created By : National TAB **Assigned To :** National TAB - Dan Hertenstein
Status : Open
Priority : Low **Asset Tag :**
Originated Date : 07/22/2025 - David Nicolas Sanchez - National TAB

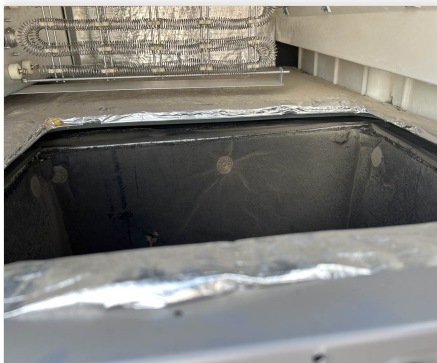
Issue Name : RTU-3 SUPPLY DUCT LEAK
Description : Supply duct is not properly seal to unit. Leakage around the base of unit. Recommend properly sealing supply duct to unit to prevent leakage and debris from entering duct.
Created By : National TAB **Assigned To :** National TAB - Dan Hertenstein
Status : Open
Priority : Medium **Asset Tag :**
Originated Date : 07/22/2025 - David Nicolas Sanchez - National TAB
