Report: Punchlist

Function: Test, Adjust, & Balance

07-21-25 ALBERTSONS #1948 MESA, AZ

441 N VAL VISTA DRIVE

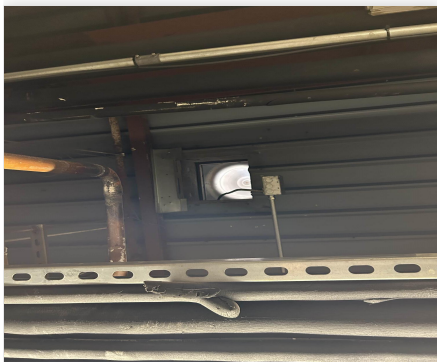
Issue Name : EF-10 & 11 LOW AIRFLOW
Description : Exhaust fans 10 & 11 low on airflow. Both units have been set to maximum speed on speed controller. Unable to further speed up the unit. No restriction found to ductwork.
Created By : National TAB **Assigned To :** National TAB - Dan Hertenstein
Status : Open
Priority : Low **Asset Tag :**
Originated Date : 07/29/2025 - David Nicolas Sanchez - National TAB

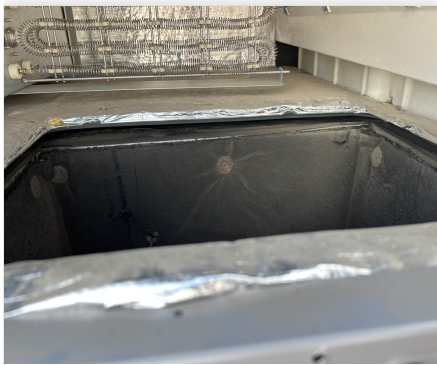
Issue Name : RTU-3 SUPPLY DUCT LEAK
Description : Supply duct is not properly seal to unit. Leakage around the base of unit. Recommend properly sealing supply duct to unit to prevent leakage and debris from entering duct.
Created By : National TAB **Assigned To :** National TAB - Dan Hertenstein
Status : Open
Priority : **Medium** **Asset Tag :**
Originated Date : 07/22/2025 - David Nicolas Sanchez - National TAB
