Report: REMARKS
Function: Test, Adjust, & Balance
Date: 11/05/2025
Completed By: National TAB

PROJECT
11-03-25 CULVERS QUEEN CREEK, AZ

Project: 11-03-25 CULVERS QUEEN CREEK, AZ

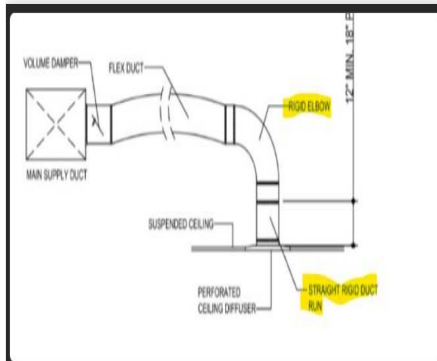
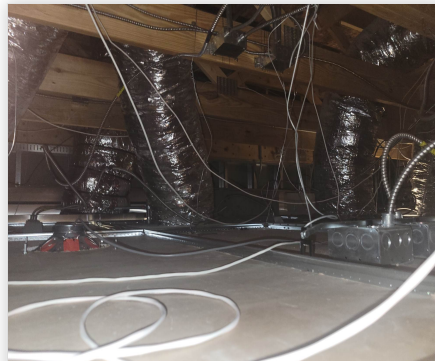
Issue Name : IMPROPER DUCT IN KITCHEN
Description : Diffusers in front of kitchen exhaust hoods are fed by flex only instead of hard elbows and straight duct.
Created By : National TAB **Assigned To :** National TAB - Dan Hertenstein
Status : Open
Priority : Medium **Asset Tag :** RTU2
Originated Date : 11/05/2025 - Christine Weale - National TAB

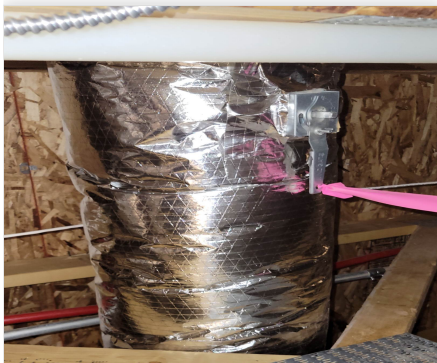
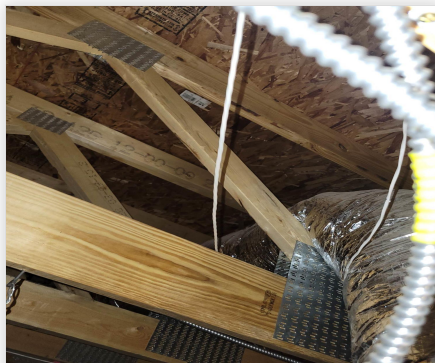
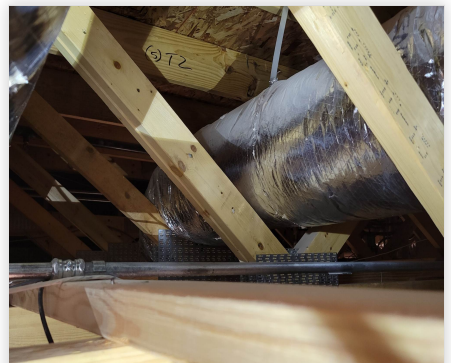
Issue Name : KINKED DUCT - LOW FLOW
Description : Super low flow ~45cfm/400cfm due to kinked duct. Actually creating backflow and reading as a negative sometimes. Damper is fully open
Created By : National TAB **Assigned To :** National TAB - Dan Hertenstein
Status : Open
Priority : Urgent **Asset Tag :** SGRD5
Originated Date : 11/04/2025 - Christine Weale - National TAB

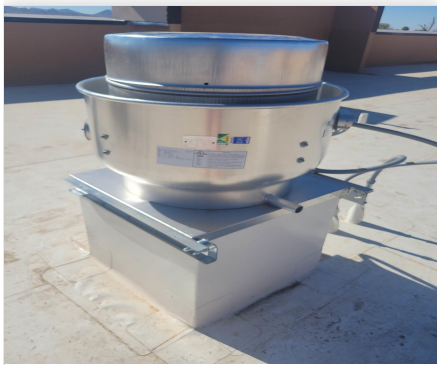
Issue Name : NO GREASE CUPS ON HOOD EXHAUSTS
Description : Grease traps not installed under grease conduits for both Kitchen Hood exhausts, PRV-2 and PRV-3.
Created By : National TAB **Assigned To :** National TAB - Dan Hertenstein
Status : Open
Priority : Low **Asset Tag :**
Originated Date : 11/05/2025 - Christine Weale - National TAB
