Report: Issue Data
Function: Test, Adjust, & Balance
Date: 12/04/2025
Completed By: National TAB

PROJECT
CW 8950 - Mr Cooper (Coppell, TX)

Project: CW 8950 - Mr Cooper (Coppell, TX)

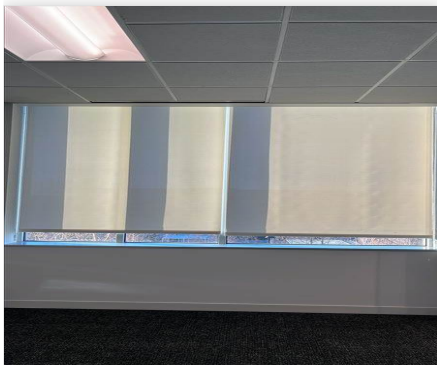
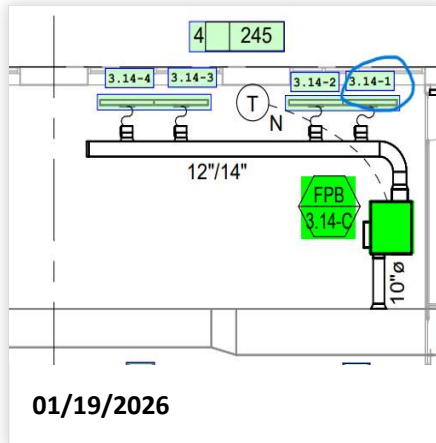
Issue Name : FPB3.14C Missing Diffuser
Description : Missing diffuser #1 in space. A side 3rd floor Open Office 313.
Created By : National TAB **Assigned To :** National TAB - Stephan Gabbert
Status : Open
Priority : Urgent **Asset Tag :**
Originated Date : 01/19/2026 - Bayley Morvant - National TAB

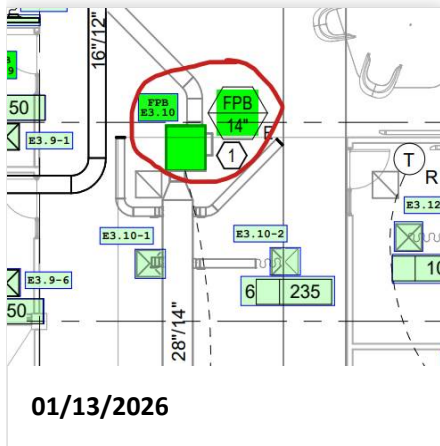
Issue Name : FPBE3-10 Fan Not Operational
Description : Fan not operational during time of testing. Unit is an existing box. (controls label is FPB3-38)
Created By : National TAB **Assigned To :** National TAB - Stephan Gabbert
Status : Open
Priority : Urgent **Asset Tag :**
Originated Date : 01/13/2026 - Bayley Morvant - National TAB

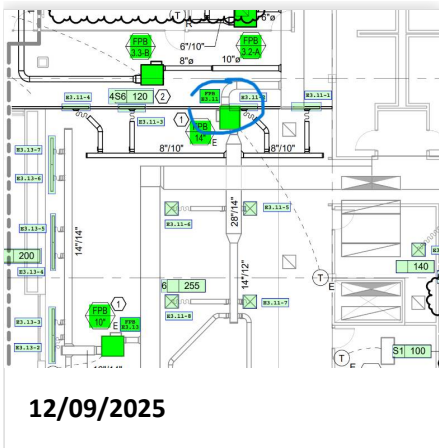
Issue Name : FPBE3-11 Fan Not Operational
Description : FPB3E3-11 fan is not operational. Unit is an existing box. (Controls label is FPB3-51)
Created By : National TAB **Assigned To :** National TAB - Stephan Gabbert
Status : Open
Priority : **Urgent** **Asset Tag :**
Originated Date : 12/09/2025 - Bayley Morvant - National TAB

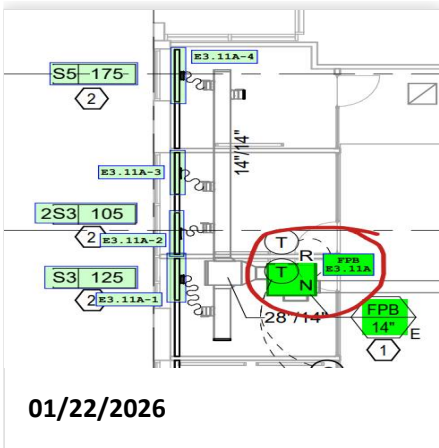
Issue Name : FPBE3.11A Fan Not Operational
Description : Fan not operational during time of testing. Unit is existing box. (box labeled as FPB3-14 on controls graphics)
Created By : National TAB **Assigned To :** National TAB - Stephan Gabbert
Status : Open
Priority : **Urgent** **Asset Tag :**
Originated Date : 01/22/2026 - Bayley Morvant - National TAB

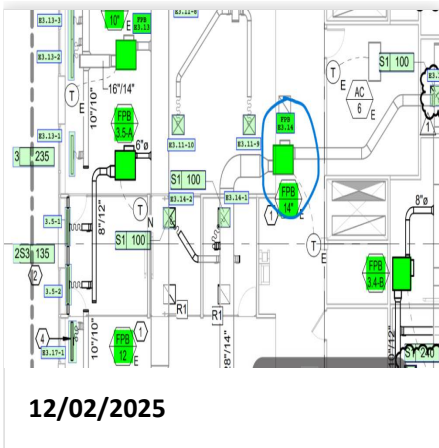
Issue Name : FPBE3.14 Fan not operational
Description : Fan not operational during time of testing. Unit is existing box. (box labeled as FPB3-48 on controls graphics)
Created By : National TAB **Assigned To :** National TAB - Stephan Gabbert
Status : Open
Priority : **Urgent** **Asset Tag :**
Originated Date : 12/02/2025 - Bayley Morvant - National TAB

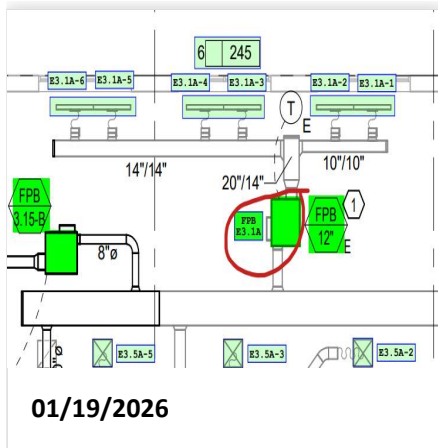
Issue Name : FPBE3.1A Fan Not Operational
Description : Unit fan not operational in heating mode. Unable to balance fan to design. Unit is an existing unit.
Created By : National TAB **Assigned To :** National TAB - Stephan Gabbert
Status : Open
Priority : Urgent **Asset Tag :**
Originated Date : 01/19/2026 - Bayley Morvant - National TAB

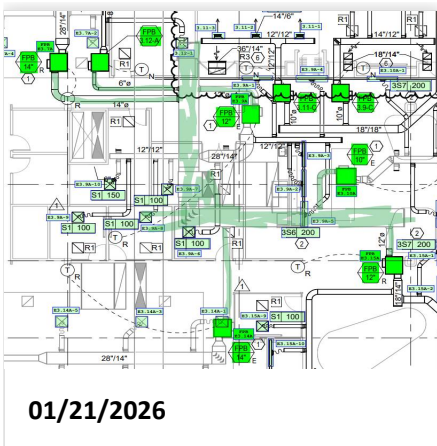
Issue Name : RTU-7 Not Operating Correctly
Description : RTU-7 has an issue that is keeping the unit from operating correctly. This is making every FPB served by RTU-7 low on airflow. This includes FPBE3.7A, FPB3.12-A, FPBE3.9A, FPBE3.14A, FPBE3.10A and FPBE3.15A. Billingsley building engineers are aware of the issue and are looking into the unit to get it corrected.
