## Issue List

### NCANG Repair Bldg 51 (Charlotte, NC)

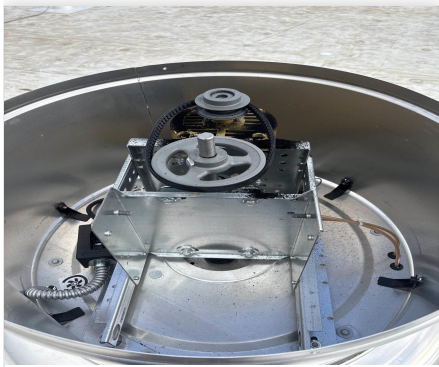
**Issue Name :** EF-11 Not Operational  
**Description :** EF-11 motor sheave unscrewed itself and damaged the belt.  
Recommended to repair and replace  
**Created By :** National TAB                      **Assigned To :** National TAB - Antonio Flores-De La Cruz  
**Status :** Open  
**Priority :** Urgent                                      **Asset Tag :**  
**Originated Date :** 03/09/2026 - Antonio Flores-De La Cruz - National TAB

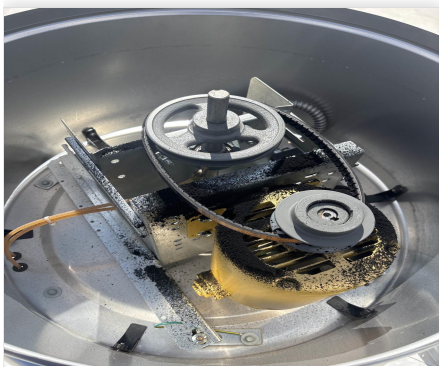
**Issue Name :** EF-12 Not Operational

**Description :** EF-12 motor sheave unscrewed itself and damaged the belt.  
Recommended to repair and replace belt.

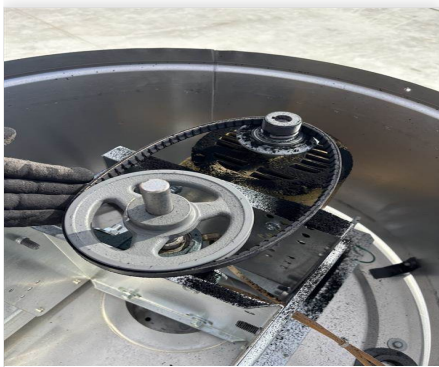
**Issue Name :** EF-14 Not Operational

**Description :** EF-14 is not operational because the motor sheave and belt are damaged. The motor sheave broke into two pieces.

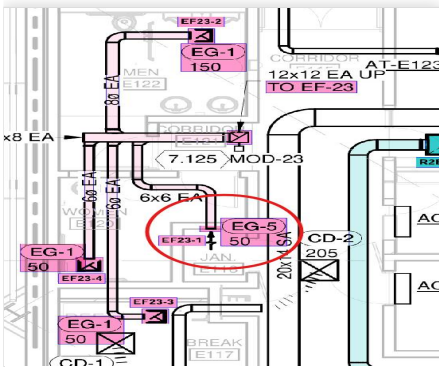
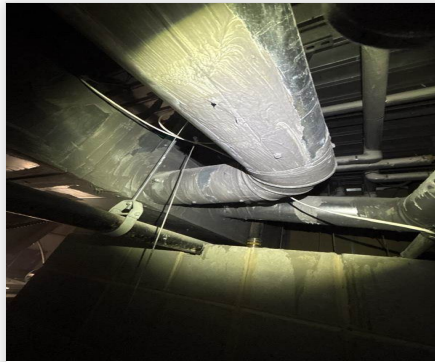
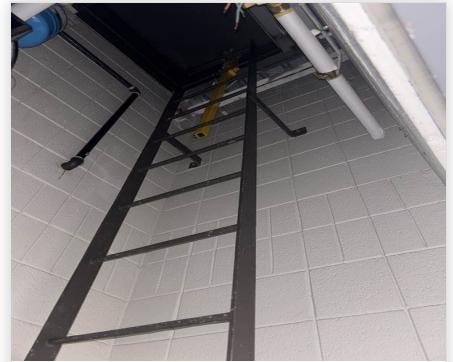
**Issue Name :** EF-23 Missing Grille  
**Description :** Grille EF-23-1 in JANITORS E118 is not installed.  
**Created By :** National TAB  
**Assigned To :** National TAB - Antonio Flores-De La Cruz  
**Status :** Open  
**Priority :** High  
**Asset Tag :**  
**Originated Date :** 02/12/2026 - Antonio Flores-De La Cruz - National TAB

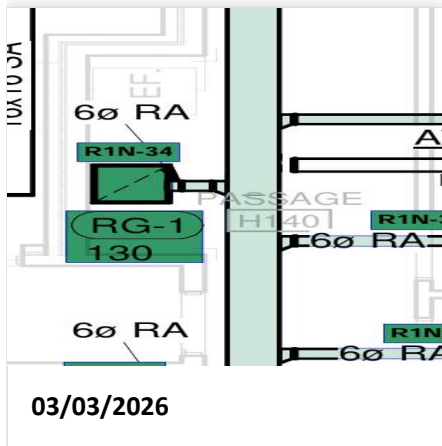
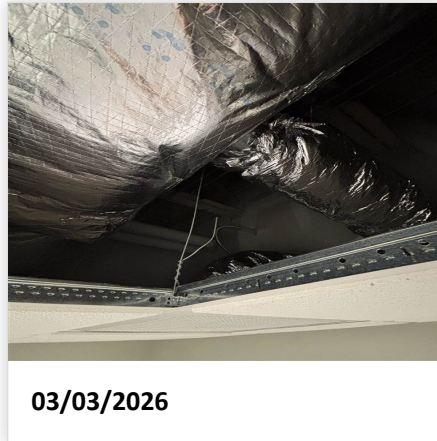
**Issue Name :** Incorrect Connected Return Grille  
**Description :** Return Grille R1N-34 is connected to the supply, not the return.  
**Created By :** National TAB                      **Assigned To :** National TAB - Antonio Flores-De La Cruz  
**Status :** Open  
**Priority :** Urgent                                      **Asset Tag :**  
**Originated Date :** 03/03/2026 - Antonio Flores-De La Cruz - National TAB

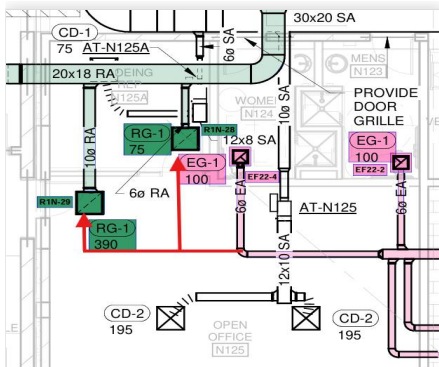
**Issue Name :** Incorrectly Installed Duct for Return  
**Description :** Grilles R1N-28 and R1N-29 were attached to EF-22 ductwork.  
**Created By :** National TAB                      **Assigned To :** National TAB - Antonio Flores-De La Cruz  
**Status :** Open  
**Priority :** **Urgent**                                      **Asset Tag :**  
**Originated Date :** 03/03/2026 - Antonio Flores-De La Cruz - National TAB

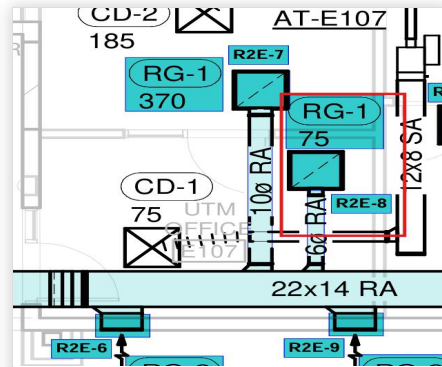
**Issue Name :** Missing Damper for Return Grille in E107  
**Description :** Grille R2E-8 is missing the damper to balance.  
**Created By :** National TAB                      **Assigned To :** National TAB - Antonio Flores-De La Cruz  
**Status :** Open  
**Priority :** Urgent                                      **Asset Tag :**  
**Originated Date :** 03/02/2026 - Antonio Flores-De La Cruz - National TAB

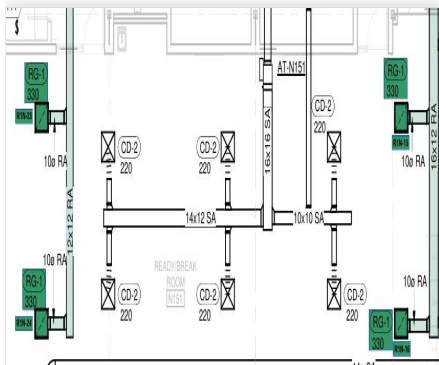
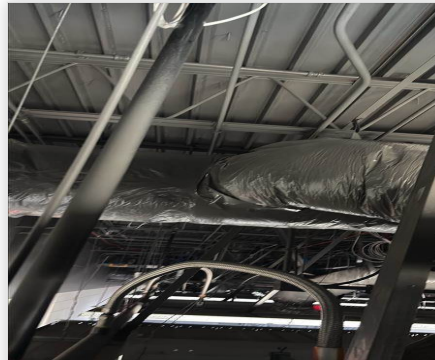
**Issue Name :** Missing Multiple Return Dampers in ROOM READY/BREAKROOM N151  
**Description :** Return grilles: R1N-15, R1N-16, R1N-23, and R1N-24 are all missing dampers to TAB.

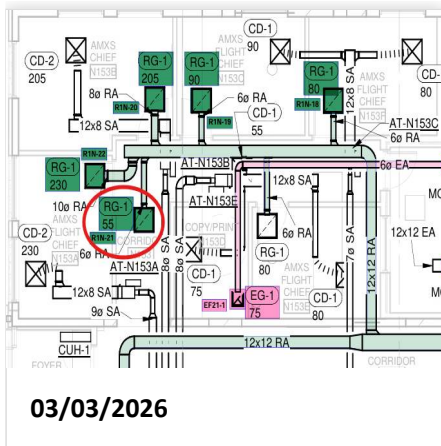
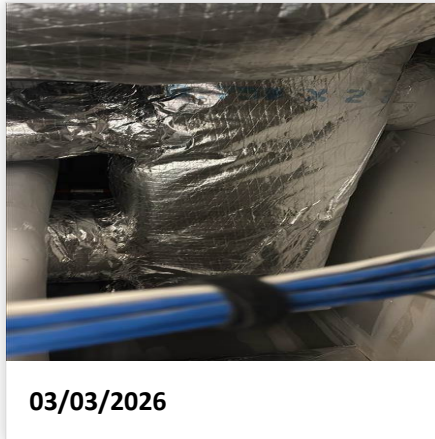
**Issue Name :** Missing Return Damper for CORRIDOR N153  
**Description :** Grille R1N-21 is missing the damper ot TAB.  
**Created By :** National TAB **Assigned To :** National TAB - Antonio Flores-De La Cruz  
**Status :** Open  
**Priority :** **Urgent** **Asset Tag :**  
**Originated Date :** 03/03/2026 - Antonio Flores-De La Cruz - National TAB

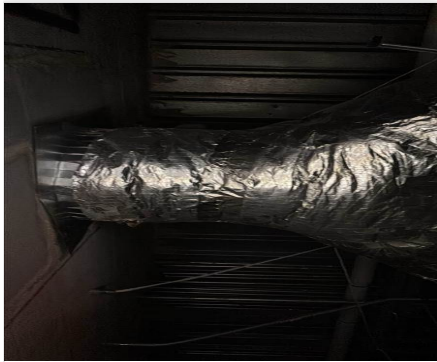
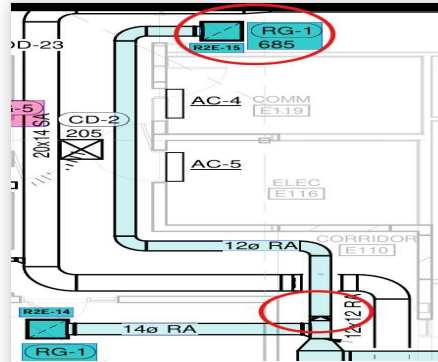
**Issue Name :** Missing Return Damper in OPEN OFFICE E123  
**Description :** Damper for Grille R2E-15 is missing to balance.  
**Created By :** National TAB **Assigned To :** National TAB - Antonio Flores-De La Cruz  
**Status :** Open  
**Priority :** Urgent **Asset Tag :**  
**Originated Date :** 03/02/2026 - Antonio Flores-De La Cruz - National TAB

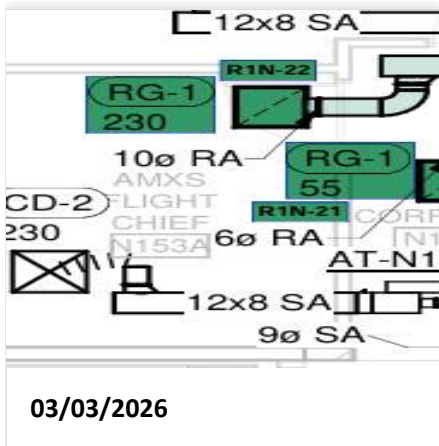
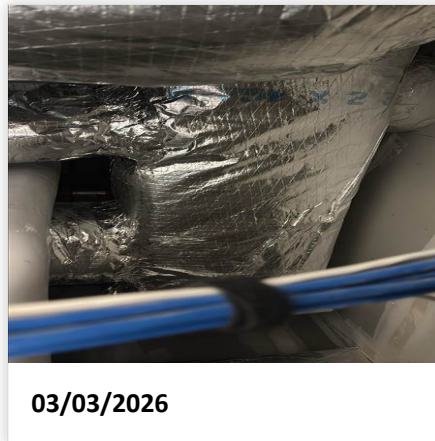
**Issue Name :** Missing Return Damper in ROOM AMXS FLIGHT CHIEF N153A  
**Description :** Grille R1N-22 is missing the damper to TAB.  
**Created By :** National TAB                      **Assigned To :** National TAB - Antonio Flores-De La Cruz  
**Status :** Open  
**Priority :** Urgent                                      **Asset Tag :**  
**Originated Date :** 03/03/2026 - Antonio Flores-De La Cruz - National TAB

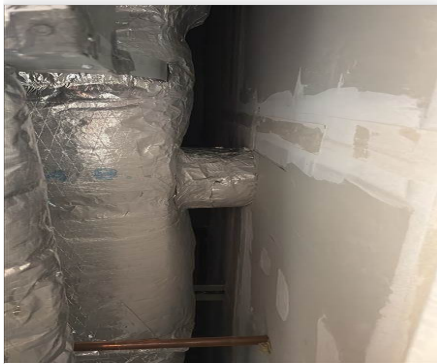
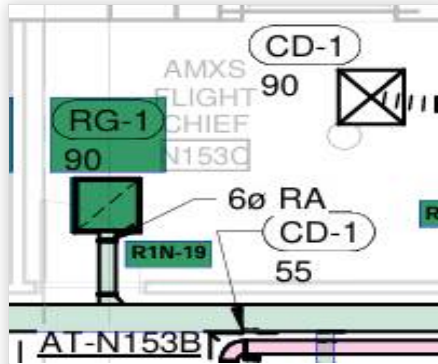
**Issue Name :** Missing Return Damper in ROOM AMXS FLIGHT CHIEF N153C  
**Description :** Grille R1N-19 is missing the damper to TAB.  
**Created By :** National TAB                      **Assigned To :** National TAB - Antonio Flores-De La Cruz  
**Status :** Open  
**Priority :** Urgent                                      **Asset Tag :**  
**Originated Date :** 03/03/2026 - Antonio Flores-De La Cruz - National TAB

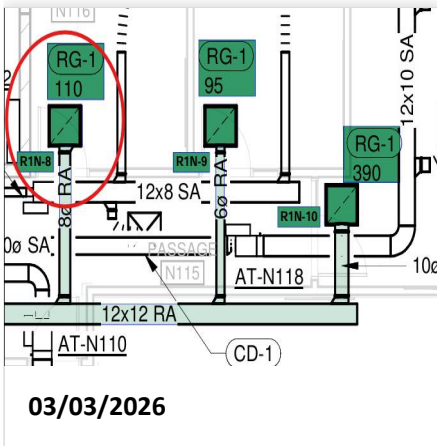
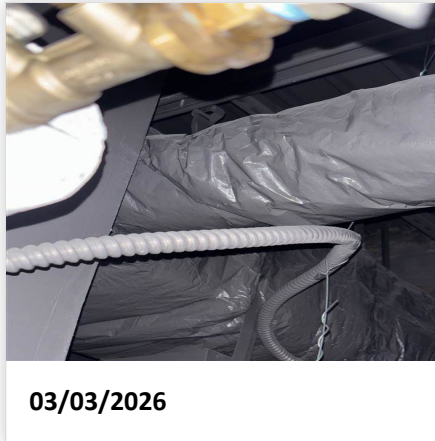
**Issue Name :** Missing Return Damper in ROOM AVIONICS ELEMENT CHIEF N116  
**Description :** Grille R1N-8 is missing the damper to TAB.  
**Created By :** National TAB                      **Assigned To :** National TAB - Antonio Flores-De La Cruz  
**Status :** Open  
**Priority :** **Urgent**                                      **Asset Tag :**  
**Originated Date :** 03/03/2026 - Antonio Flores-De La Cruz - National TAB

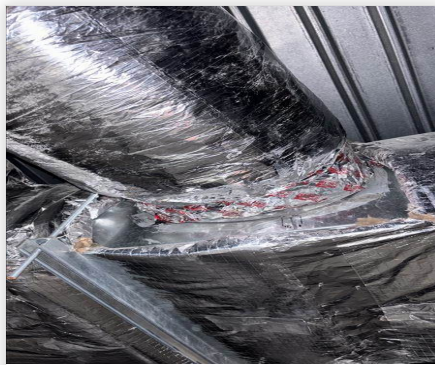
**Issue Name :** Missing Return Damper in ROOM CLASSROOM E108  
**Description :** Damper for Grille R2E-14 in ROOM CLASSROOM E108 is missing to balance.  
**Created By :** National TAB                      **Assigned To :** National TAB - Antonio Flores-De La Cruz  
**Status :** Open  
**Priority :** **Urgent**                                      **Asset Tag :**  
**Originated Date :** 03/02/2026 - Antonio Flores-De La Cruz - National TAB

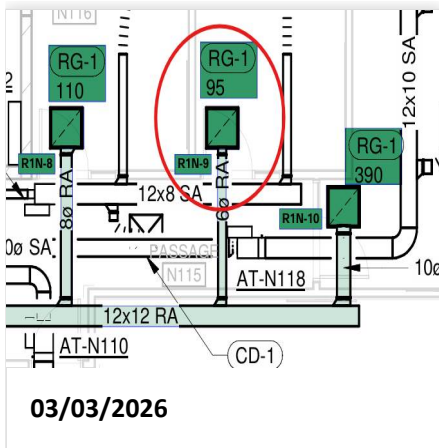
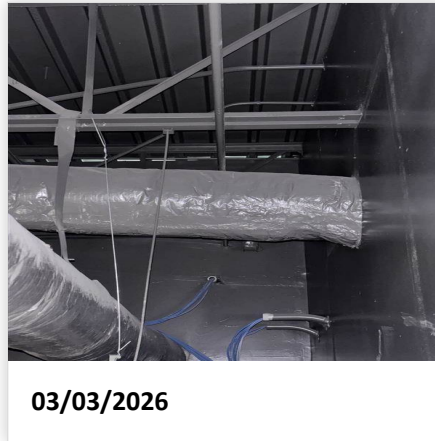
**Issue Name :** Missing Return Damper in ROOM CMF CHIEF N117  
**Description :** Grille R1N-9 is missing the damper to TAB.  
**Created By :** National TAB                      **Assigned To :** National TAB - Antonio Flores-De La Cruz  
**Status :** Open  
**Priority :** **Urgent**                                      **Asset Tag :**  
**Originated Date :** 03/03/2026 - Antonio Flores-De La Cruz - National TAB

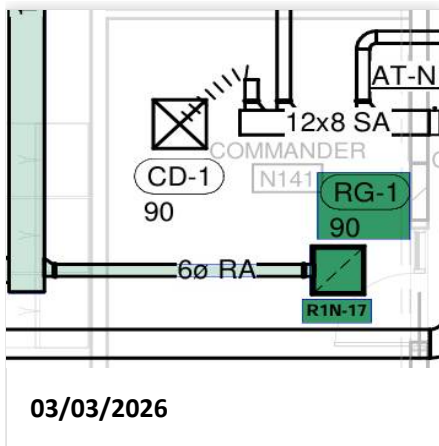
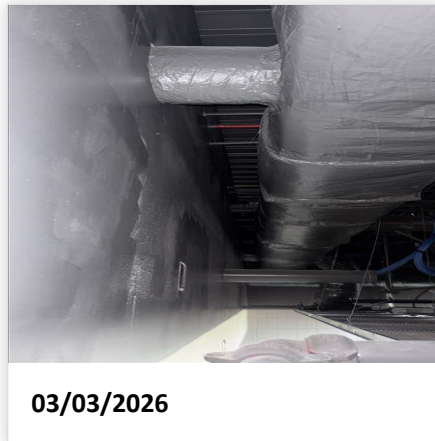
**Issue Name :** Missing Return Damper in ROOM COMMANDER N141  
**Description :** Grille R1N-17 is missing the return damper to TAB.  
**Created By :** National TAB                      **Assigned To :** National TAB - Antonio Flores-De La Cruz  
**Status :** Open  
**Priority :** Urgent                                      **Asset Tag :**  
**Originated Date :** 03/03/2026 - Antonio Flores-De La Cruz - National TAB

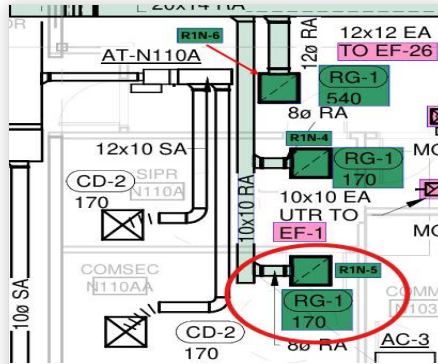
**Issue Name :** Missing Return Damper in ROOM COMSEC N110AA  
**Description :** Grille R1N-5 is missing the damper to TAB.  
**Created By :** National TAB **Assigned To :** National TAB - Antonio Flores-De La Cruz  
**Status :** Open  
**Priority :** Urgent **Asset Tag :**  
**Originated Date :** 03/03/2026 - Antonio Flores-De La Cruz - National TAB

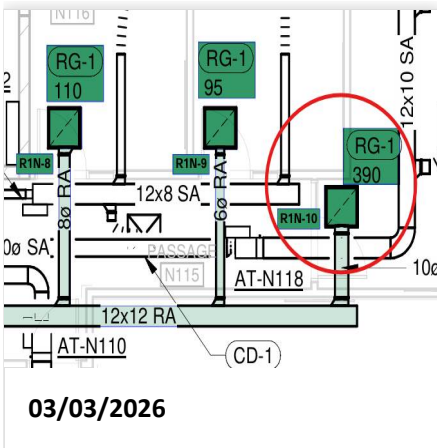
**Issue Name :** Missing Return Damper in ROOM CONFERENCE N118  
**Description :** Grille R1N-10 is missing the damper to TAB.  
**Created By :** National TAB                      **Assigned To :** National TAB - Antonio Flores-De La Cruz  
**Status :** Open  
**Priority :** **Urgent**                                      **Asset Tag :**  
**Originated Date :** 03/03/2026 - Antonio Flores-De La Cruz - National TAB

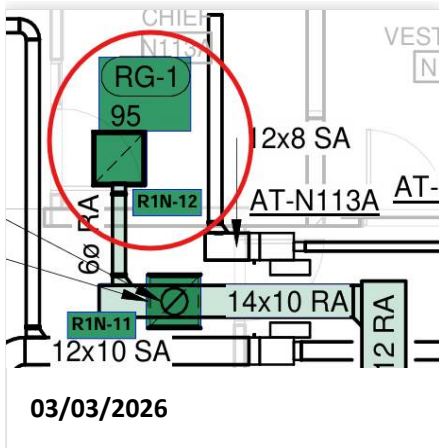
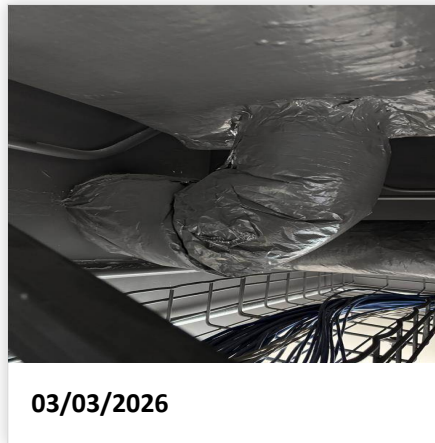
**Issue Name :** Missing Return Damper in ROOM ENG ELEMENT CHIEF N113A  
**Description :** Grille R1N-12 is missing the damper to TAB.  
**Created By :** National TAB                      **Assigned To :** National TAB - Antonio Flores-De La Cruz  
**Status :** Open  
**Priority :** **Urgent**                                      **Asset Tag :**  
**Originated Date :** 03/03/2026 - Antonio Flores-De La Cruz - National TAB

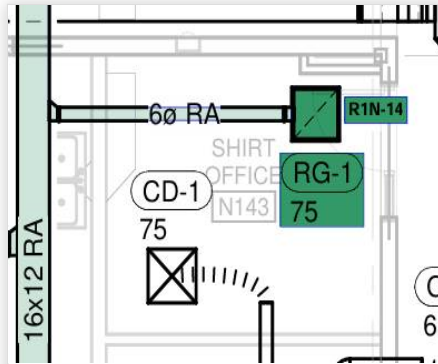
**Issue Name :** Missing Return Damper in ROOM SHIRT OFFICE N143  
**Description :** Grille R1N-14 is missing the return damper to TAB.  
**Created By :** National TAB                      **Assigned To :** National TAB - Antonio Flores-De La Cruz  
**Status :** Open  
**Priority :** Urgent                                      **Asset Tag :**  
**Originated Date :** 03/03/2026 - Antonio Flores-De La Cruz - National TAB

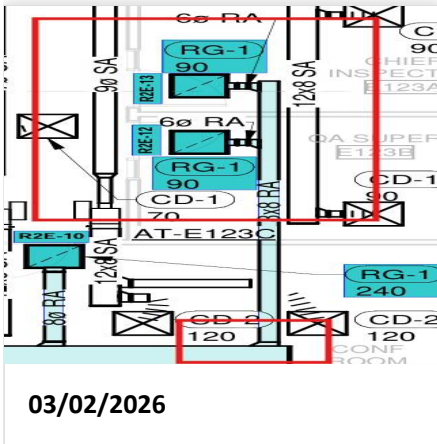
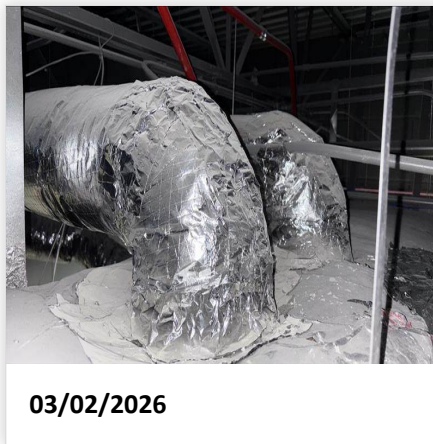
**Issue Name :** Missing Return Dampers in Offices  
**Description :** Grilles R2E-12 and R2E-13 are missing their dampers to balance the return.  
**Created By :** National TAB                      **Assigned To :** National TAB - Antonio Flores-De La Cruz  
**Status :** Open  
**Priority :** **Urgent**                                      **Asset Tag :**  
**Originated Date :** 03/02/2026 - Antonio Flores-De La Cruz - National TAB

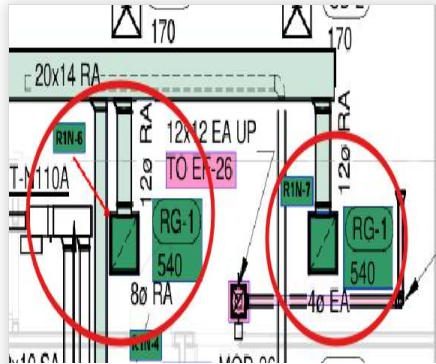
**Issue Name :** Missing Return Dampers in ROOM AVIONICS N110  
**Description :** Grilles R1N-6 and R1N-7 are missing the dampers to TAB.  
**Created By :** National TAB                      **Assigned To :** National TAB - Antonio Flores-De La Cruz  
**Status :** Open  
**Priority :** Urgent                                      **Asset Tag :**  
**Originated Date :** 03/03/2026 - Antonio Flores-De La Cruz - National TAB

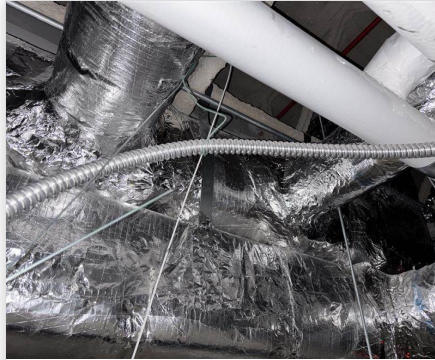
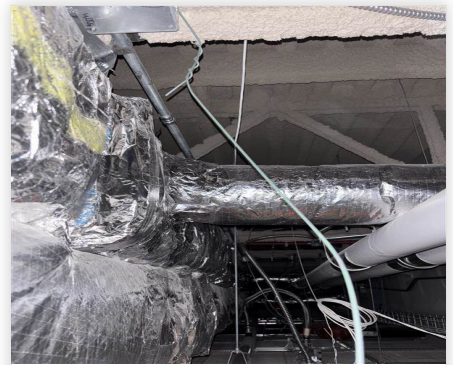
**Issue Name :** Multiple Dampers Missing HANGER SHOP NORTH  
**Description :** Return Grilles R1N-31 through R1N-37, EXCEPT R1N-34, are missing dampers to balance the return.  
**Created By :** National TAB **Assigned To :** National TAB - Antonio Flores-De La Cruz  
**Status :** Open  
**Priority :** Urgent **Asset Tag :**  
**Originated Date :** 03/03/2026 - Antonio Flores-De La Cruz - National TAB

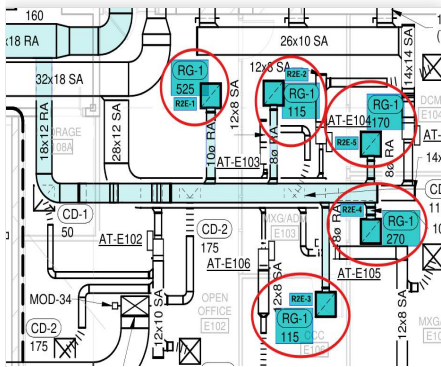
**Issue Name :** Multiple Return Dampers missing  
**Description :** Dampers for Return Grilles: RE2-1 through RE2-5 are missing to balance.  
**Created By :** National TAB                      **Assigned To :** National TAB - Antonio Flores-De La Cruz  
**Status :** Open  
**Priority :** **Urgent**                                      **Asset Tag :**  
**Originated Date :** 03/02/2026 - Antonio Flores-De La Cruz - National TAB

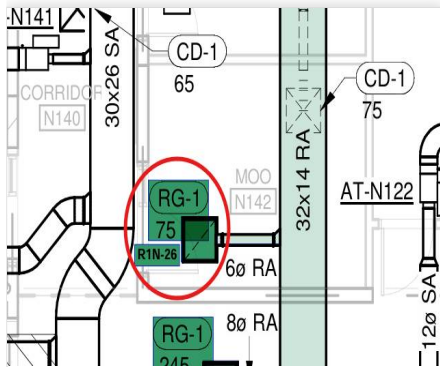
**Issue Name :** Return Damper Missing in ROOM MOO 142  
**Description :** Return Grille R1N-26 is missing the damper to TAB.  
**Created By :** National TAB                      **Assigned To :** National TAB - Antonio Flores-De La Cruz  
**Status :** Open  
**Priority :** **Urgent**                                      **Asset Tag :**  
**Originated Date :** 03/03/2026 - Antonio Flores-De La Cruz - National TAB
