Issue List

NCANG Repair Bldg 51 (Charlotte, NC)

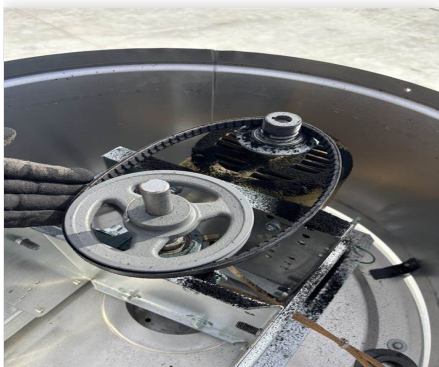
Issue Name : EF-14 Not Operational
Description : EF-14 is not operational because the motor sheave and belt are damaged. The motor sheave broke into two pieces.
Created By : National TAB **Assigned To :** National TAB - Antonio Flores-De La Cruz
Status : Open
Priority : Urgent **Asset Tag :**
Originated Date : 02/12/2026 - Antonio Flores-De La Cruz - National TAB

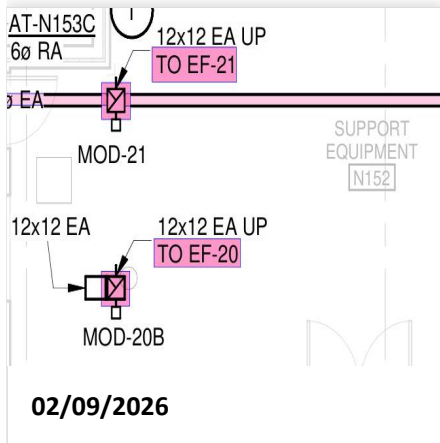
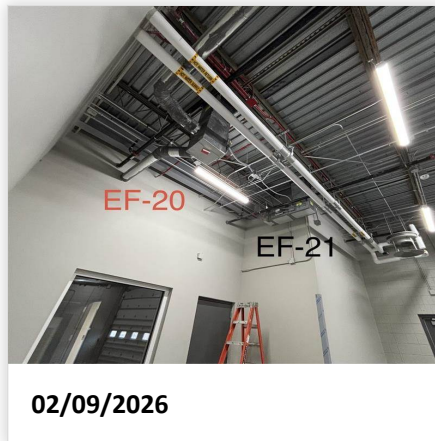
Issue Name : EF-20 and EF-21 Ductwork swapped
Description : According to the drawings, EF-21 and EF-20 ductwork have been swapped, but the fans were not. According to the submittal, EF-21 GB-097-6 is rated for max 275 CFM and is unable to satisfy 900 CFM.
Created By : National TAB **Assigned To :** National TAB - Antonio Flores-De La Cruz
Status : Open
Priority : Urgent **Asset Tag :**
Originated Date : 02/09/2026 - Antonio Flores-De La Cruz - National TAB

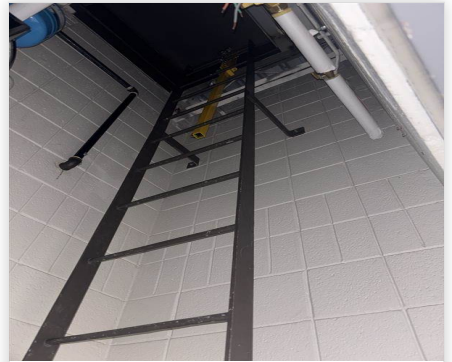
Issue Name : EF-23 Missing Grille
Description : Grille EF-23-1 in JANITORS E118 is not installed.
Created By : National TAB **Assigned To :** National TAB - Antonio Flores-De La Cruz
Status : Open
Priority : High **Asset Tag :**
Originated Date : 02/12/2026 - Antonio Flores-De La Cruz - National TAB

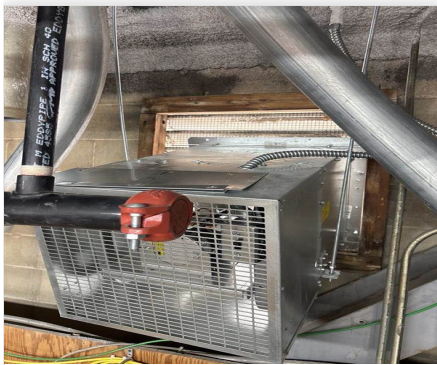
Issue Name : EF-7 Concerns
Description : EF-7 has been balanced as-is with how it is installed, but unsure if there will be any changes to installment after it's been balanced.
Created By : National TAB **Assigned To :** National TAB - Antonio Flores-De La Cruz
Status : Open
Priority : Urgent **Asset Tag :**
Originated Date : 02/12/2026 - Antonio Flores-De La Cruz - National TAB

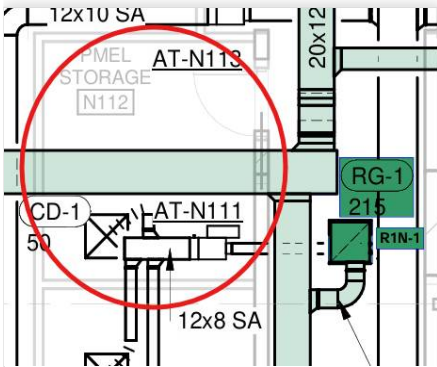
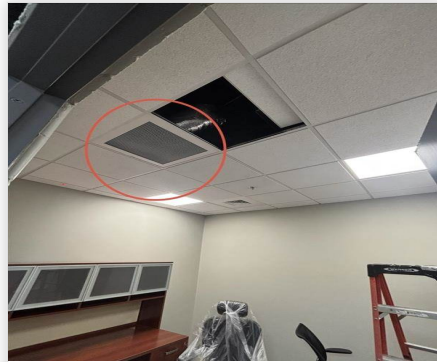
Issue Name : Extra Return Grille located in PMEL STORAGE N112
Description : Per the drawings, there is an extra return grille located in PMEL STORAGE N112.
Created By : National TAB **Assigned To :** National TAB - Antonio Flores-De La Cruz
Status : Open
Priority : Urgent **Asset Tag :**
Originated Date : 02/09/2026 - Antonio Flores-De La Cruz - National TAB

- **02/12/2026 National TAB - Antonio Flores-De La Cruz**
 - Grille was removed.

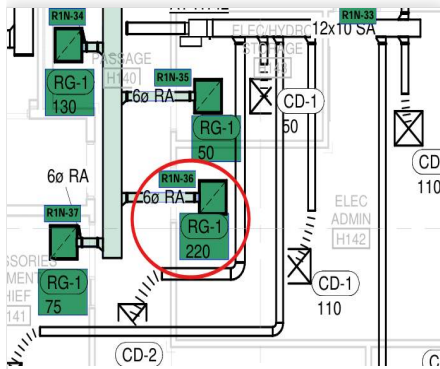
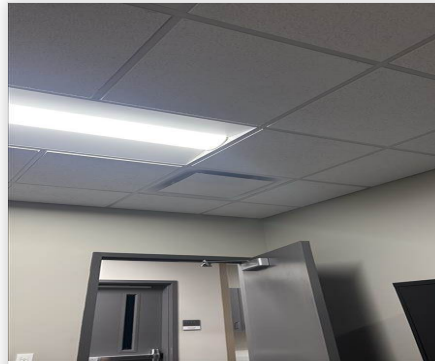
Issue Name : Incorrect Grille Type used for Return
Description : Return Grille R1N-36 is a supply-type diffuser and not type RG-1. Recommended to install the correct grille to balance.
Created By : National TAB **Assigned To :** National TAB - Antonio Flores-De La Cruz
Status : Open
Priority : **Urgent** **Asset Tag :**
Originated Date : 02/09/2026 - Antonio Flores-De La Cruz - National TAB

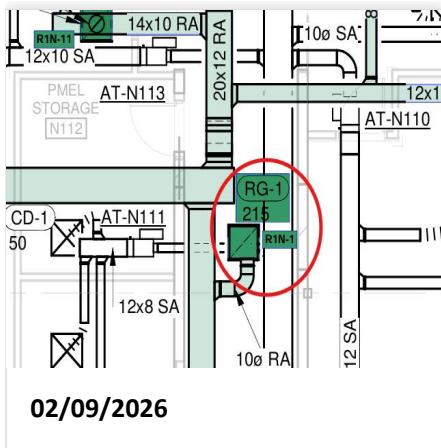
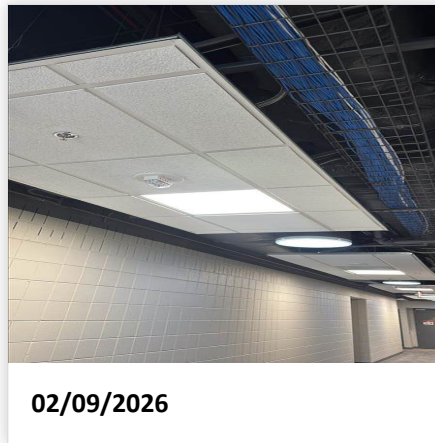
Issue Name : Return Grille for AHUN1 Not installed
Description : Grille R1N-1 in CORRIDOR N107, not installed.
Created By : National TAB **Assigned To :** National TAB - Antonio Flores-De La Cruz
Status : Open
Priority : **Urgent** **Asset Tag :**
Originated Date : 02/09/2026 - Antonio Flores-De La Cruz - National TAB

- **02/12/2026 National TAB - Antonio Flores-De La Cruz**
 - Grille Installed

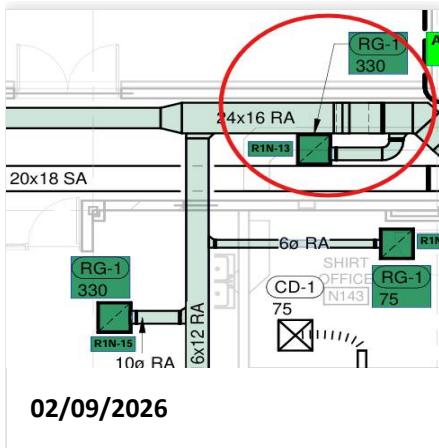
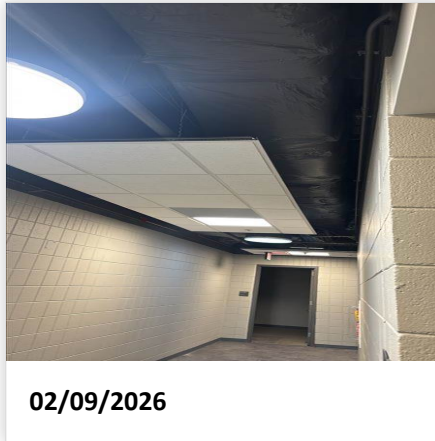
Issue Name : Return Grille not installed in CORRIDOR N150
Description : Return Grille R1N-15 not installed in CORRIDOR N150.
Created By : National TAB **Assigned To :** National TAB - Antonio Flores-De La Cruz
Status : Open
Priority : Urgent **Asset Tag :**
Originated Date : 02/09/2026 - Antonio Flores-De La Cruz - National TAB

- **02/12/2026 National TAB - Antonio Flores-De La Cruz**
 - Grille Inserted

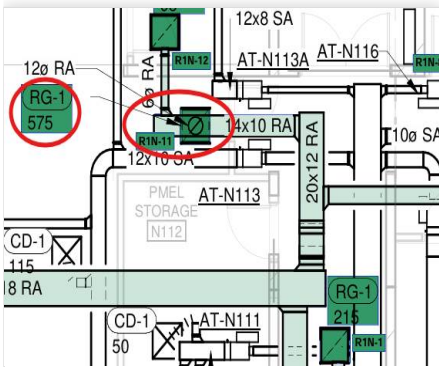
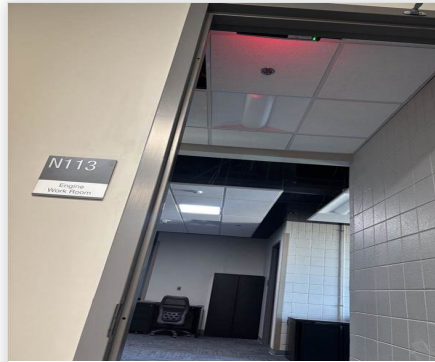
Issue Name : Return Grille not installed in ENGINE WORKROOM N113
Description : Return grille R1N-11 not installed in ENGINE WORKROOM N113.
Created By : National TAB **Assigned To :** National TAB - Antonio Flores-De La Cruz
Status : Open
Priority : **Urgent** **Asset Tag :**
Originated Date : 02/09/2026 - Antonio Flores-De La Cruz - National TAB

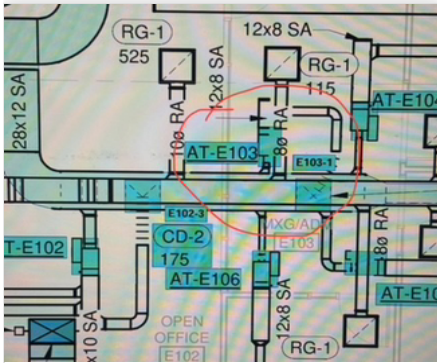
Issue Name : VAV AT-E103 Wrong Location
Description : VAV AT-E103 is installed in the wrong location per the drawings. It should have been installed in MXG/ADM E103 but instead was installed in room OPEN OFFICE E102. A diffuser is installed in room E103, but it is connected to VAV AT-E101, which is incorrect.
