## Issue List

### NCANG Repair Bldg 51 (Charlotte, NC)

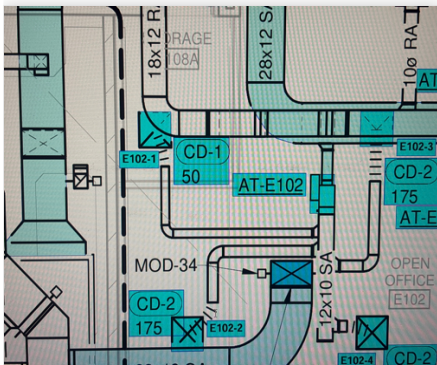
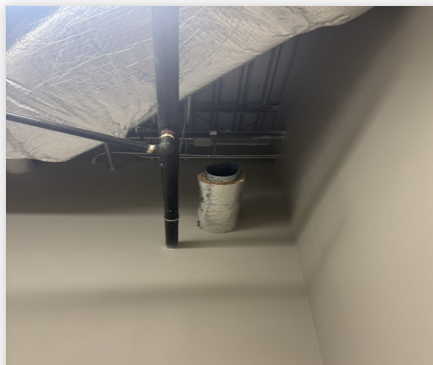
**Issue Name :** VAV AT-E102 Missing Diffuser  
**Description :** Diffuser E102-1 is missing in room STORAGE 108A  
**Created By :** National TAB                      **Assigned To :** National TAB - Antonio Flores-De La Cruz  
**Status :** Open  
**Priority :**    **Asset Tag :**  
**Originated Date :** 01/21/2026 - Antonio Flores-De La Cruz - National TAB

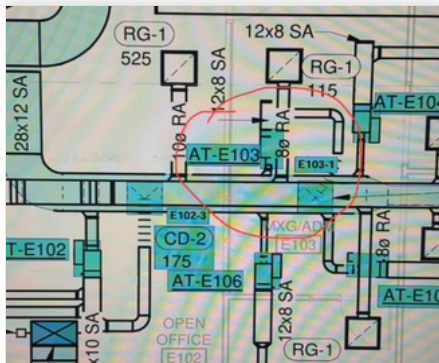
**Issue Name :** VAV AT-E103 Wrong Location  
**Description :** VAV AT-E103 is installed in the wrong location per the drawings. It should have been installed in MXG/ADM E103, but instead was installed in room OPEN OFFICE E102.  
**Created By :** National TAB                      **Assigned To :** National TAB - Antonio Flores-De La Cruz  
**Status :** Open  
**Priority :**    **Asset Tag :**  
**Originated Date :** 01/21/2026 - Antonio Flores-De La Cruz - National TAB

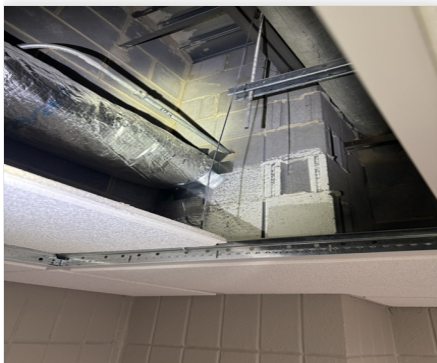
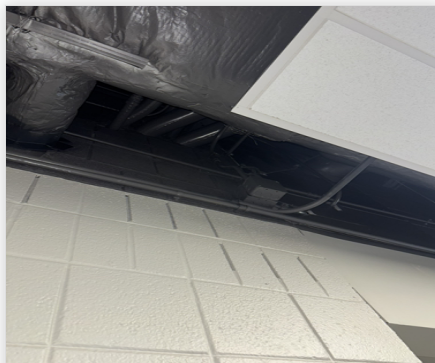
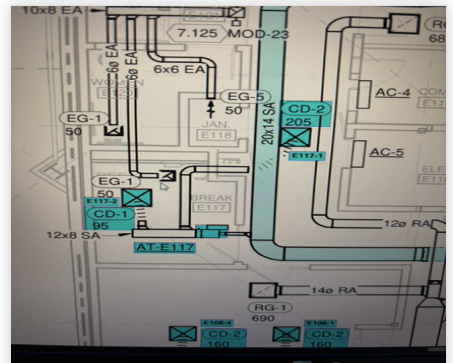
**Issue Name :** VAV AT-E117 Missing Grille  
**Description :** Diffuser E117-1 in CORRIDOR E115 is missing. Upon inspection, it appears that the duct is attached to the VAV but it stops at the brick wall of room BREAK E117 and doesn't penetrate to the other side.  
**Created By :** National TAB                      **Assigned To :** National TAB - Antonio Flores-De La Cruz  
**Status :** Open  
**Priority :**    **Asset Tag :**  
**Originated Date :** 01/21/2026 - Antonio Flores-De La Cruz - National TAB

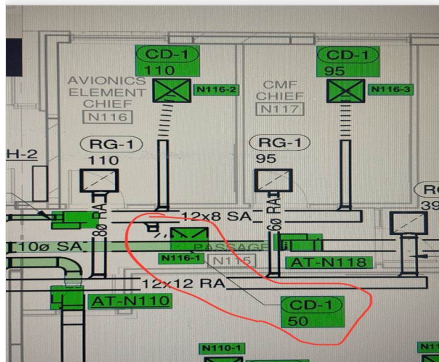
**Issue Name :** VAV AT-N116 Missing Diffuser  
**Description :** Diffuser missing in Passage N115 (N116-1).  
**Created By :** National TAB                      **Assigned To :** National TAB - Antonio Flores-De La Cruz  
**Status :** Open  
**Priority :** **Urgent**                                      **Asset Tag :**  
**Originated Date :** 11/11/2025 - Antonio Flores-De La Cruz - National TAB

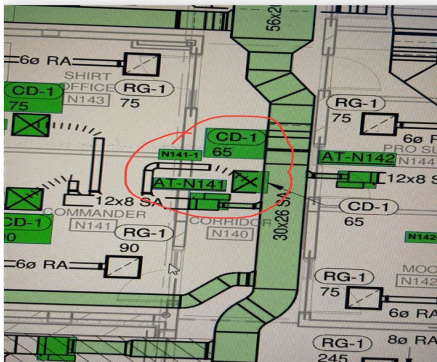
**Issue Name :** VAV AT-N141 Missing Diffuser  
**Description :** Diffuser in Corridor N140 (N141-1) is missing.  
**Created By :** National TAB                      **Assigned To :** National TAB - Antonio Flores-De La Cruz  
**Status :** Open  
**Priority :** **Urgent**                                      **Asset Tag :**  
**Originated Date :** 11/11/2025 - Antonio Flores-De La Cruz - National TAB

- **01/21/2026 National TAB - Antonio Flores-De La Cruz**
  - SAW MECHANICAL CONTRACTOR FIXING ISSUE, WILL CHECK

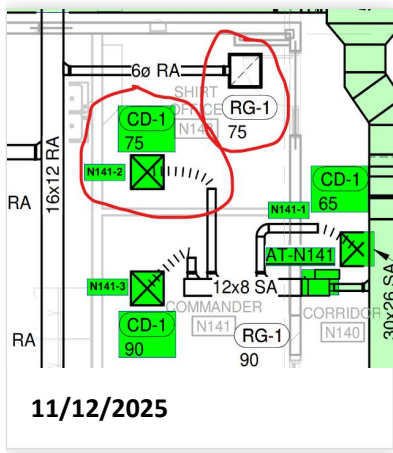
- **11/12/2025 National TAB - Antonio Flores-De La Cruz**
  - Diffuser was installed, but after attempting to balance, the supply grille in Shirt Office N143 (N141-2) is swapped with the grille for the return. It must be swapped.
