Issue List

NCANG Repair Bldg 51 (Charlotte, NC)

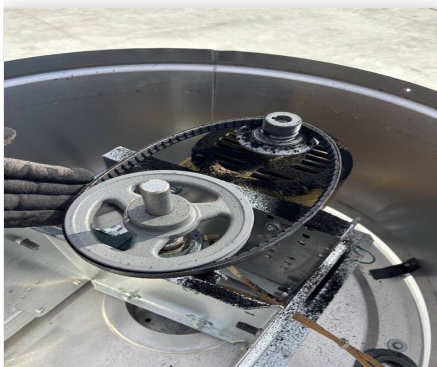
Issue Name : EF-14 Not Operational
Description : EF-14 is not operational because the motor sheave and belt are damaged. The motor sheave broke into two pieces.
Created By : National TAB **Assigned To :** National TAB - Antonio Flores-De La Cruz
Status : Open
Priority : Urgent **Asset Tag :**
Originated Date : 02/12/2026 - Antonio Flores-De La Cruz - National TAB

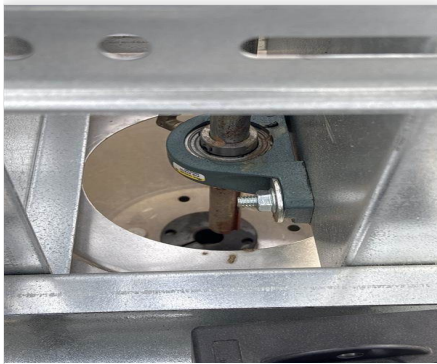
Issue Name : EF-15 Not Operational

Description : EF-15 shaft to the blower is not connected at this time.

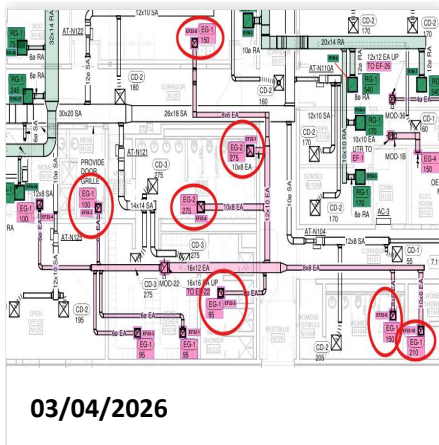
Issue Name : EF-22 Missing Dampers
Description : EF-22 is missing all dampers but 3 to TAB. The grilles with dampers are: EF22-1, EF22-3, and EF22-4. Recommended to install dampers with access due to the hard ceiling.
Created By : National TAB
Assigned To : National TAB - Antonio Flores-De La Cruz
Status : Open
Priority : Urgent
Asset Tag :
Originated Date : 03/03/2026 - Antonio Flores-De La Cruz - National TAB

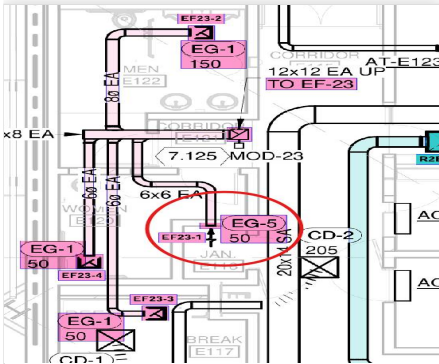
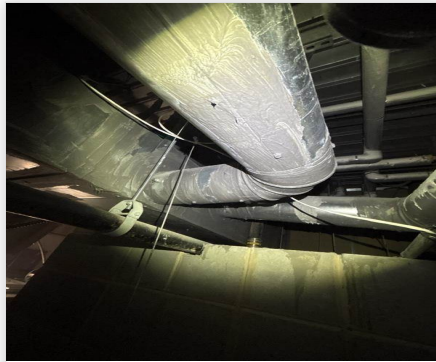
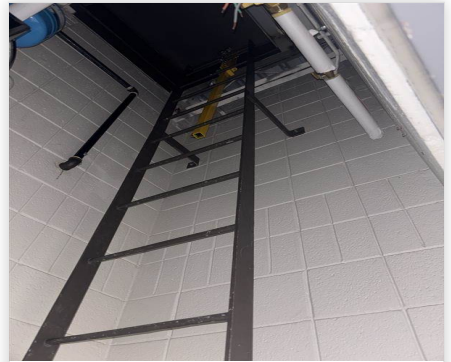
Issue Name : EF-23 Missing Grille
Description : Grille EF-23-1 in JANITORS E118 is not installed.
Created By : National TAB **Assigned To :** National TAB - Antonio Flores-De La Cruz
Status : Open
Priority : High **Asset Tag :**
Originated Date : 02/12/2026 - Antonio Flores-De La Cruz - National TAB

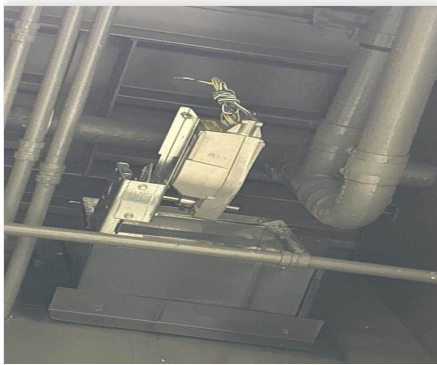
Issue Name : EF-3 Not operational and Motor Damper not wired
Description : The exhaust damper for EF-3 is not wired, and Controls stated that the fan is not wired to be operational.
Created By : National TAB **Assigned To :** National TAB - Antonio Flores-De La Cruz
Status : Open
Priority : Urgent **Asset Tag :**
Originated Date : 02/12/2026 - Antonio Flores-De La Cruz - National TAB

- **03/05/2026 National TAB - Antonio Flores-De La Cruz**
 - FAN APPEARS WIRED, BUT DAMPER IS STILL NOT WIRED TO OPEN.

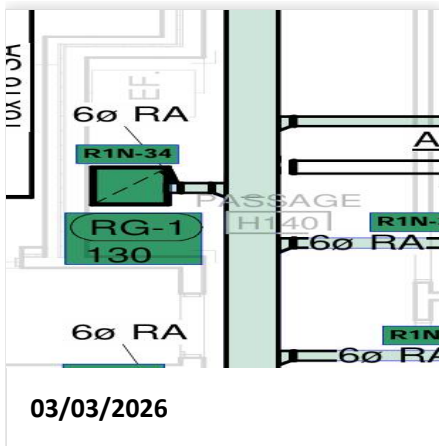
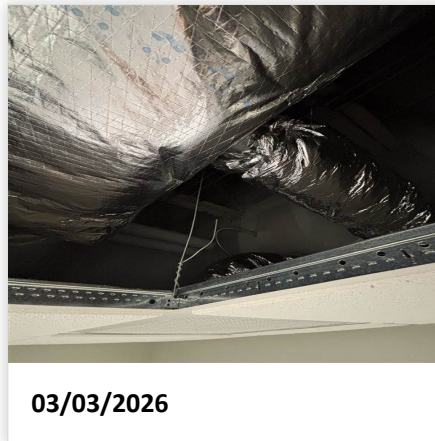
Issue Name : Incorrect Connected Return Grille
Description : Return Grille R1N-34 is connected to the supply, not the return.
Created By : National TAB **Assigned To :** National TAB - Antonio Flores-De La Cruz
Status : Open
Priority : Urgent **Asset Tag :**
Originated Date : 03/03/2026 - Antonio Flores-De La Cruz - National TAB

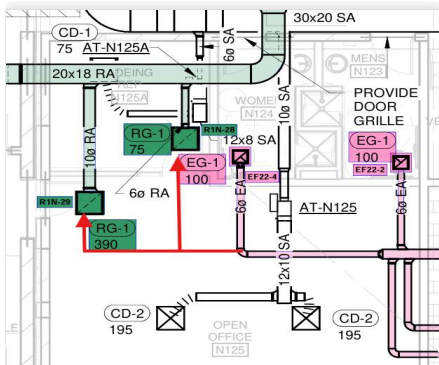
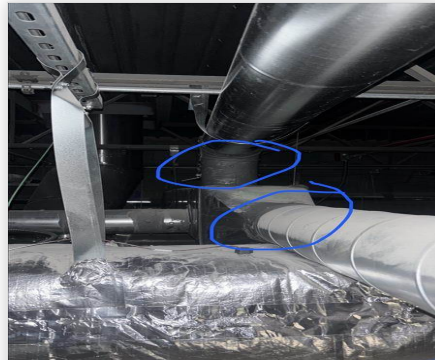
Issue Name : Incorrectly Installed Duct for Return
Description : Grilles R1N-28 and R1N-29 were attached to EF-22 ductwork.
Created By : National TAB **Assigned To :** National TAB - Antonio Flores-De La Cruz
Status : Open
Priority : **Urgent** **Asset Tag :**
Originated Date : 03/03/2026 - Antonio Flores-De La Cruz - National TAB

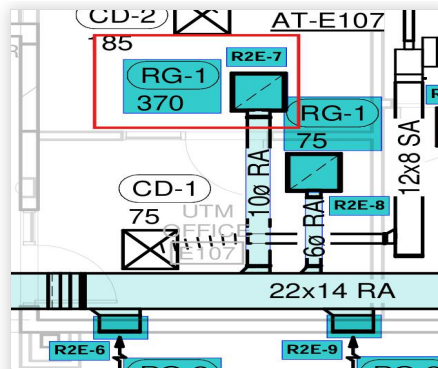
Issue Name : Missing Damper for Return Grille
Description : Return Grille R2E-7 in E107A is missing the damper to balance.
Created By : National TAB **Assigned To :** National TAB - Antonio Flores-De La Cruz
Status : Open
Priority : Urgent **Asset Tag :**
Originated Date : 03/02/2026 - Antonio Flores-De La Cruz - National TAB

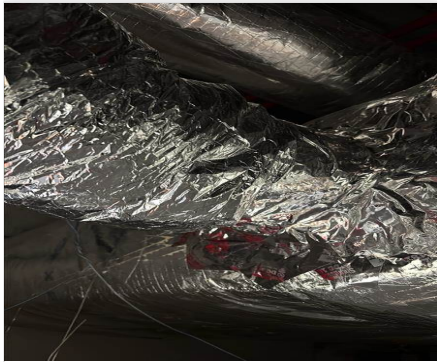
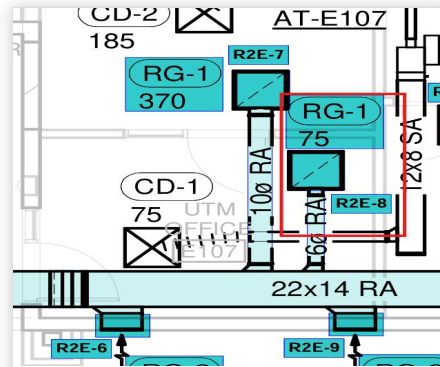
Issue Name : Missing Damper for Return Grille in E107
Description : Grille R2E-8 is missing the damper to balance.
Created By : National TAB **Assigned To :** National TAB - Antonio Flores-De La Cruz
Status : Open
Priority : Urgent **Asset Tag :**
Originated Date : 03/02/2026 - Antonio Flores-De La Cruz - National TAB

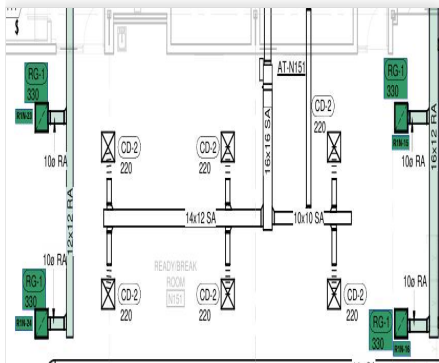
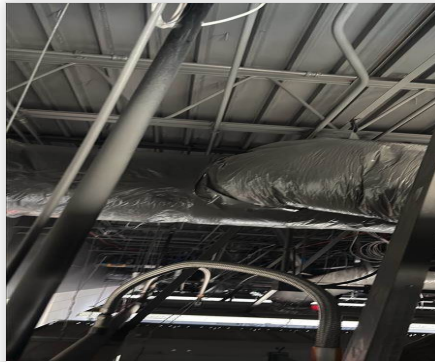
Issue Name : Missing Multiple Return Dampers in ROOM READY/BREAKROOM N151
Description : Return grilles: R1N-15, R1N-16, R1N-23, and R1N-24 are all missing dampers to TAB.

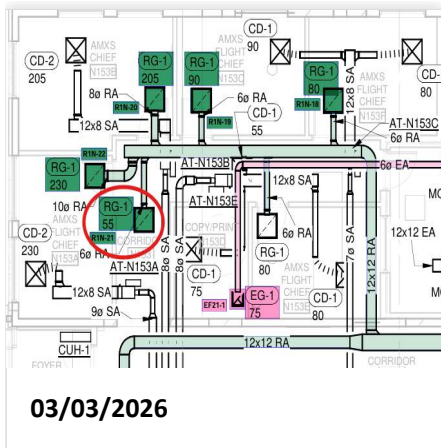
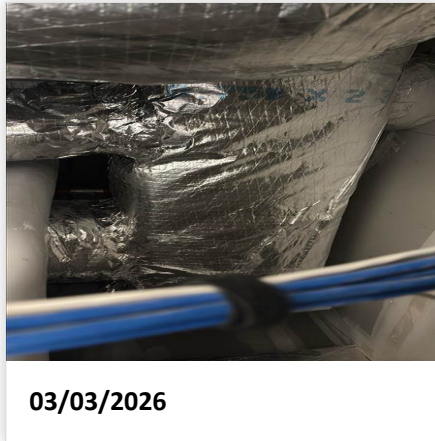
Issue Name : Missing Return Damper for CORRIDOR N153
Description : Grille R1N-21 is missing the damper ot TAB.
Created By : National TAB **Assigned To :** National TAB - Antonio Flores-De La Cruz
Status : Open
Priority : **Urgent** **Asset Tag :**
Originated Date : 03/03/2026 - Antonio Flores-De La Cruz - National TAB

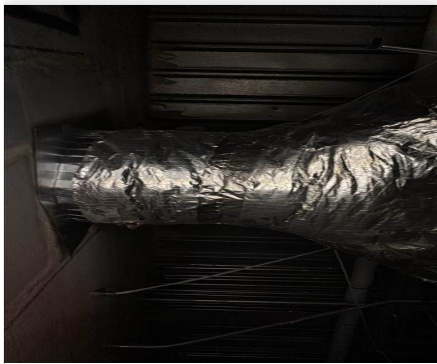
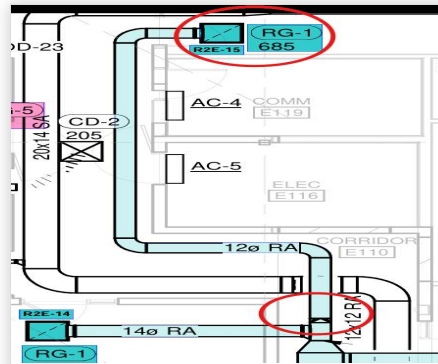
Issue Name : Missing Return Damper in OPEN OFFICE E123
Description : Damper for Grille R2E-15 is missing to balance.
Created By : National TAB **Assigned To :** National TAB - Antonio Flores-De La Cruz
Status : Open
Priority : Urgent **Asset Tag :**
Originated Date : 03/02/2026 - Antonio Flores-De La Cruz - National TAB

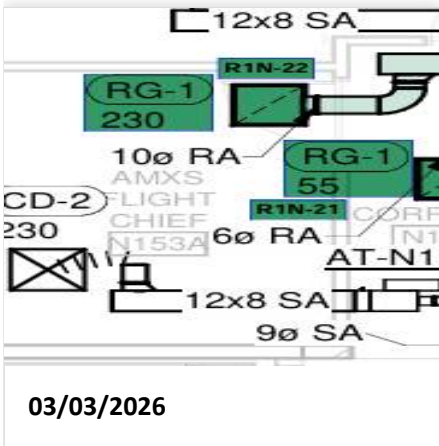
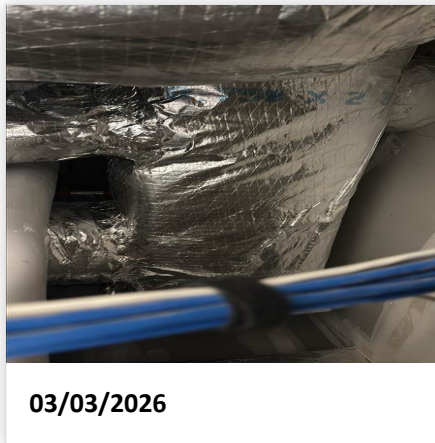
Issue Name : Missing Return Damper in ROOM AMXS FLIGHT CHIEF N153A
Description : Grille R1N-22 is missing the damper to TAB.
Created By : National TAB **Assigned To :** National TAB - Antonio Flores-De La Cruz
Status : Open
Priority : Urgent **Asset Tag :**
Originated Date : 03/03/2026 - Antonio Flores-De La Cruz - National TAB

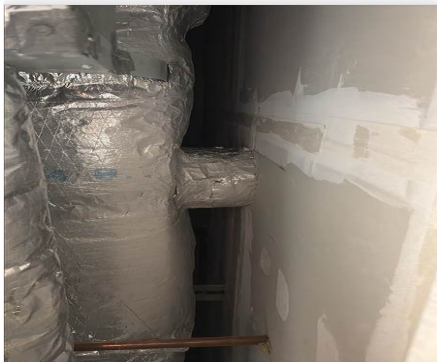
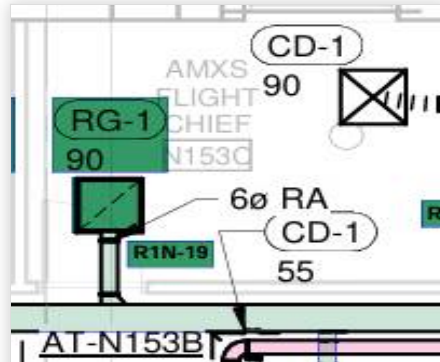
Issue Name : Missing Return Damper in ROOM AMXS FLIGHT CHIEF N153C
Description : Grille R1N-19 is missing the damper to TAB.
Created By : National TAB **Assigned To :** National TAB - Antonio Flores-De La Cruz
Status : Open
Priority : Urgent **Asset Tag :**
Originated Date : 03/03/2026 - Antonio Flores-De La Cruz - National TAB

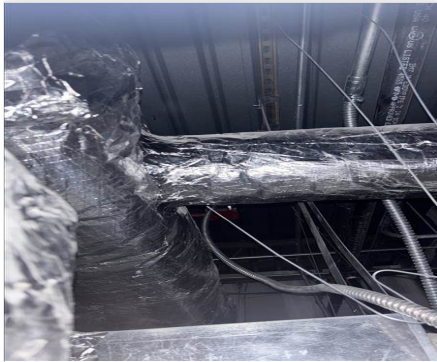
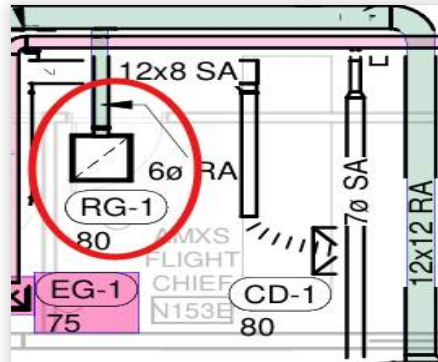
Issue Name : Missing Return Damper in ROOM AMXS FLIGHT CHIEF N153E
Description : Grille in ROOM AMXS FLIGHT CHIEF N153E is missing the damper to TAB.
Created By : National TAB **Assigned To :** National TAB - Antonio Flores-De La Cruz
Status : Open
Priority : Urgent **Asset Tag :**
Originated Date : 03/03/2026 - Antonio Flores-De La Cruz - National TAB

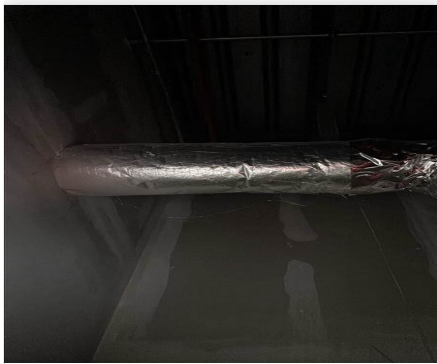
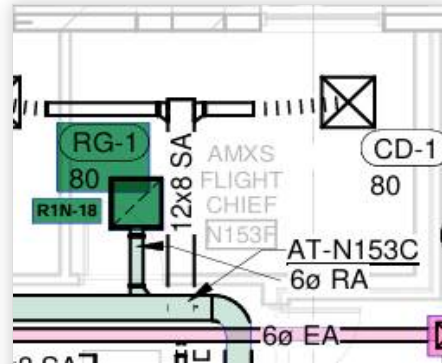
Issue Name : Missing Return Damper in ROOM AMXS FLIGHT CHIEF N153F
Description : Grille R1N-18 is missing the damper to TAB.
Created By : National TAB **Assigned To :** National TAB - Antonio Flores-De La Cruz
Status : Open
Priority : Urgent **Asset Tag :**
Originated Date : 03/03/2026 - Antonio Flores-De La Cruz - National TAB

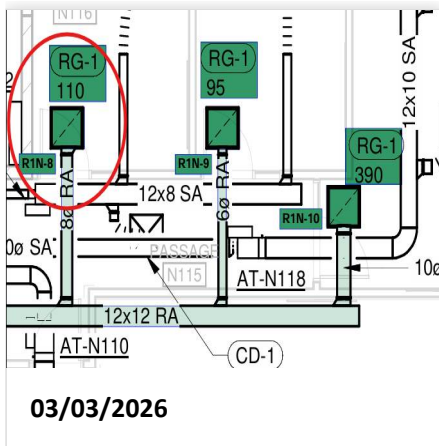
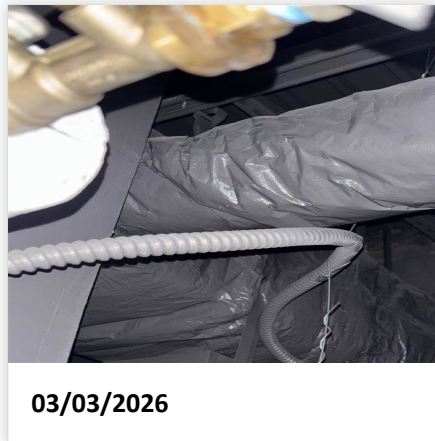
Issue Name : Missing Return Damper in ROOM AVIONICS ELEMENT CHIEF N116
Description : Grille R1N-8 is missing the damper to TAB.
Created By : National TAB **Assigned To :** National TAB - Antonio Flores-De La Cruz
Status : Open
Priority : **Urgent** **Asset Tag :**
Originated Date : 03/03/2026 - Antonio Flores-De La Cruz - National TAB

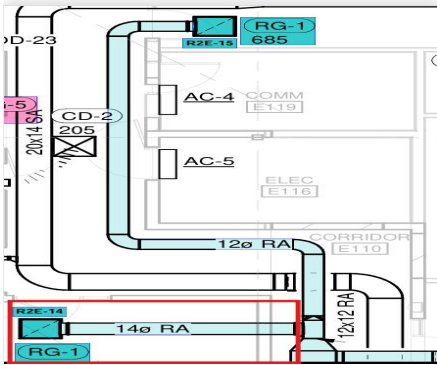
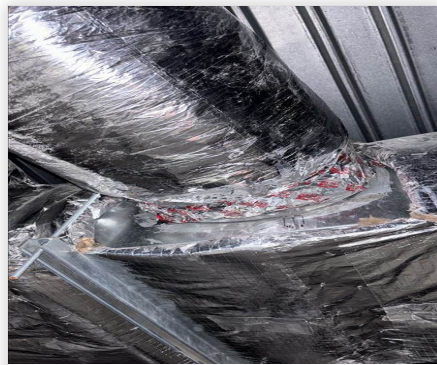
Issue Name : Missing Return Damper in ROOM CLASSROOM E108
Description : Damper for Grille R2E-14 in ROOM CLASSROOM E108 is missing to balance.
Created By : National TAB **Assigned To :** National TAB - Antonio Flores-De La Cruz
Status : Open
Priority : **Urgent** **Asset Tag :**
Originated Date : 03/02/2026 - Antonio Flores-De La Cruz - National TAB

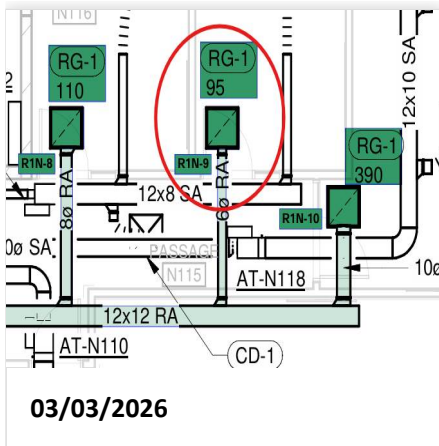
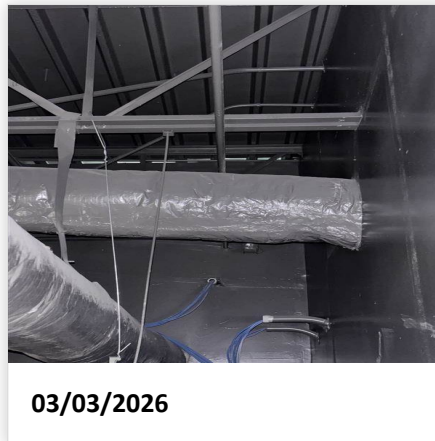
Issue Name : Missing Return Damper in ROOM CMF CHIEF N117
Description : Grille R1N-9 is missing the damper to TAB.
Created By : National TAB **Assigned To :** National TAB - Antonio Flores-De La Cruz
Status : Open
Priority : **Urgent** **Asset Tag :**
Originated Date : 03/03/2026 - Antonio Flores-De La Cruz - National TAB

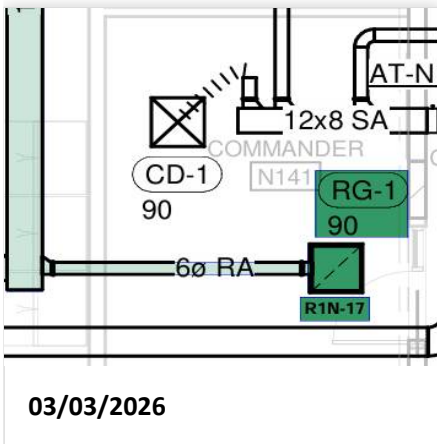
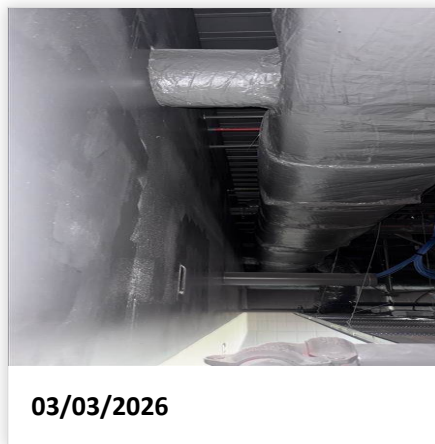
Issue Name : Missing Return Damper in ROOM COMMANDER N141
Description : Grille R1N-17 is missing the return damper to TAB.
Created By : National TAB **Assigned To :** National TAB - Antonio Flores-De La Cruz
Status : Open
Priority : Urgent **Asset Tag :**
Originated Date : 03/03/2026 - Antonio Flores-De La Cruz - National TAB

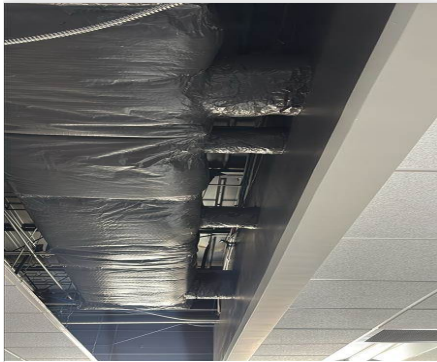
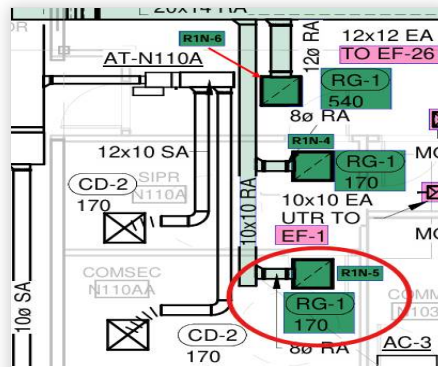
Issue Name : Missing Return Damper in ROOM COMSEC N110AA
Description : Grille R1N-5 is missing the damper to TAB.
Created By : National TAB **Assigned To :** National TAB - Antonio Flores-De La Cruz
Status : Open
Priority : Urgent **Asset Tag :**
Originated Date : 03/03/2026 - Antonio Flores-De La Cruz - National TAB

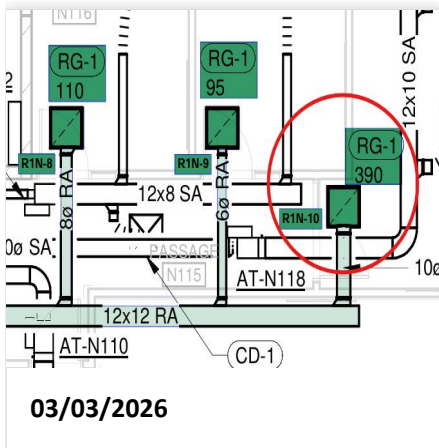
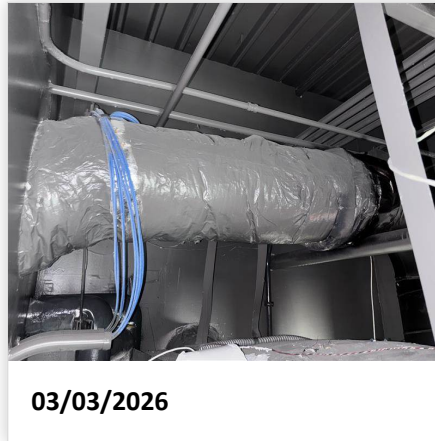
Issue Name : Missing Return Damper in ROOM CONFERENCE N118
Description : Grille R1N-10 is missing the damper to TAB.
Created By : National TAB **Assigned To :** National TAB - Antonio Flores-De La Cruz
Status : Open
Priority : **Urgent** **Asset Tag :**
Originated Date : 03/03/2026 - Antonio Flores-De La Cruz - National TAB

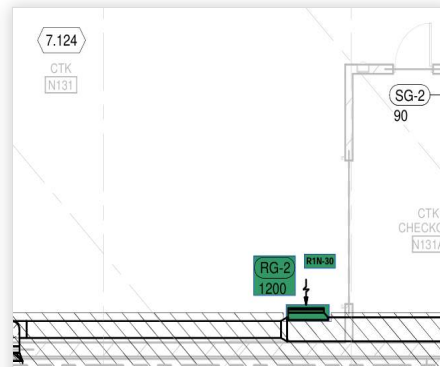
Issue Name : Missing Return Damper in ROOM CTK N131
Description : Grille R1N-30 is missing the damper to TAB.
Created By : National TAB **Assigned To :** National TAB - Antonio Flores-De La Cruz
Status : Open
Priority : Urgent **Asset Tag :**
Originated Date : 03/03/2026 - Antonio Flores-De La Cruz - National TAB

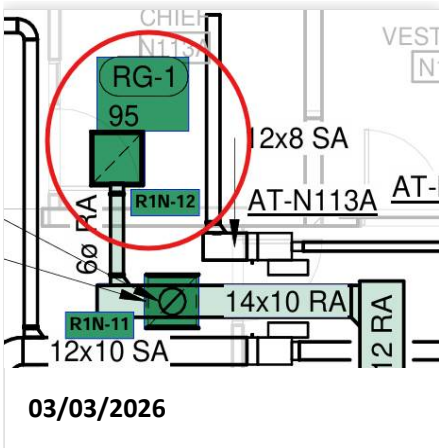
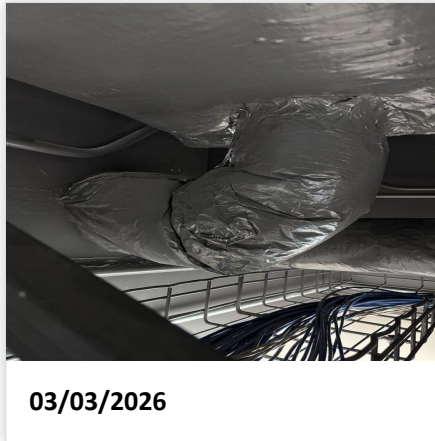
Issue Name : Missing Return Damper in ROOM ENG ELEMENT CHIEF N113A
Description : Grille R1N-12 is missing the damper to TAB.
Created By : National TAB **Assigned To :** National TAB - Antonio Flores-De La Cruz
Status : Open
Priority : **Urgent** **Asset Tag :**
Originated Date : 03/03/2026 - Antonio Flores-De La Cruz - National TAB

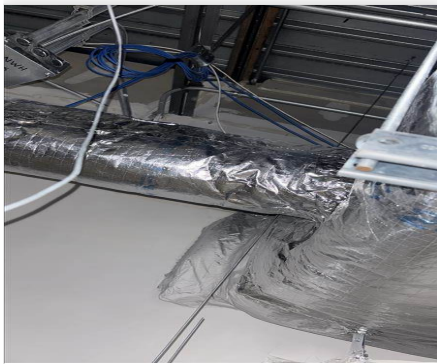
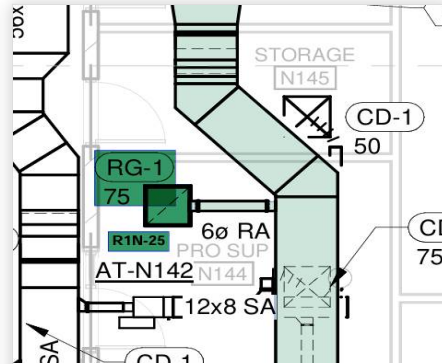
Issue Name : Missing Return Damper in Room PRO SUP N144
Description : Return Damper for Grille R1N-45 is missing to TAB.
Created By : National TAB **Assigned To :** National TAB - Antonio Flores-De La Cruz
Status : Open
Priority : Urgent **Asset Tag :**
Originated Date : 03/03/2026 - Antonio Flores-De La Cruz - National TAB

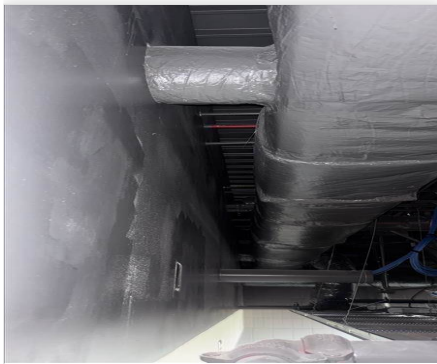
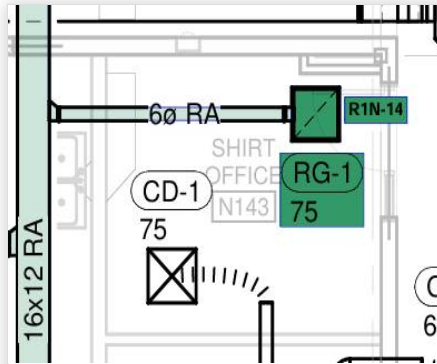
Issue Name : Missing Return Damper in ROOM SHIRT OFFICE N143
Description : Grille R1N-14 is missing the return damper to TAB.
Created By : National TAB **Assigned To :** National TAB - Antonio Flores-De La Cruz
Status : Open
Priority : Urgent **Asset Tag :**
Originated Date : 03/03/2026 - Antonio Flores-De La Cruz - National TAB

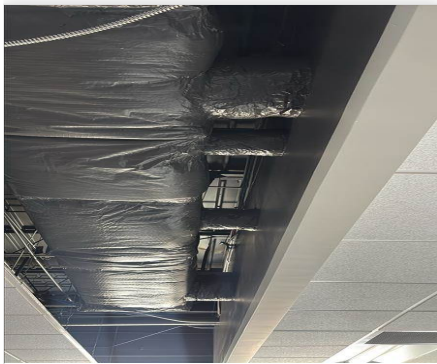
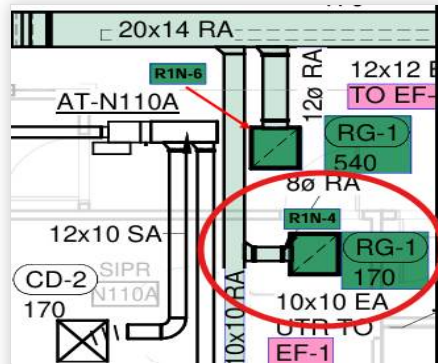
Issue Name : Missing Return Damper in ROOM SIPR N110A
Description : Grille R1N-4 is missing the damper to TAB.
Created By : National TAB **Assigned To :** National TAB - Antonio Flores-De La Cruz
Status : Open
Priority : Urgent **Asset Tag :**
Originated Date : 03/03/2026 - Antonio Flores-De La Cruz - National TAB

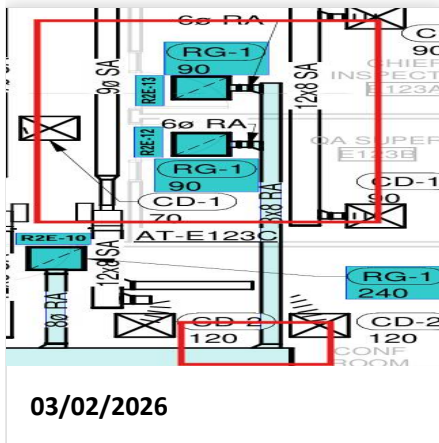
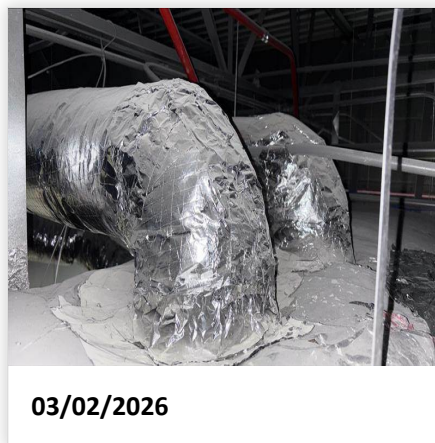
Issue Name : Missing Return Dampers in Offices
Description : Grilles R2E-12 and R2E-13 are missing their dampers to balance the return.
Created By : National TAB **Assigned To :** National TAB - Antonio Flores-De La Cruz
Status : Open
Priority : **Urgent** **Asset Tag :**
Originated Date : 03/02/2026 - Antonio Flores-De La Cruz - National TAB

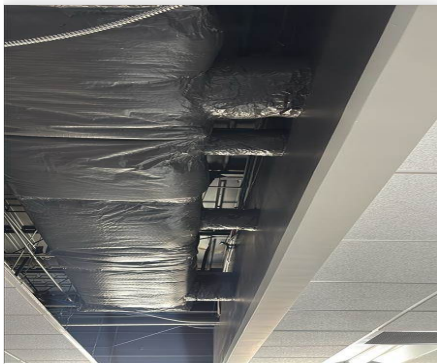
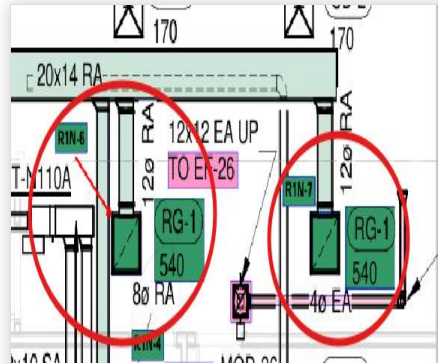
Issue Name : Missing Return Dampers in ROOM AVIONICS N110
Description : Grilles R1N-6 and R1N-7 are missing the dampers to TAB.
Created By : National TAB **Assigned To :** National TAB - Antonio Flores-De La Cruz
Status : Open
Priority : Urgent **Asset Tag :**
Originated Date : 03/03/2026 - Antonio Flores-De La Cruz - National TAB

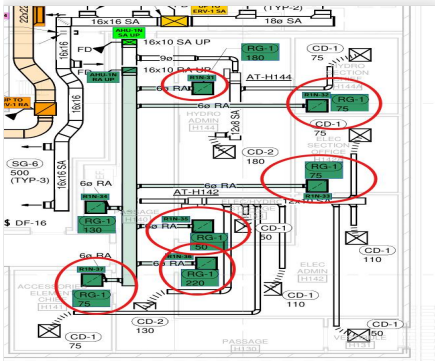
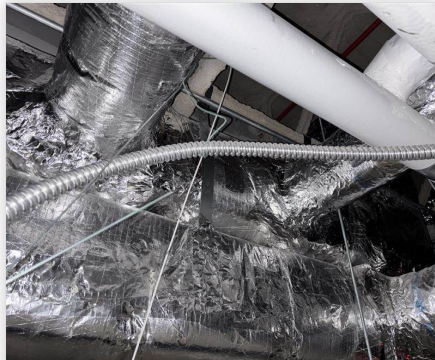
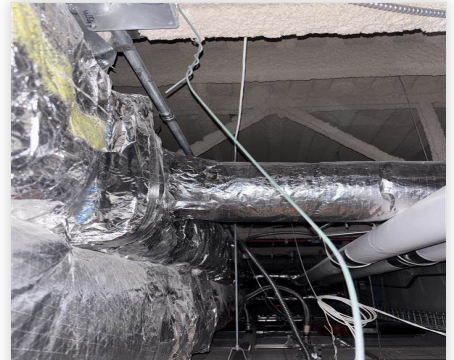
Issue Name : Multiple Dampers Missing HANGER SHOP NORTH
Description : Return Grilles R1N-31 through R1N-37, EXCEPT R1N-34, are missing dampers to balance the return.
Created By : National TAB **Assigned To :** National TAB - Antonio Flores-De La Cruz
Status : Open
Priority : Urgent **Asset Tag :**
Originated Date : 03/03/2026 - Antonio Flores-De La Cruz - National TAB

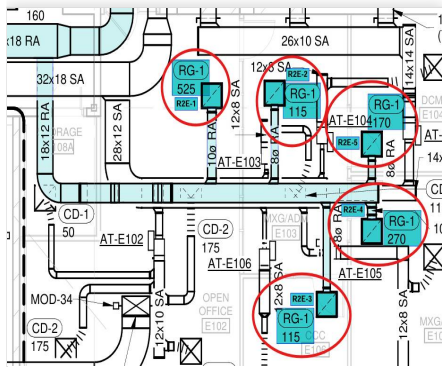
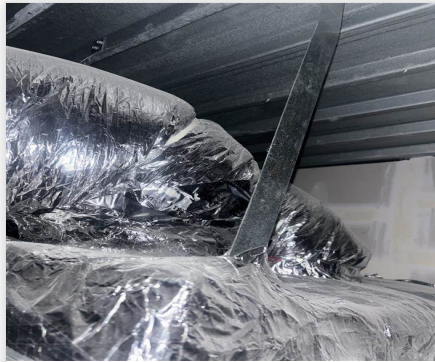
Issue Name : Multiple Return Dampers missing
Description : Dampers for Return Grilles: RE2-1 through RE2-5 are missing to balance.
Created By : National TAB
Assigned To : National TAB - Antonio Flores-De La Cruz
Status : Open
Priority : Urgent
Asset Tag :
Originated Date : 03/02/2026 - Antonio Flores-De La Cruz - National TAB

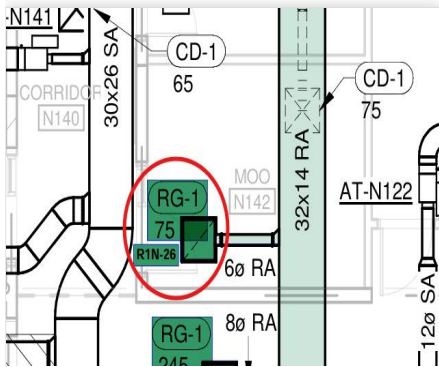
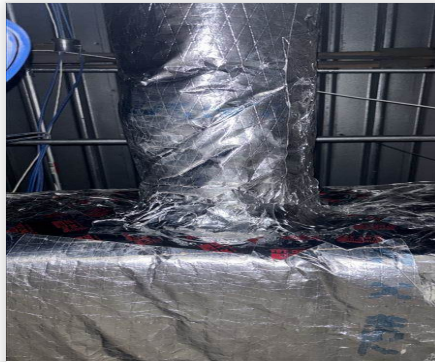
Issue Name : Return Damper Missing in ROOM MOO 142
Description : Return Grille R1N-26 is missing the damper to TAB.
Created By : National TAB **Assigned To :** National TAB - Antonio Flores-De La Cruz
Status : Open
Priority : **Urgent** **Asset Tag :**
Originated Date : 03/03/2026 - Antonio Flores-De La Cruz - National TAB
