## Issue List

## NCANG Repair Bldg 51 (Charlotte, NC)

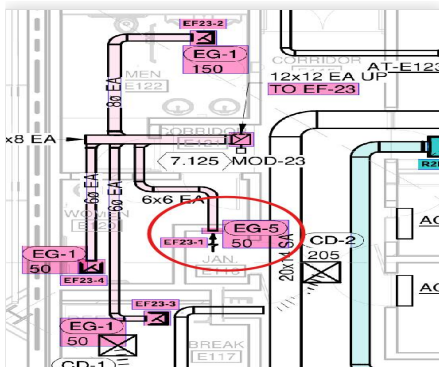
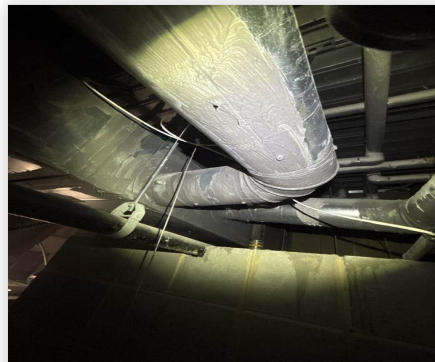
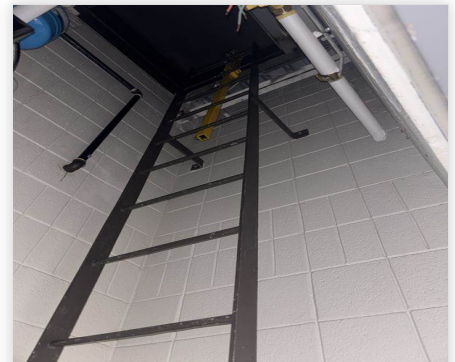
**Issue Name :** EF-23 Missing Grille  
**Description :** Grille EF-23-1 in JANITORS E118 is not installed.  
**Created By :** National TAB  
**Assigned To :** National TAB - Antonio Flores-De La Cruz  
**Status :** Open  
**Priority :** High  
**Asset Tag :**  
**Originated Date :** 02/12/2026 - Antonio Flores-De La Cruz - National TAB

- **03/30/2026 National TAB - Antonio Flores-De La Cruz**
  - Will not be installed

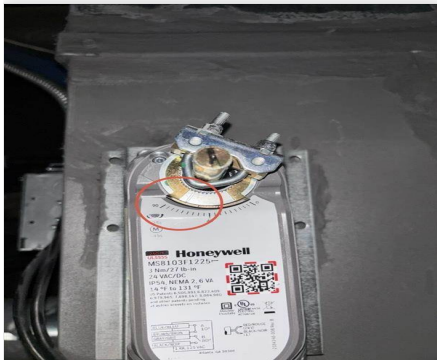
**Issue Name :** EF-26 Low Flow  
**Description :** EF-26 is at 66% of design (99 CFM ACTUAL / 150 CFM DESIGN). The speed dial is at max. A possible cause could be a partially opened exhaust motorized damper. It was found that there is a damper at the takeoff and one at the arm of the equipment where the duct connects, which may add resistance to the system.

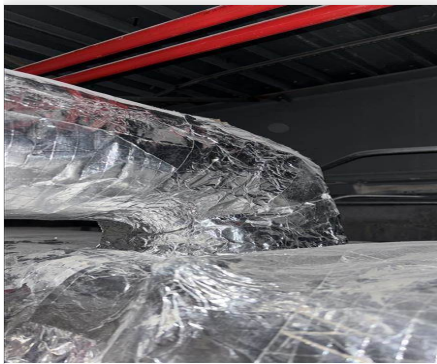
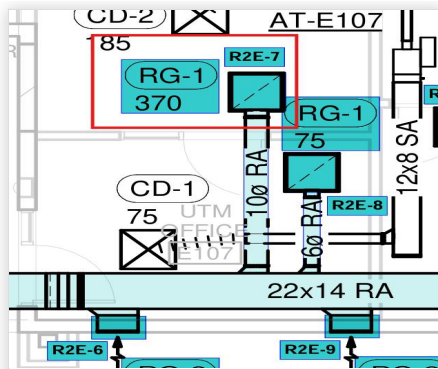
**Issue Name :** Missing Damper for Return Grille  
**Description :** Return Grille R2E-7 in E107A is missing the damper to balance.  
**Created By :** National TAB **Assigned To :** National TAB - Antonio Flores-De La Cruz  
**Status :** Open  
**Priority :** Urgent **Asset Tag :**  
**Originated Date :** 03/02/2026 - Antonio Flores-De La Cruz - National TAB

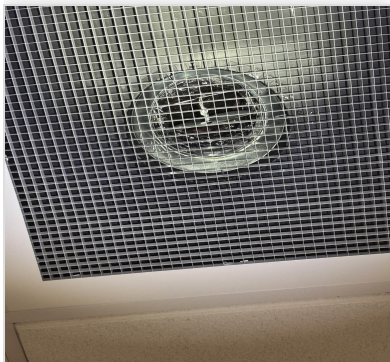
- **04/01/2026 National TAB - Antonio Flores-De La Cruz**
  - Installed but during balancing, flow is being restricted. Possible cause could be the transition at the collar reducing flow.

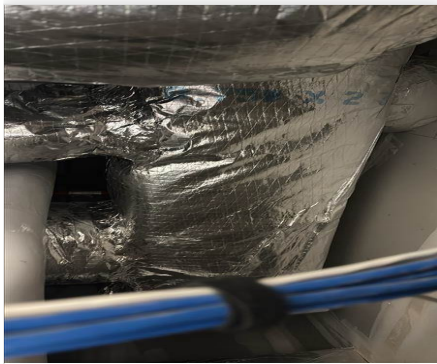
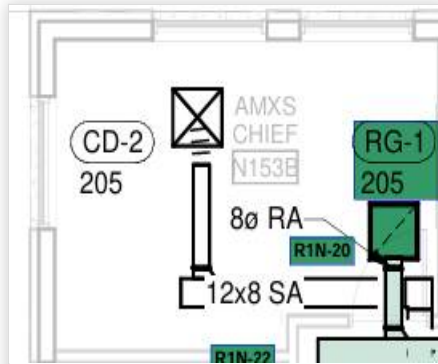
**Issue Name :** Missing Return Damper in ROOM AXMS CHIEF N153B  
**Description :** Grille R1N-20 is missing the damper to TAB.  
**Created By :** National TAB                      **Assigned To :** National TAB - Antonio Flores-De La Cruz  
**Status :** Open  
**Priority :** Urgent                                      **Asset Tag :**  
**Originated Date :** 03/03/2026 - Antonio Flores-De La Cruz - National TAB

- **04/02/2026 National TAB - Antonio Flores-De La Cruz**
  - Not Installed.

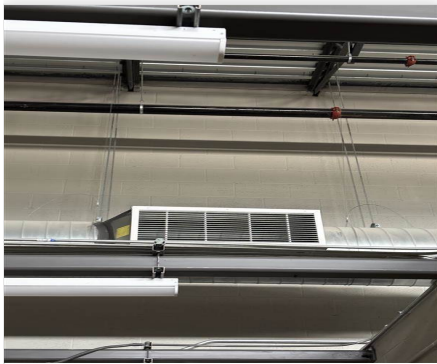
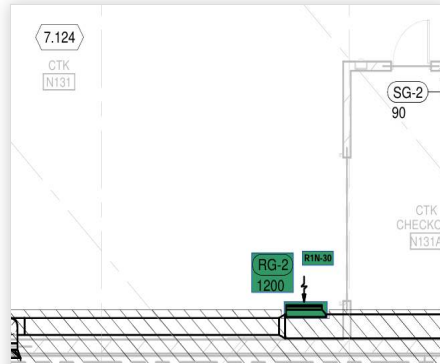
**Issue Name :** Missing Return Damper in ROOM CTK N131  
**Description :** Grille R1N-30 is missing the damper to TAB.  
**Created By :** National TAB                      **Assigned To :** National TAB - Antonio Flores-De La Cruz  
**Status :** Open  
**Priority :** Urgent                                      **Asset Tag :**  
**Originated Date :** 03/03/2026 - Antonio Flores-De La Cruz - National TAB

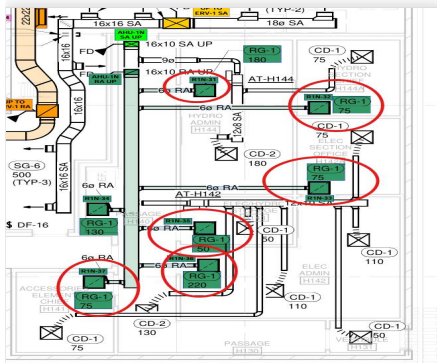
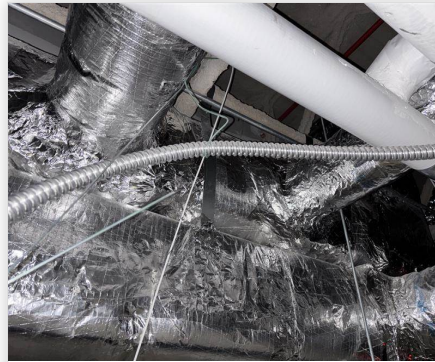
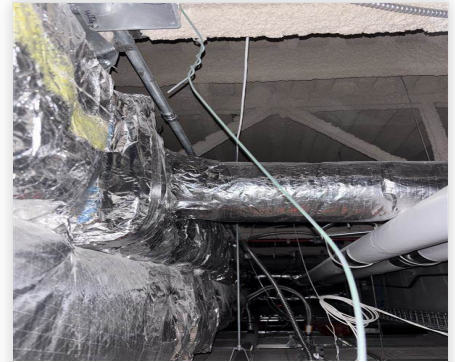
**Issue Name :** Multiple Dampers Missing HANGER SHOP NORTH  
**Description :** Return Grilles R1N-31 through R1N-37, EXCEPT R1N-34, are missing dampers to balance the return.  
**Created By :** National TAB **Assigned To :** National TAB - Antonio Flores-De La Cruz  
**Status :** Open  
**Priority :** Urgent **Asset Tag :**  
**Originated Date :** 03/03/2026 - Antonio Flores-De La Cruz - National TAB
