National TAB
1329 E. KEMPER ROAD
SUITE 4210
CINCINNATI, OH 45246

Report: TAB REPORT
Function: Test, Adjust, & Balance
Date: 10/09/2023

PROJECT
08-14-23 CULVERS KANSAS CITY, KS
REVIVE

1925 Prairie Crossing

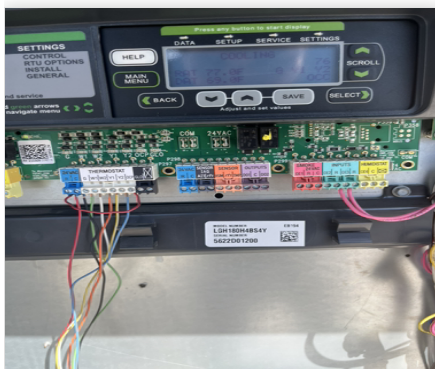
Rtu2(1)
09/05/2023

Issue Name : copper lines freezing rtu2
Description : Upon inspecting Rtu2, copper lines are freezing
Created By : National TAB **Assigned To :** National TAB - Sergio Del Toro
Status : Open
Originated Date : 09/05/2023 - Sergio Del Toro - National TAB

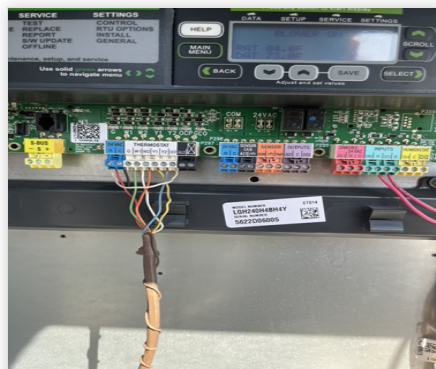
Rtu1
09/05/2023

Issue Name : pulley seized / loose belt
Description : rtu1 pulley are seized and need to be released in order to have unit sped up. also, belt was loose upon inspecting and was tightened.
Created By : National TAB **Assigned To :** National TAB - Sergio Del Toro
Status : Open
Originated Date : 09/05/2023 - Sergio Del Toro - National TAB

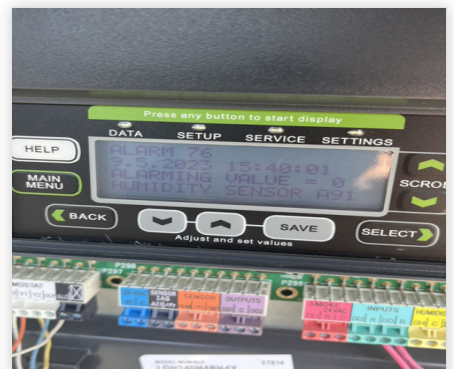
HumidityFault
09/05/2023

Issue Name : not wired for humidity control
Description : Rtus are not wired for humidity control
Created By : National TAB **Assigned To :** National TAB - Sergio Del Toro
Status : Open
Originated Date : 09/05/2023 - Sergio Del Toro - National TAB

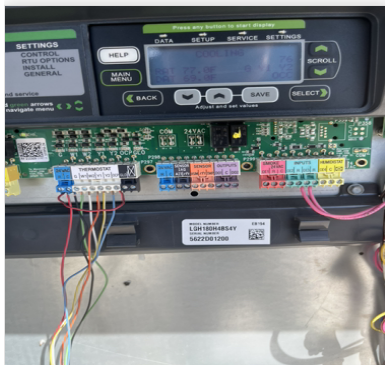
Rtu2(1)
09/05/2023

Issue Name : rtu 2 low flow
Description : airflow was increased on rtu2 by opening economizer and having motor pulley open to two turns but unit is still low on flow. recommend pulley change.
Created By : National TAB **Assigned To :** National TAB - Sergio Del Toro
Status : Open
Originated Date : 09/05/2023 - Sergio Del Toro - National TAB

Issue Name : units not wired for occupancy
Description : economizer on both rtus are not functioning due to unit not showing occupancy. tech jumpered r to ocp on the thermostat strip and has temporarily fixed building pressurization to positive. Need someone to install wiring for occupancy on both units.
Created By : National TAB **Assigned To :** National TAB - Sergio Del Toro
Status : Open
Originated Date : 09/05/2023 - Sergio Del Toro - National TAB
