**Report: TAB REPORT
Function: Test, Adjust, & Balance
Date: 02/16/2026
Completed By: National TAB**

M'Lady Nissan Dealership (Crystal Lake, IL)

Project: M'Lady Nissan Dealership (Crystal Lake, IL)

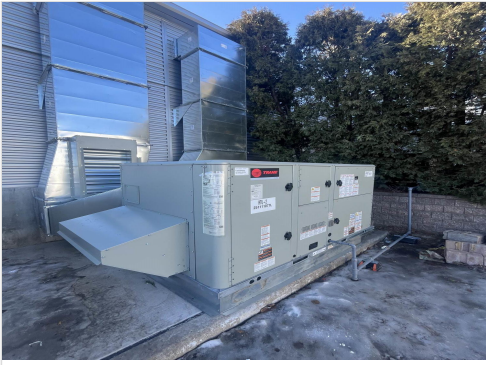
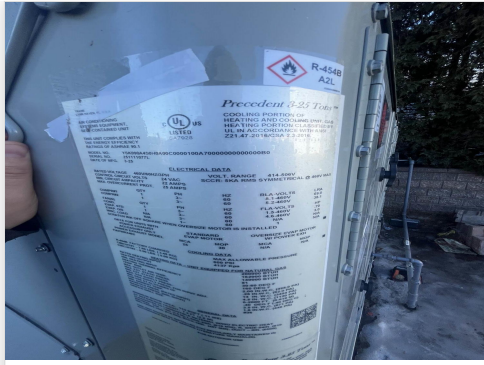
Asset: RTU1

Return air reduced proportionally to accommodate outside air.

- [1] Unit is labeled RTU-2 but is RTU-1 on plans.
- [2] diffuser 17 is not installed.
- [3] dampers not installed on returns.

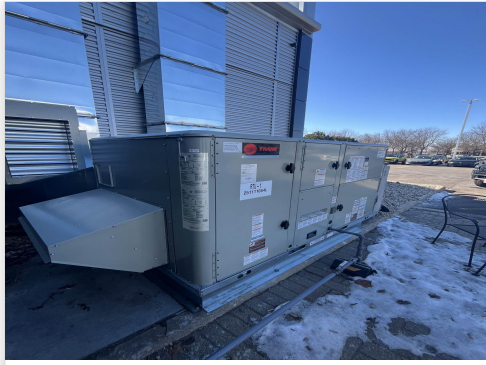
Asset: RTU2

[1] labeled RTU-1 but is RTU-2 on plans.

[2] dampers not installed on returns

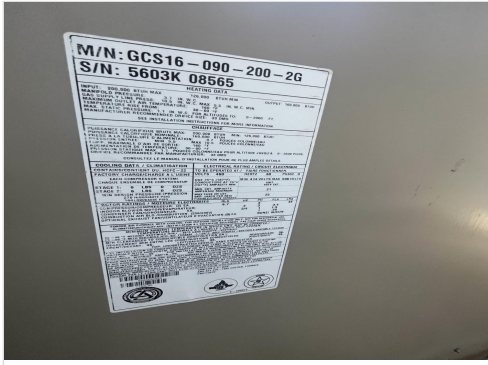
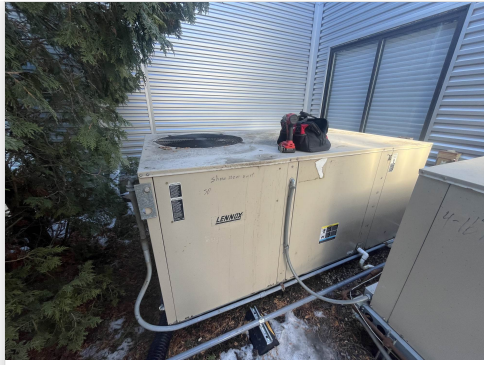
Asset: RTU3

[1] Unable to proportionally balance low due to linear diffusers 1 thru 5 being high on airflow with no dampers installed to decrease airflow. showrrom 2x2 diffusers are all low on flow.

[2] Motor sheave is seized, unable to adjust sheave to increase airflow. Airflow is at 2752/3000 CFM 91.73%

[3] Can not locate controller for OA dampers to be adjusted. could not properly set OA. Reported as is.

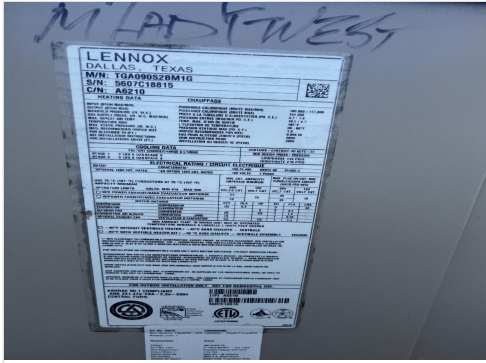
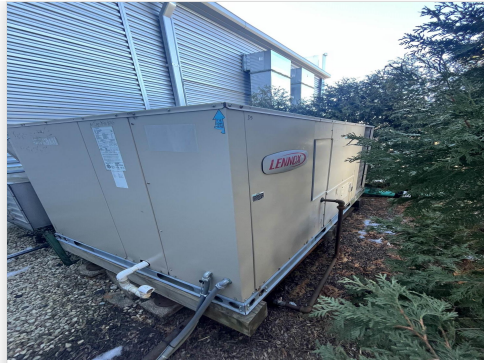
Asset: RTU4

Return air reduced proportionally to accommodate outside air.
 Unit is very low on flow and only runs when jumpered to blower only. See issue regarding mechanical inspection.
 Due to low flow could not balance as this would result in further airflow loss.
 Could not set OA due to damper not functioning. Damper is closed.

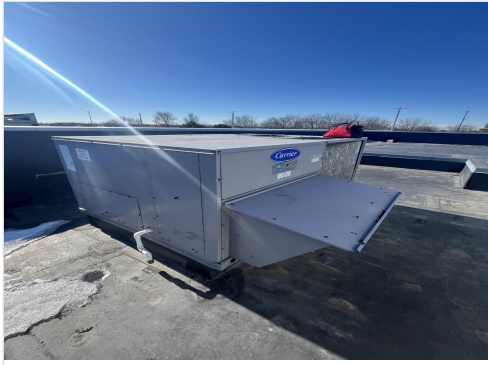
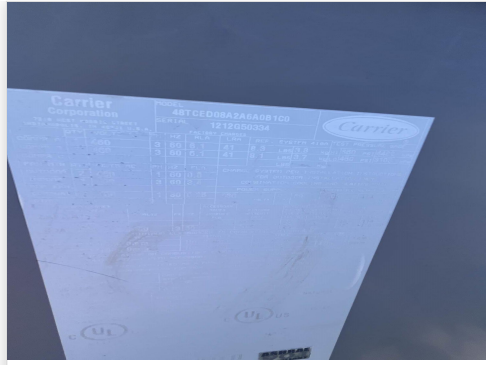
Asset: RTU5

- Return air reduced proportionally to accommodate outside air.
- OA damper manually set at 0.75" open
- [1] could not locate dampers for Returns.

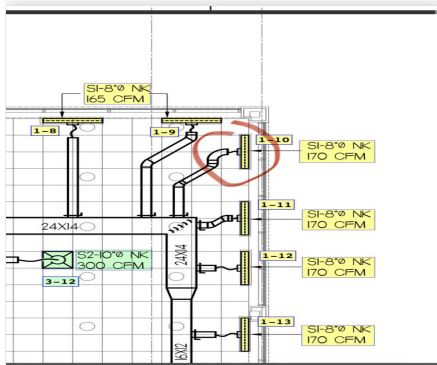
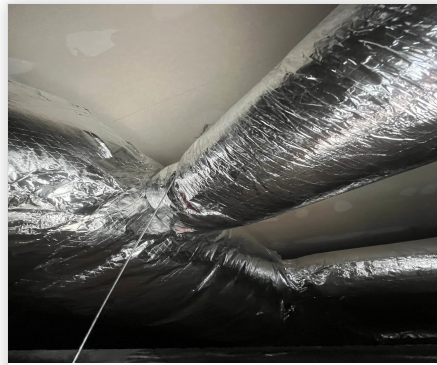
Issue Name : Diffuser 1-10 missing damper
Description : Diffuser 1-10 is missing a damper, diffuser is high on flow. Unable to balance properly
Created By : National TAB **Assigned To :** National TAB - Stephan Gabbert
Status : Open
Priority : Urgent **Asset Tag :**
Originated Date : 02/12/2026 - Dylan Crisman - National TAB

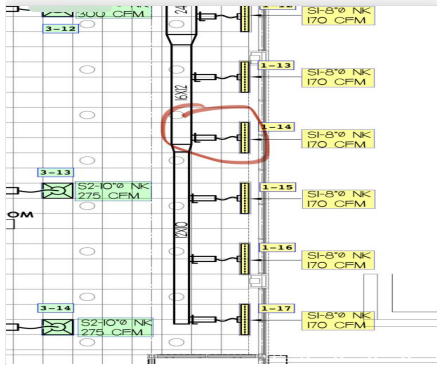
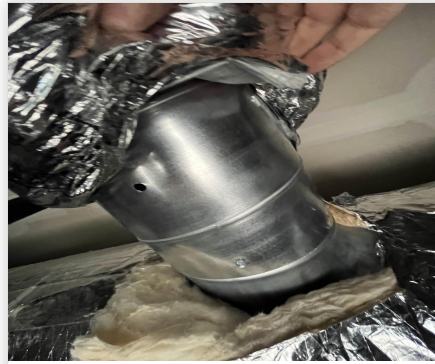
Issue Name : Diffuser 1-14 missing damper.
Description : Missing damper on Diffuser 1-14 for RTU-1 on showroom linear diffuser. Diffuser is high on flow. Unable to balance properly
Created By : National TAB **Assigned To :** National TAB - Dylan Crisman
Status : Open
Priority : Urgent **Asset Tag :**
Originated Date : 02/12/2026 - Dylan Crisman - National TAB

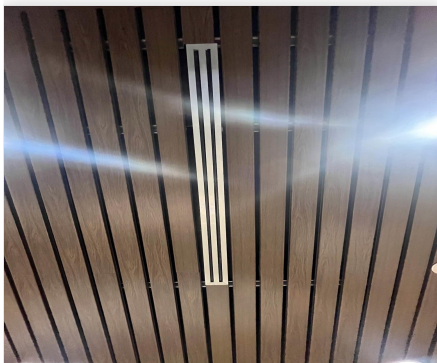
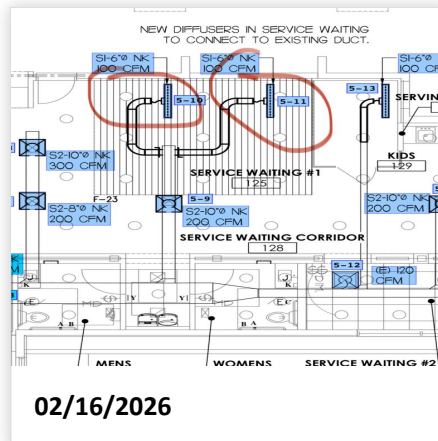
Issue Name : Diffuser 5-11/5-10 no airflow
Description : Diffusers 5-11/5-12 linear above the service waiting room were receiving no airflow, due to hard ceiling we were unable to determine direct root cause. Recommend mechanical inspection.
Created By : National TAB **Assigned To :** National TAB - Stephan Gabbert
Status : Open
Priority : Urgent **Asset Tag :**
Originated Date : 02/16/2026 - Dylan Crisman - National TAB

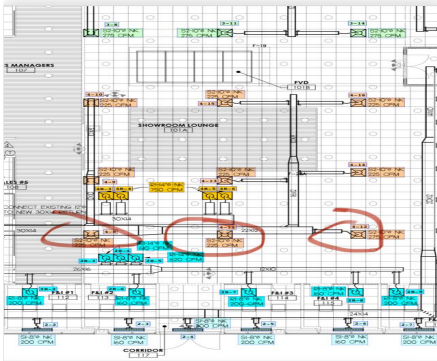
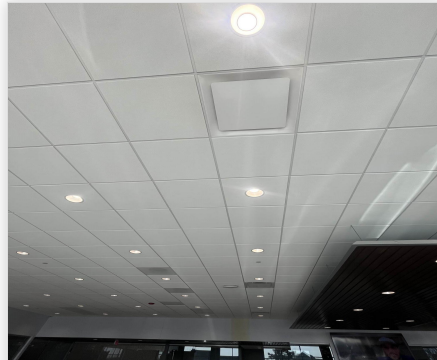
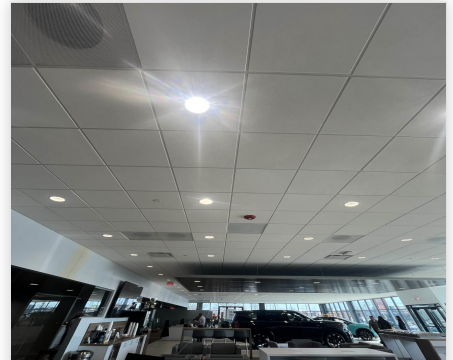
Issue Name : Diffusers on RTU-4 8-11-12 missing
Description : Diffusers 4-8,4-11,4-12 are missing on site, noted in plans to show where they should be installed.
Created By : National TAB **Assigned To :** National TAB - Dylan Crisman
Status : Open
Priority : **Urgent** **Asset Tag :**
Originated Date : 02/16/2026 - Dylan Crisman - National TAB

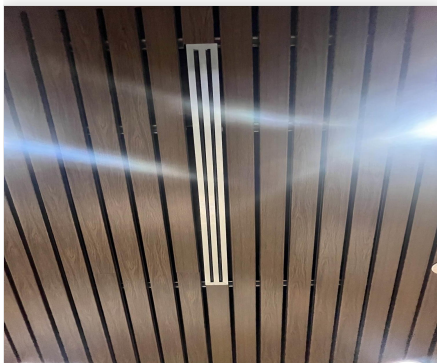
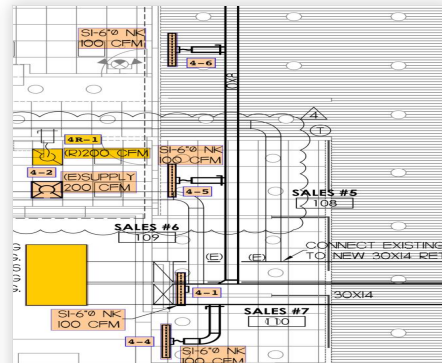
Issue Name : No airflow Diffuser 4-5
Description : Diffuser 4-5 is getting no airflow, unable to get a good look above ceiling to see if duct is disconnected or damper is fully closed at takeoff, blades at the face of the diffuser are fully open.
Created By : National TAB **Assigned To :** National TAB - Dylan Crisman
Status : Open
Priority : Urgent **Asset Tag :**
Originated Date : 02/16/2026 - Dylan Crisman - National TAB

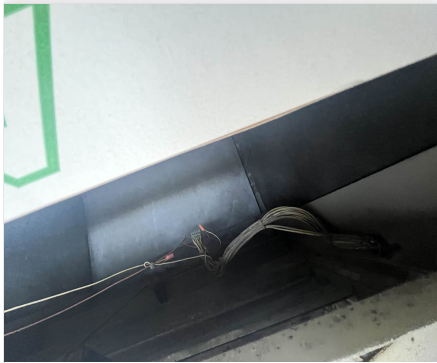
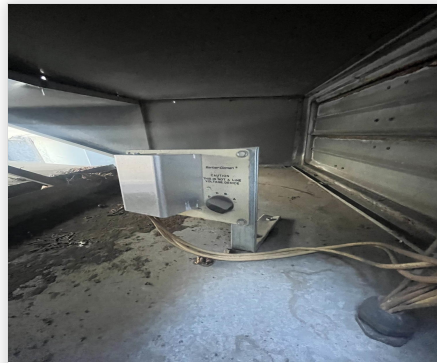
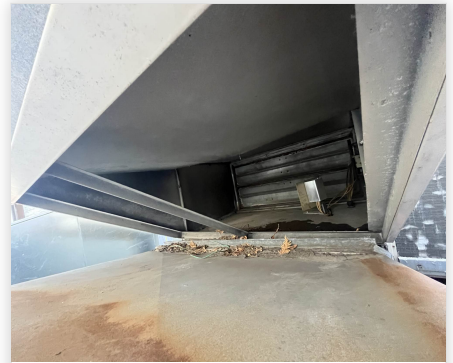
Issue Name : OA dampers on RTU-3/RTU4 could not be set
Description : OA dampers for RTU-4/RTU-3 could not be set. Couldn't locate controllers for function and limited access to damper actuators to manually adjust.
Created By : National TAB **Assigned To :** National TAB - Stephan Gabbert
Status : Open
Priority : Urgent **Asset Tag :**
Originated Date : 02/16/2026 - Dylan Crisman - National TAB

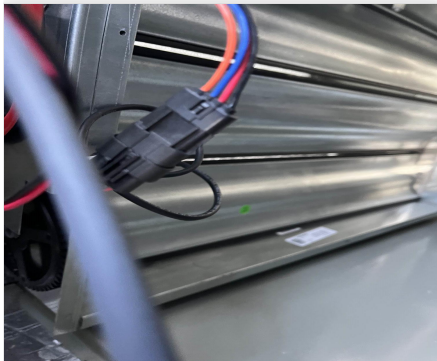
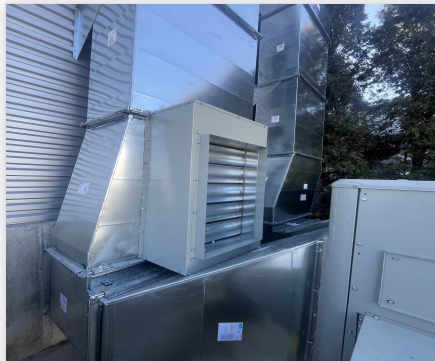
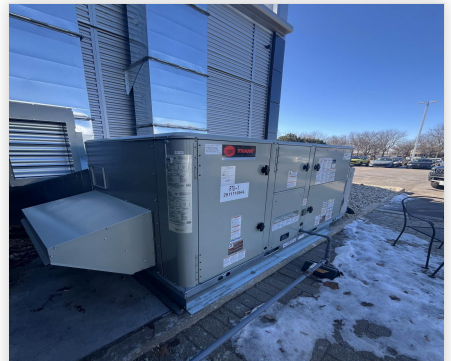
Issue Name : RTU-1/RTU/2 return dampers not functional
Description : New units RTU-1/RTU-2 return dampers installed on exterior duct run do not function when OA dampers move, they should be interlocked with the OA dampers. Returns remain closed at any setpoint the OA is set to.
Created By : National TAB **Assigned To :** National TAB - Dylan Crisman
Status : Open
Priority : Urgent **Asset Tag :**
Originated Date : 02/16/2026 - Dylan Crisman - National TAB

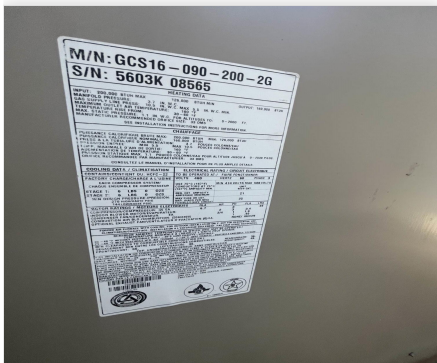
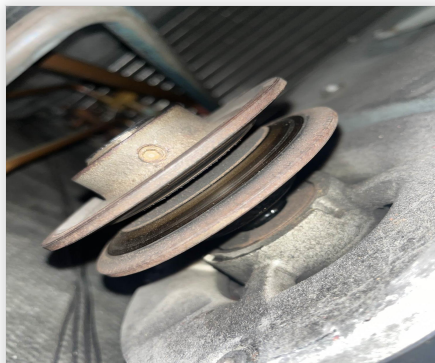
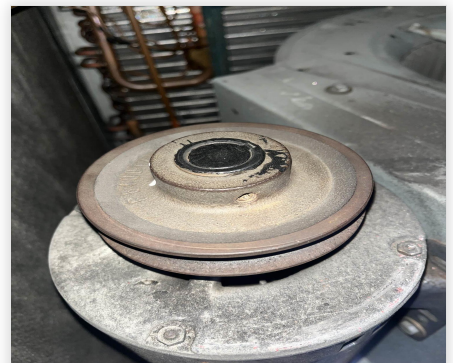
Issue Name : RTU-3 motor sheave seized
Description : RTU-3 motor sheave is seized. Rusted shut, and hex set keys on pulley are stripped. Unable to free to make speed adjustment on unit. Unit is at 92% of design airflow 2752/3000CFM.

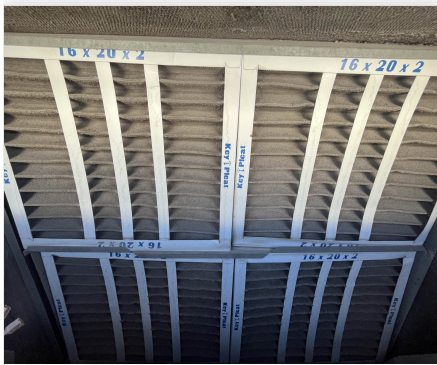
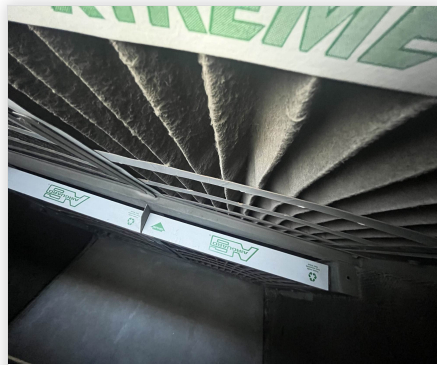
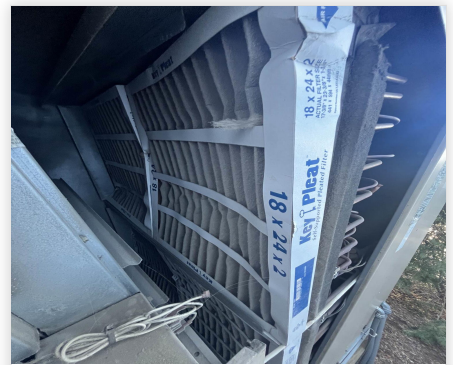
Issue Name : RTU-3/RTU-4/RTU-5 final filters
Description : Existing RTUs 3,4,5 final filters are very dirty. Recommend replacing with correct size merv 8 rated pleated filters.
Created By : National TAB **Assigned To :** National TAB - Dylan Crisman
Status : Open
Priority : Low **Asset Tag :**
Originated Date : 02/12/2026 - Dylan Crisman - National TAB

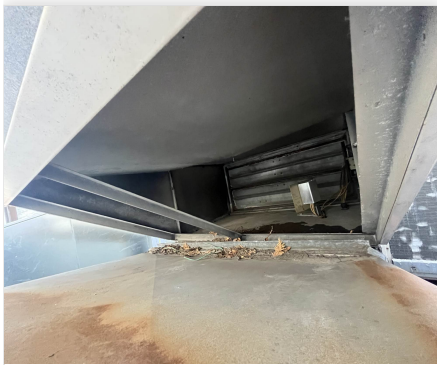
Issue Name : RTU-3/RTU-4/RTU-5 OA filters
Description : OA filters for existing units are in rough shape, clogged with debris. Recommend replacing. RTU-3 is missing the OA filters entirely.
Created By : National TAB **Assigned To :** National TAB - Stephan Gabbert
Status : Open
Priority : Low **Asset Tag :**
Originated Date : 02/12/2026 - Dylan Crisman - National TAB

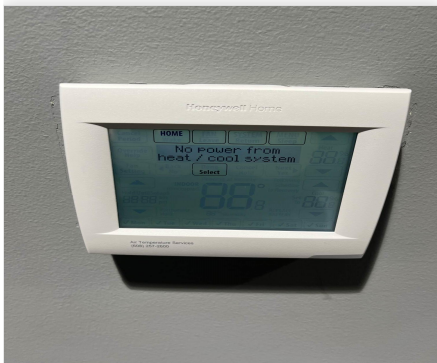
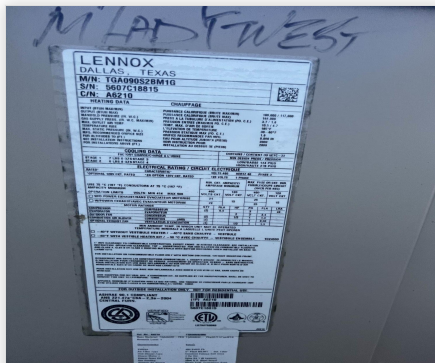
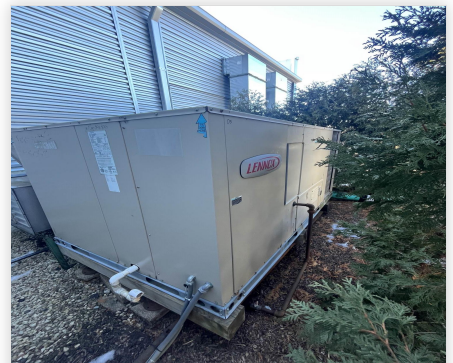
Issue Name : RTU-4 not operational
Description : RTU-4 is not operational at time of TAB. When commanded to run via thermostat or jumpering at unit the thermostat displays an alarm “no power from heat / cool System”
Created By : National TAB **Assigned To :** National TAB - Dylan Crisman
Status : Open
Priority : Urgent **Asset Tag :**
Originated Date : 02/12/2026 - Dylan Crisman - National TAB

- **02/16/2026 National TAB - Dylan Crisman**
 - RTU-4 was able to be Jumpered to run in blower only to get an airflow reading, the unit was very low on flow. Suspected to be because it couldn't be ran in full cool/full heat. gas was turned off and unit would not run heating or cooling, mechanical is unaware of any issues with this unit as they did not work on it and advised to contact the owners of Nissan to further diagnose.
