Report: Punch list
Function: Test, Adjust, & Balance
Date: 11/05/2025
Completed By: National TAB

11-03-25 Freddys - Versailles, KY

1031 TYRONE PIKE

Estopp Energy

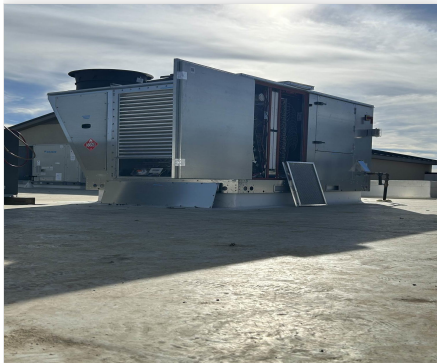
Issue Name : DOAS not operational
Description : DOAS not operational. Per the GC, startup will be on Friday. (11/7/25)
Created By : National TAB **Assigned To :** National TAB - Dan Hertenstein
Status : Open
Priority : Urgent **Asset Tag :** DOAS2
Originated Date : 11/05/2025 - Jearod Ferrette - National TAB

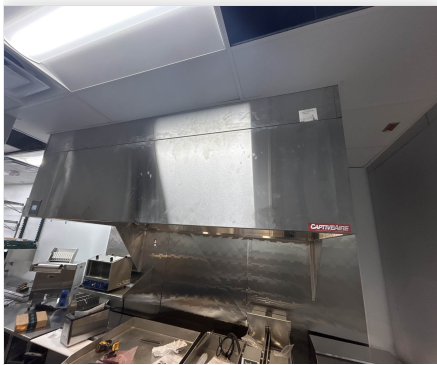
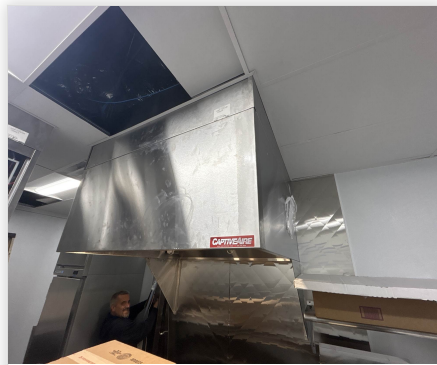
Issue Name : Hood HMI not functioning properly
Description : HMI controls both hoods with a single speed. They cannot be controlled independently of each hood. DRD mechanical wasn't to adjust speed.
Created By : National TAB **Assigned To :** National TAB - Dan Hertenstein
Status : Open
Priority : High **Asset Tag :** HVAC EQUIPMENT1
Originated Date : 11/05/2025 - Jearod Ferrette - National TAB

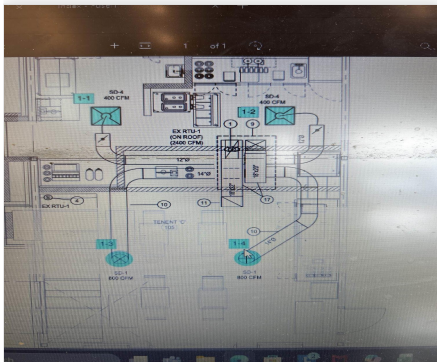
Issue Name : RTU 1 no dampers
Description : No dampers on RTU-1.
Created By : National TAB **Assigned To :** National TAB - Dan Hertenstein
Status : Open
Priority : Medium **Asset Tag :** RTU1
Originated Date : 11/05/2025 - Jearod Ferrette - National TAB
