Report: TAB REPORT
Function: Test, Adjust, & Balance
Date: 10/07/2025
Completed By: National TAB

PROJECT
09-29-25 QT #0541 DES MOINES, IA

2428 HUBBELL AVE.

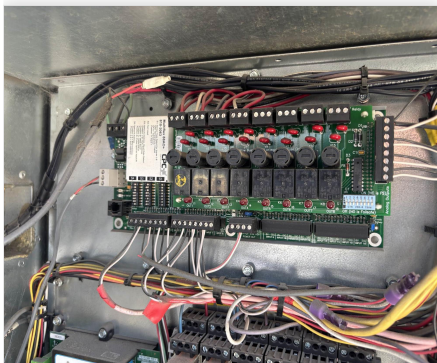
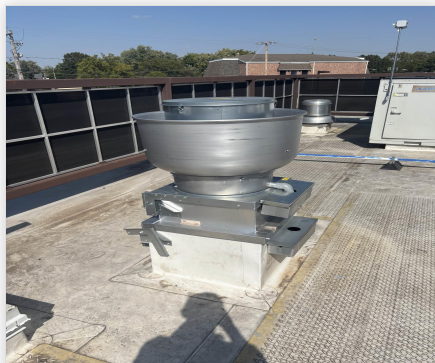
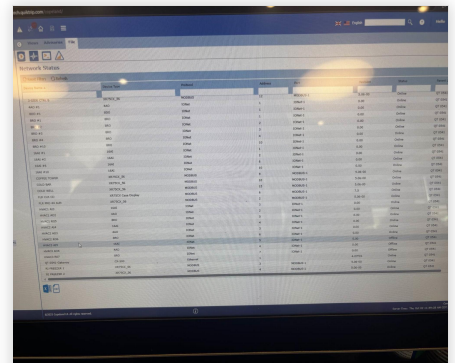
Issue Name : Building Controls Not All functional.
Description : RTU-3 is not connected to the Emerson system and not operating. The Emerson board in the unit does not have power. It was balanced in hand mode. EF-3 is not visible in the Emerson system and is not functioning normally. Recommend review of wiring and submittals.
Created By : National TAB **Assigned To :** National TAB - Brianna Biggs
Status : Open
Priority : High **Asset Tag :**
Originated Date : 10/03/2025 - Michael McDonnell - National TAB

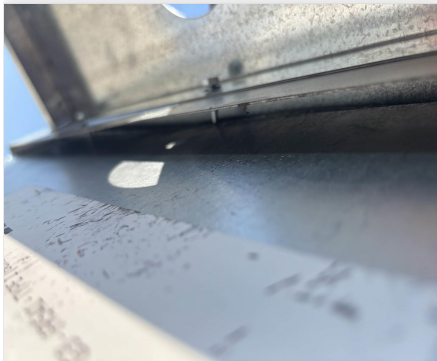
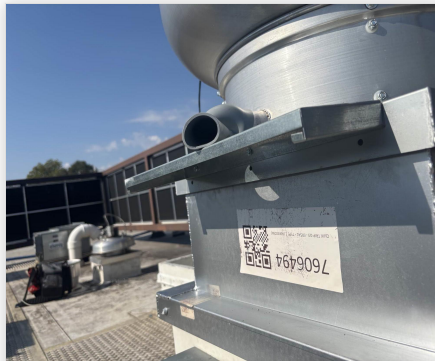
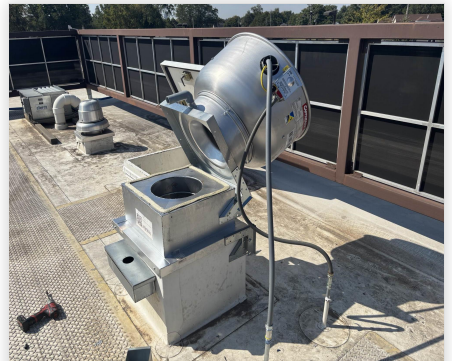
Issue Name : EF-3: Electrical / Controls Conduit
Description : EF-3 conduit for controls is not long enough for fan to be completely tilted back without risking damage. Recommend it is lengthened. Also, grease cup is screwed through to fan base, requiring removal to tilt fan back. Recommend this is corrected.
Created By : National TAB **Assigned To :** National TAB - Michael McDonnell
Status : Open
Priority : Medium **Asset Tag :**
Originated Date : 10/03/2025 - Michael McDonnell - National TAB

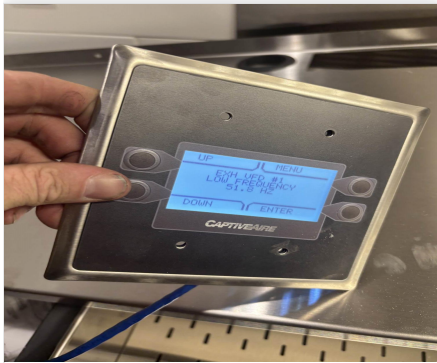
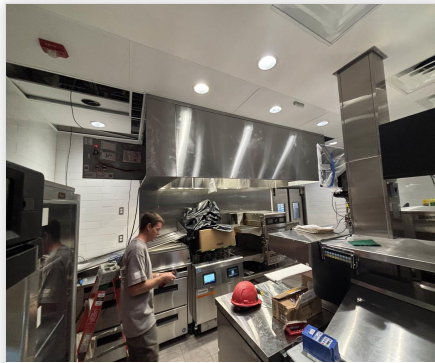
Issue Name : Exhaust Hood: End panels, Grease Cups, lights.
Description : Hood quarter end panels and grease cups are not yet installed. Hood HMI was connected to board by NTAB to control hood, but is not installed. Also, hood HMI button does not turn hood lights on or off. Recommend review.
Created By : National TAB **Assigned To :** National TAB - Michael McDonnell
Status : Open
Priority : Medium **Asset Tag :**
Originated Date : 10/03/2025 - Michael McDonnell - National TAB

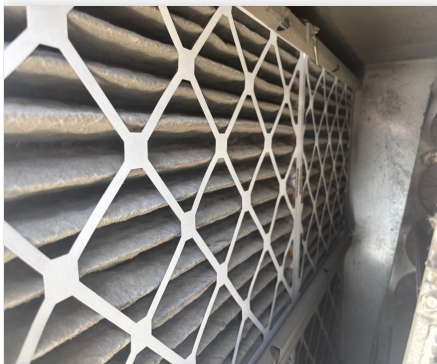
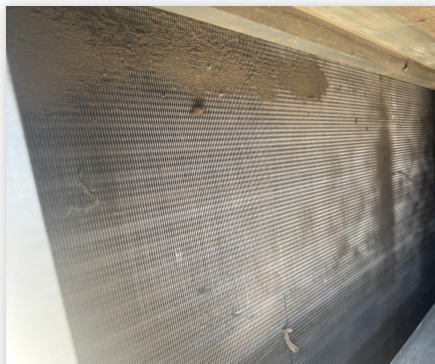
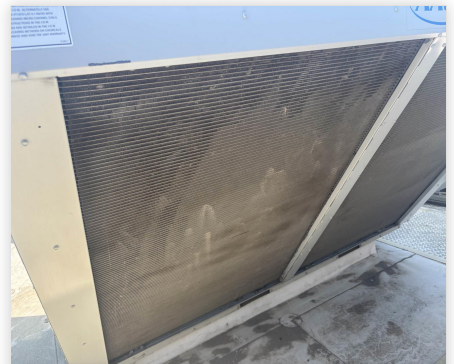
Issue Name : RTUs: In need of Cleaning
Description : Recommend RTU final filters are changed, they are dated 7/1 and dirty. RTU coils, evap and condenser, are also in need of cleaning.
Created By : National TAB **Assigned To :** National TAB - Brianna Biggs
Status : Open
Priority : Medium **Asset Tag :**
Originated Date : 10/03/2025 - Michael McDonnell - National TAB

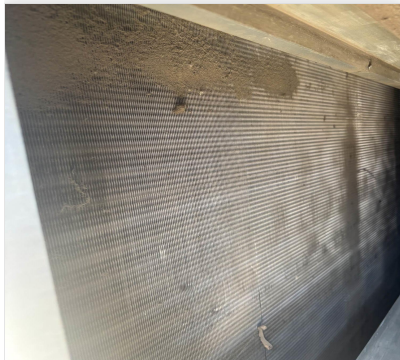
Evaporator coils are clean? Fail

In need of cleaning.

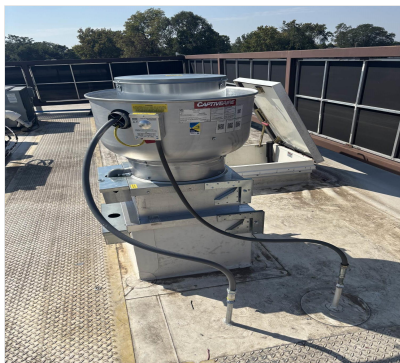
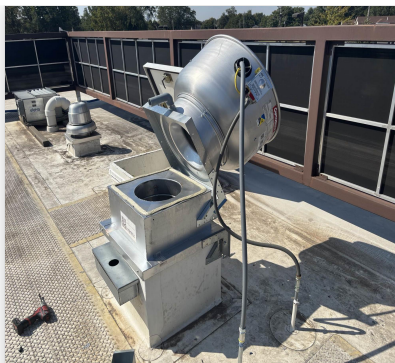
Flex conduit is long enough so that fan can be completely tilted back? Fail

Conduit is run incorrectly and needs to be lengthened.

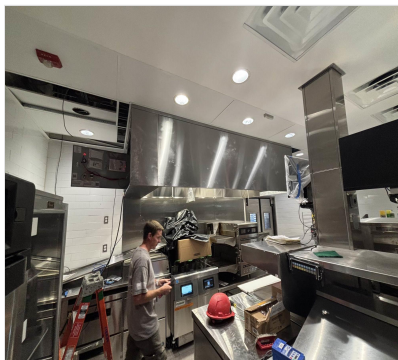
End panels are installed per prototype? Fail

End Panels were not installed at the time of TAB.

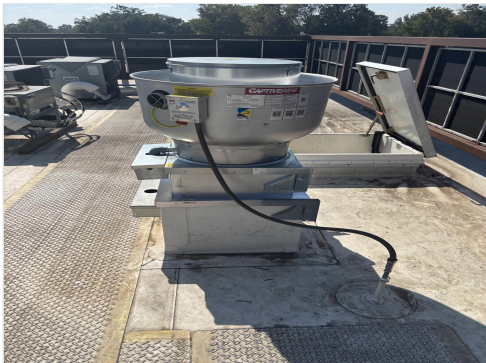
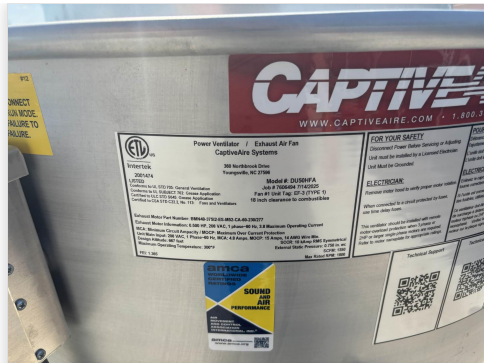
Asset: EF3

Notes:
[1] FAN NOT VISIBLE ON CONTROLS SYSTEM AT TIME OF TAB.

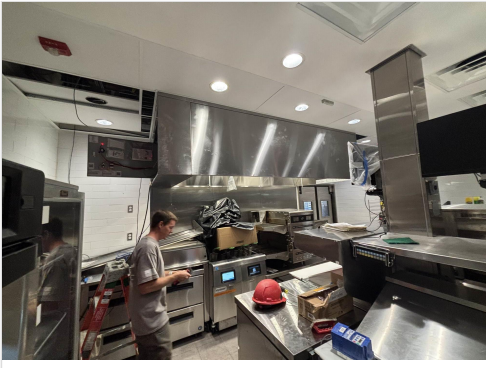
Asset: HD1

- [1] HMI NOT INSTALLED AT TIME OF TAB.
- [2] END PANELS NOT INSTALLED AT TIME OF TAB.
