Issue List

09-22-25 Firebirds Chesterfield, VA

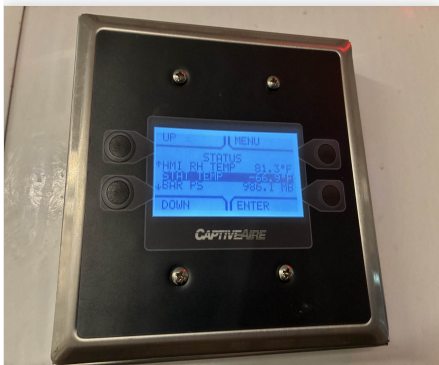
Issue Name : DOAS - 1 Temperature Sensor Malfunctioning
Description : DOAS - 1 temperature sensor not reading properly. It causes the unit to shutdown on an overheat fault.
Created By : National TAB **Assigned To :** National TAB - Antonio Flores-De La Cruz
Status : Open
Priority : Urgent **Asset Tag :**
Originated Date : 09/24/2025 - Alex Bauer - National TAB

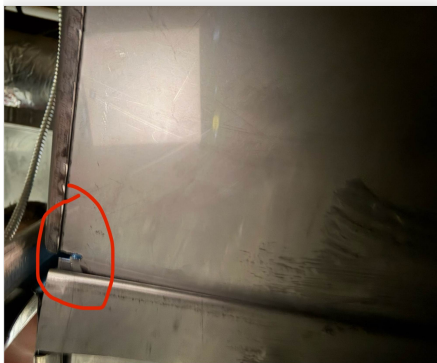
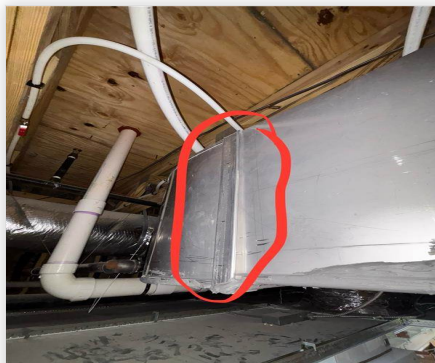
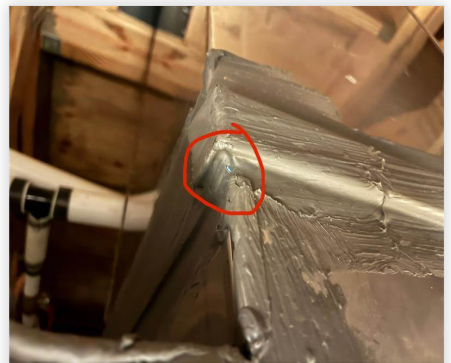
Issue Name : EF-DISH Leakage
Description : Dishwasher ductwork needs duct sealant at certain joints near the bends. Also, possible leakage at the curb. Rope Gasket is helping but may not be enough due to open corners at the curb.
Created By : National TAB **Assigned To :** National TAB - Antonio Flores-De La Cruz
Status : Open
Priority : Urgent **Asset Tag :**
Originated Date : 09/25/2025 - Antonio Flores-De La Cruz - National TAB

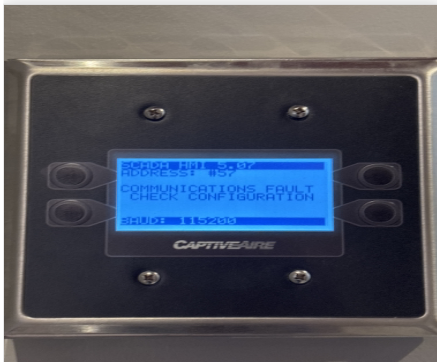
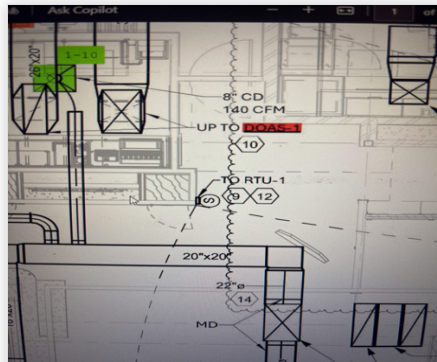
Issue Name : RTU-1 Temperature Sensor
Description : Sensor near beverage zone is not communicating properly with RTU-1.
Created By : National TAB **Assigned To :** National TAB - Antonio Flores-De La Cruz
Status : Open
Priority : High **Asset Tag :**
Originated Date : 09/24/2025 - Antonio Flores-De La Cruz - National TAB
