**Report: TAB REPORT**  
**Function: Test, Adjust, & Balance**  
**Date: 05/23/2024**

**PROJECT**  
**05-20-24 FREDDY'S - EDMOND, OK (REVIVE)**

1925 E 2ND ST

RKS Ventures, Inc.  
9340 E Central Ave  
Suite A  
Wichita, KS 67206

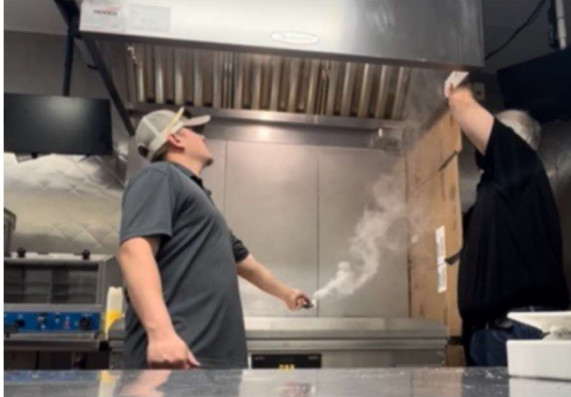
Went to the roof and found that the MUA intake air filter was clogged. Removed this temporarily and re-measured airflow to be close to the original design. Re-smoked all hoods and smoke was rolling out on the right side of the main grille hood. Mocked up a cardboard end panel and capture improved to 100%. A full stainless steel end panel is recommended on the right of the hood and a quarter end panel is recommended on the left of the hood.

*End panel mockup on main griddle*

3. Full vertical end panel needs to be added to the right side of the griddle hood. A quarter end panel needs to be added to the left of the griddle hood.

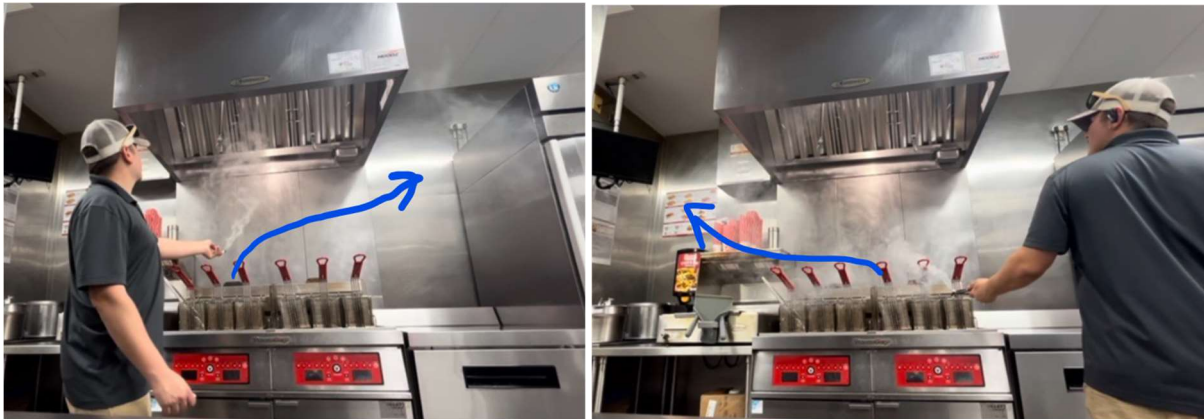
5. The fryer hood capture is poor as well. There is a large amount of smoke escaping primarily on the left side but also on the right side. The griddle hood is the primary concern as that is what causes grease to accumulate on the return grilles and surfaces. But improving the fryer capture will reduce fry smell, and improve comfort in the building. Ideally, full vertical end panels would be added, but if that's not possible from an operational standpoint then quarter end panels should be added on both sides.

The fryer hood capture is now poor. Reducing the MUA should help. But quarter end panels are also recommended. Full vertical end panels would be ideal if they don't effect Operations.

*Fryer smoke capture loss*

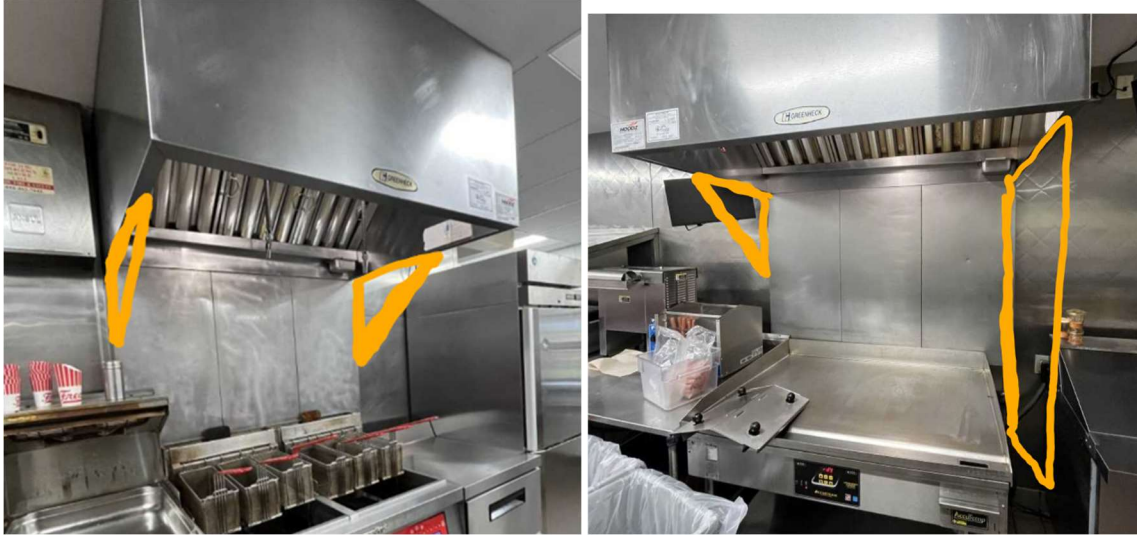
*Recommend end panel locations*

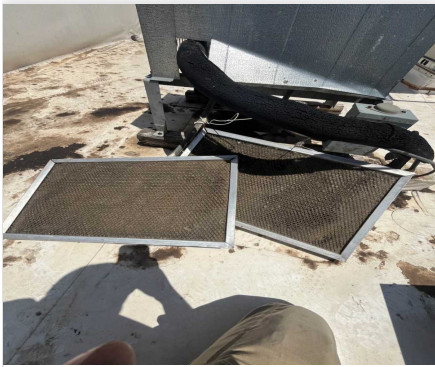
IMG\_4197  
05/23/2024

2. The MUA filter is clogged and is reducing airflow by about 50%. This needs to be cleaned. But, doing so will also cause the smoke capture to worsen. So it needs to be done at the same time as the pulley change.

**Issue Name :** MUA intake filters dirty  
**Description :** MUA OA intake filters are dirty. Recommend replacing. Removed for testing.  
**Created By :** National TAB                      **Assigned To :** National TAB - Dylan Crisman  
**Status :** Open  
**Priority :** Low    **Asset Tag :**  
**Originated Date :** 05/23/2024 - Dylan Crisman - National TAB

1. The MUA back supply style plenum is notorious for causing smoke capture issues and that is a major factor here. The pulley needs to be changed to reduce airflow by half to around 1000 CFM. It is a non heated/non conditioned MUA so this will also be better for comfort.

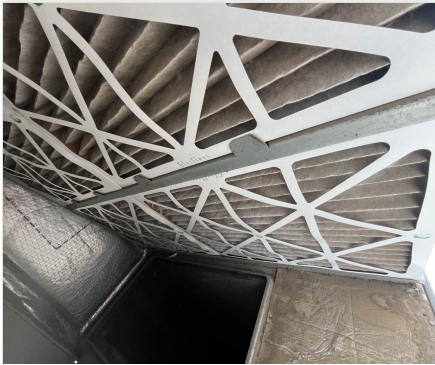
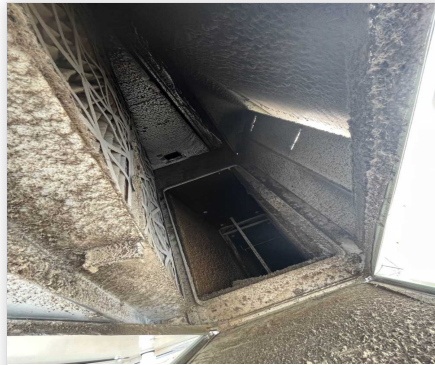
**Issue Name :** RTU-1/RTU-2/RTU-3 final filters dirty  
**Description :** Final filters for all 3 RTUs are dirty. Recommend replacing with correct 20x25x2 merv 8 rated pleated filters. RTU-1 kitchen unit OA section is very dirty, recommend cleaning.  
**Created By :** National TAB                      **Assigned To :** National TAB - Dylan Crisman  
**Status :** Open  
**Priority :** Low                                      **Asset Tag :**  
**Originated Date :** 05/22/2024 - Dylan Crisman - National TAB

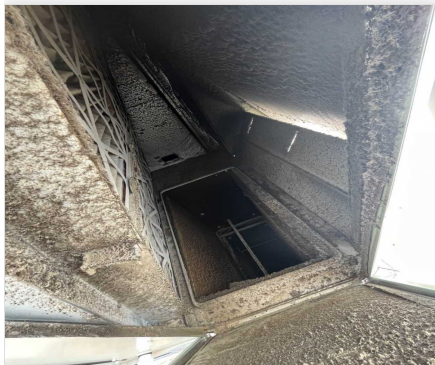
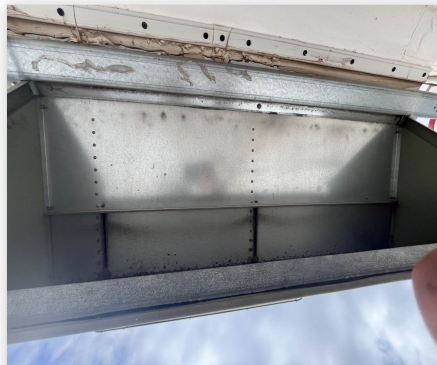
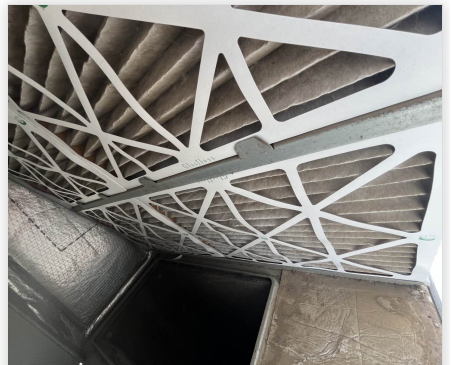
RTU's 1 and 3 are missing outside air filters so OA could not be set yet. This is creating a return path through the kitchen that is making the hood capture issues worse. Installing these and balancing the outside air should help reduce this effect.

**Issue Name :** RTU-1/RTU-3 OA filters missing  
**Description :** OA hood is installed but missing OA filters. Once installed the OA should be balanced to ensure positive building pressure and reduce return air path.  
**Created By :** National TAB                      **Assigned To :** National TAB - Dylan Crisman  
**Status :** Open  
**Priority :** High                                      **Asset Tag :**  
**Originated Date :** 05/22/2024 - Dylan Crisman - National TAB

4. Outside air filters need to be installed on RTU's 1 and 3 so that the outside air can be balanced for building pressurization. Additionally, this helps reduce return air paths in the kitchen which are contributing to the poor smoke capture.

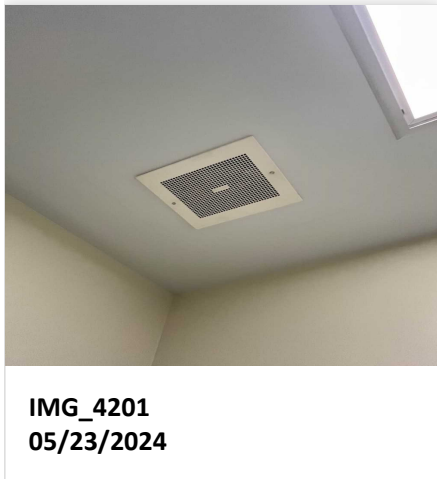
Additionally found that the women's restroom exhaust fan rotation was backwards.

**Issue Name :** Women's RR Exhaust fan  
**Description :** Women's RR ceiling Exhaust fan is spinning backwards, read very low negative (-11CFM) to a slightly positive reading. Recommend mechanical contractor flip rotation on fan. May require that fan be replaced altogether.  
**Created By :** National TAB                      **Assigned To :** National TAB - Dylan Crisman  
**Status :** Open  
**Priority :** Low                                      **Asset Tag :**  
**Originated Date :** 05/23/2024 - Dylan Crisman - National TAB
