Report: TAB REPORT
Function: Test, Adjust, & Balance
Date: 05/23/2024

05-20-24 FREDDY'S - EDMOND, OK (REVIVE)

Project: 05-20-24 FREDDY'S - EDMOND, OK (REVIVE)

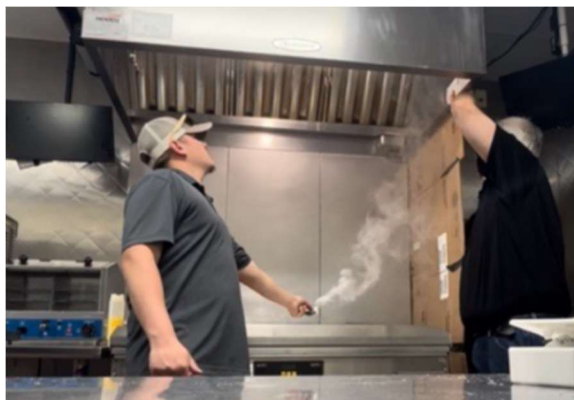
Went to the roof and found that the MUA intake air filter was clogged. Removed this temporarily and re-measured airflow to be close to the original design. Re-smoked all hoods and smoke was rolling out on the right side of the main grille hood. Mocked up a cardboard end panel and capture improved to 100%. A full stainless steel end panel is recommended on the right of the hood and a quarter end panel is recommended on the left of the hood.

End panel mockup on main griddle

3. Full vertical end panel needs to be added to the right side of the griddle hood. A quarter end panel needs to be added to the left of the griddle hood.

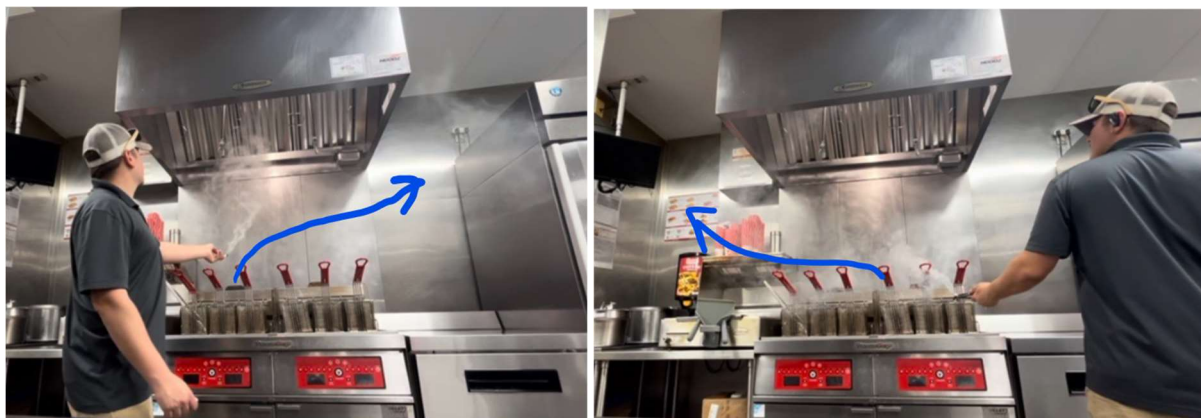
5. The fryer hood capture is poor as well. There is a large amount of smoke escaping primarily on the left side but also on the right side. The griddle hood is the primary concern as that is what causes grease to accumulate on the return grilles and surfaces. But improving the fryer capture will reduce fry smell, and improve comfort in the building. Ideally, full vertical end panels would be added, but if that's not possible from an operational standpoint then quarter end panels should be added on both sides.

The fryer hood capture is now poor. Reducing the MUA should help. But quarter end panels are also recommended. Full vertical end panels would be ideal if they don't effect Operations.

Fryer smoke capture loss

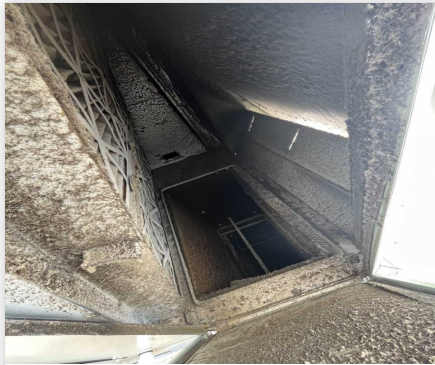
Issue Name : RTU-1/RTU-2/RTU-3 final filters dirty
Description : Final filters for all 3 RTUs are dirty. Recommend replacing with correct 20x25x2 merv 8 rated pleated filters. RTU-1 kitchen unit OA section is very dirty, recommend cleaning.
Created By : National TAB **Assigned To :** National TAB - Dylan Crisman
Status : Open
Priority : Low **Asset Tag :**
Originated Date : 05/22/2024 - Dylan Crisman - National TAB

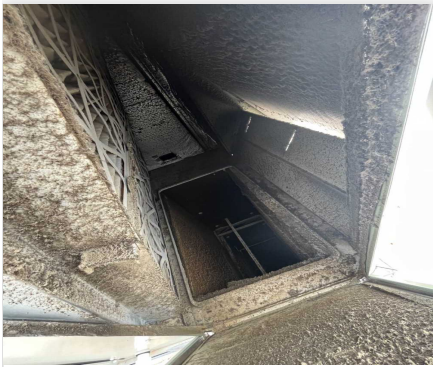
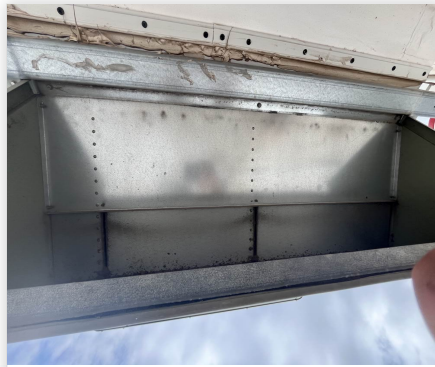
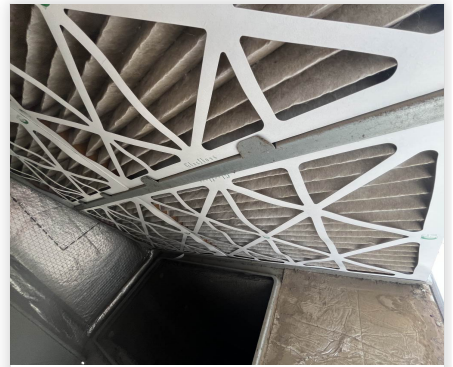
RTU's 1 and 3 are missing outside air intakes. This is creating a return path through the kitchen that is making the hood capture issues worse. Installing these and balancing the outside air should help reduce this effect.

Issue Name : RTU-1/RTU-3 OA missing
Description : OA hood is installed but missing OA filters and economizer/OA dampers. Cannot balance OA to stabilize building pressure at this time.
Created By : National TAB **Assigned To :** National TAB - Dylan Crisman
Status : Open
Priority : High **Asset Tag :**
Originated Date : 05/22/2024 - Dylan Crisman - National TAB

4. Outside air intakes need to be added to RTU's 1 and 3 to ensure positive building pressure. Additionally, this helps reduce return air paths in the kitchen which are contributing to the poor smoke capture.

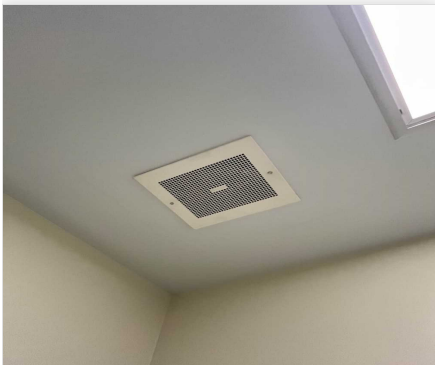
IMG_4201
05/23/2024

Additionally found that the women's restroom exhaust fan rotation was backwards.

Issue Name : Women's RR Exhaust fan
Description : Women's RR ceiling Exhaust fan is spinning backwards, read very low negative (-11CFM) to a slightly positive reading. Recommend mechanical contractor flip rotation on fan.
Created By : National TAB **Assigned To :** National TAB - Dylan Crisman
Status : Open
Priority : Low **Asset Tag :**
Originated Date : 05/23/2024 - Dylan Crisman - National TAB
