Report: TAB REPORT
Function: Test, Adjust, & Balance
Date: 05/23/2024

PROJECT
05-20-24 FREDDY'S - EDMOND, OK (REVIVE)
1925 E 2ND ST
EDMOND, OK 73003

Project: 05-20-24 FREDDY'S - EDMOND, OK (REVIVE)

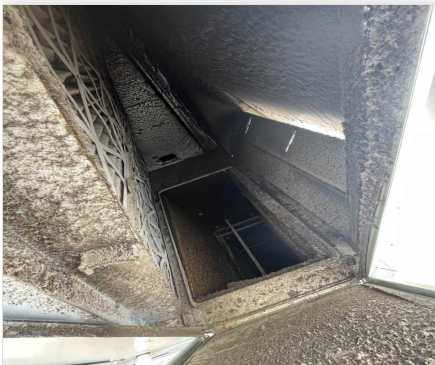
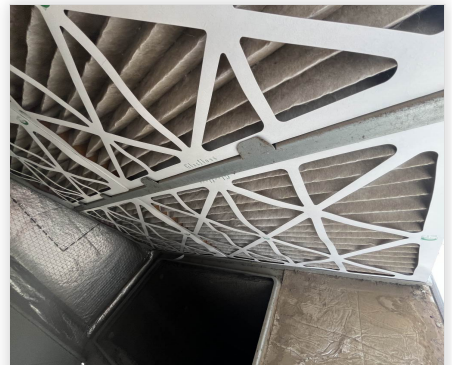
RTU's 1 and 3 are missing outside air filters so OA could not be set yet. This is creating a return path through the kitchen that is making the hood capture issues worse. Installing these and balancing the outside air should help reduce this effect.

Issue Name : RTU-1/RTU-3 OA filters missing
Description : OA hood is installed but missing OA filters. Once installed the OA should be balanced to ensure positive building pressure and reduce return air path.
Created By : National TAB **Assigned To :** National TAB - Dylan Crisman
Status : Open
Priority : High **Asset Tag :**
Originated Date : 05/22/2024 - Dylan Crisman - National TAB

4. Outside air filters need to be installed on RTU's 1 and 3 so that the outside air can be balanced for building pressurization. Additionally, this helps reduce return air paths in the kitchen which are contributing to the poor smoke capture.

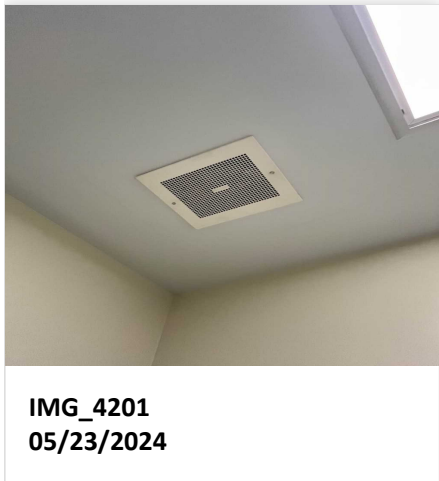
Additionally found that the women's restroom exhaust fan rotation was backwards.

Issue Name : Women's RR Exhaust fan
Description : Women's RR ceiling Exhaust fan is spinning backwards, read very low negative (-11CFM) to a slightly positive reading. Recommend mechanical contractor flip rotation on fan. May require that fan be replaced altogether.
Created By : National TAB **Assigned To :** National TAB - Dylan Crisman
Status : Open
Priority : Low **Asset Tag :**
Originated Date : 05/23/2024 - Dylan Crisman - National TAB
