Report: TAB REPORT
Function: Test, Adjust, & Balance
Date: 12/18/2025
Completed By: National TAB

**12-15-25 WALGREENS #5058 ARNOLD, MO
(REACTIVE)**

776 JEFFCO BLVD

ARNOLD, MO

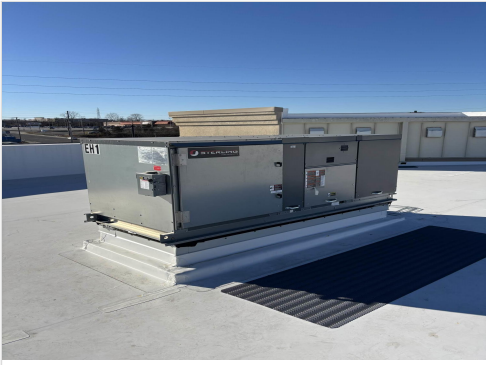
- UNIT MISALIGNED. AIR LEAKAGE AT CURB.
- MOTOR IS OVERAMPING.
- SUPPLY AIRFLOW IS 36% HIGH. MOTOR SHEAVE IS TURNED OUT AS FAR AS IT WILL GO. UNABLE TO REDUCE AIRFLOW ANY FURTHER. RECOMMEND REPLACING FAN SHEAVE.

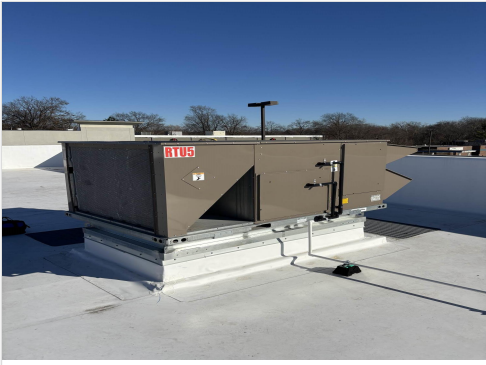
- SUPPLY AIRFLOW IS 29% HIGH. UNABLE TO REMOVE LOCK PIN ON MOTOR SHEAVE TO ADJUST SET POINT. COULD NOT REDUCE AIRFLOW TO PROPER AMOUNT. RECOMMEND CHANGING FAN SHEAVE.
- MOTOR IS OVERAMPING.
- THERE IS AN EXTRA DIFFUSER ON THIS SYSTEM. LOCATED IN THE PERSONAL HEALTH/CLINIC ROOM

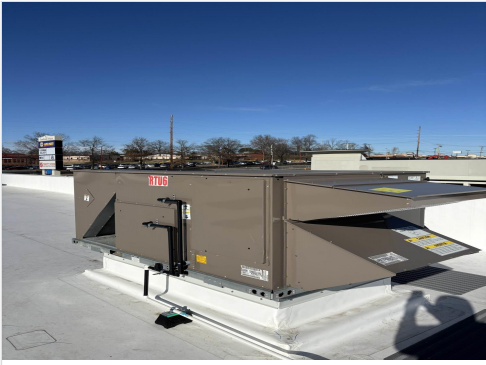
-SUPPLY AIRFLOW IS 70% HIGH. ADJUSTED MOTOR SHEAVE OUT AS FAR AS IT COULD GO. UNABLE TO REDUCE AIRFLOW ANY FURTHER. RECOMMEND SERVICE/REPLACING FAN SHEAVE.

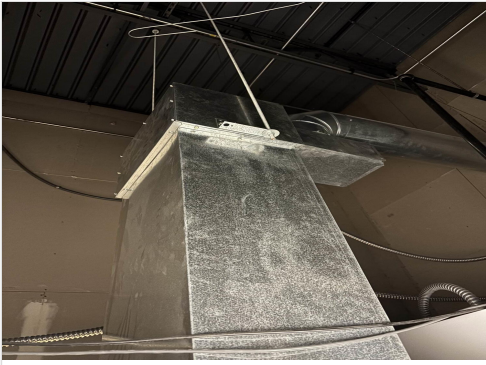
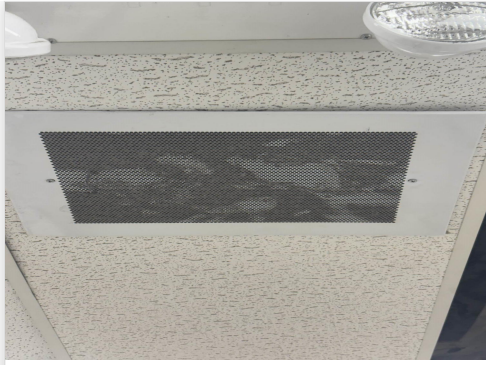
- FAN NOT RUNNING. UNABLE TO TEST/BALANCE AIRFLOW.
- FAN IS INSIDE DUCT ABOVE CEILING. CANNOT ACCESS UNIT/MOTOR LABELS.

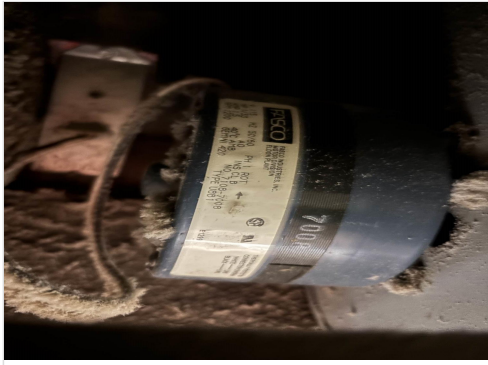
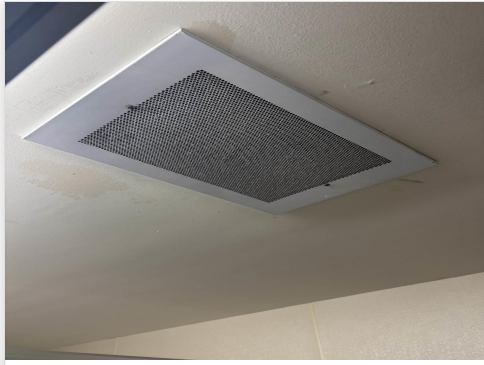
- FAN IS VERY DIRTY. RECOMMEND CLEANING.
- COULD NOT SAFELY ACCESS VOLTAGE READINGS

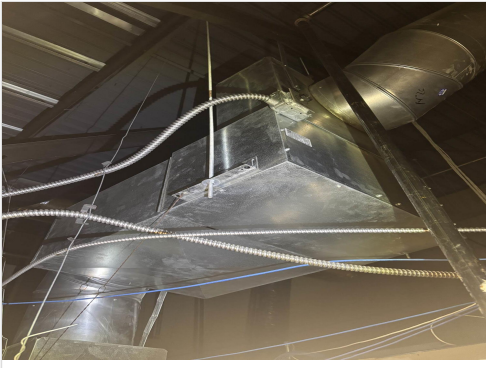
- MOTOR DATA RETRIEVED FROM UNIT TAG.
- COULD NOT SAFELY ACCESS VOLTAGE/AMPERAGE READINGS.
- EXHAUST GRILLE IS VERY DIRTY/CLOGGED. RECOMMEND CLEANING.
- FAN IS SHAKING AND MAKING A LOT OF NOISE. RECOMMEND SERVICE.
- FAN IS TYPICALLY TURNED OFF AND REMOVED PER WALGREENS REQUEST.

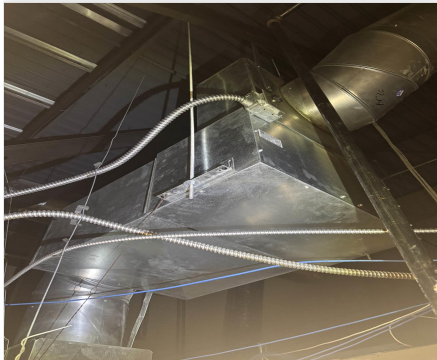
Issue Name : EF5: Fan Running
Description : EF5 is running. The fan is very loud and shaking the duct and ceiling grid. Typically the fan is turned off and removed per Walgreens request.
Created By : National TAB **Assigned To :** National TAB - Kalen Kemp
Status : Open
Priority : Medium **Asset Tag :** EF-5
Originated Date : 12/18/2025 - Kalen Kemp - National TAB

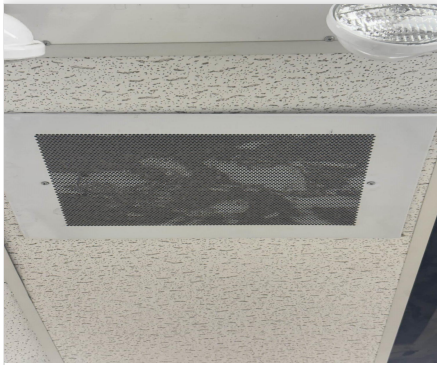
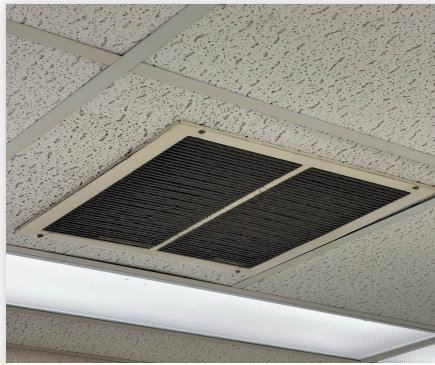
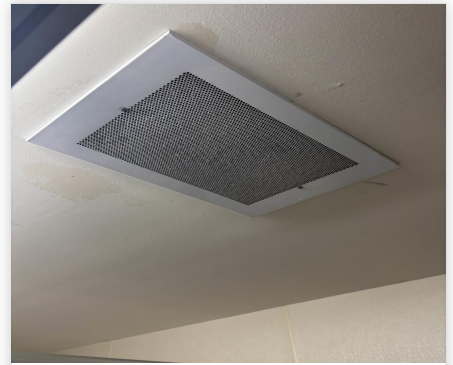
Issue Name : EFs: Dirty Exhaust Grilles
Description : The exhaust grilles for the EFs are very dirty. Recommend cleaning.
Created By : National TAB **Assigned To :** National TAB - Kalen Kemp
Status : Open
Priority : Medium **Asset Tag :**
Originated Date : 12/18/2025 - Kalen Kemp - National TAB

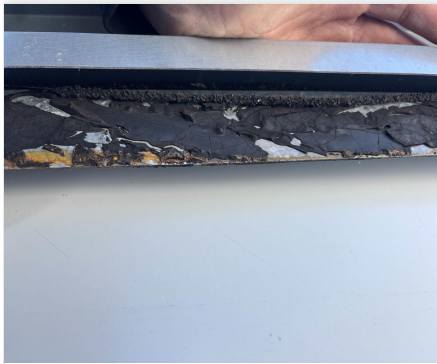
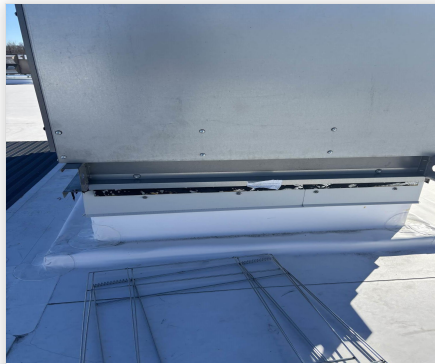
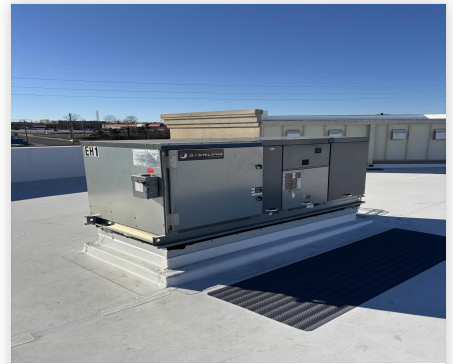
Issue Name : EH1: Air Leakage
Description : There is air leaking out of the bottom of the unit. The unit is not aligned properly which is causing the air leakage. Recommend aligning the unit and sealing properly.
Created By : National TAB **Assigned To :** National TAB - Kalen Kemp
Status : Open
Priority : Urgent **Asset Tag :** EH-1
Originated Date : 12/16/2025 - Kalen Kemp - National TAB

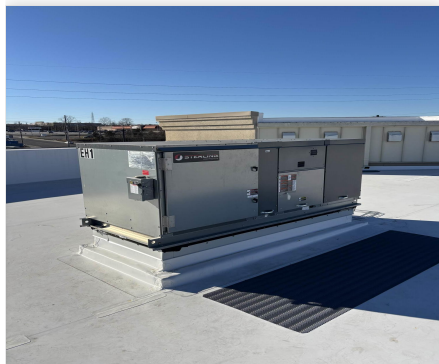
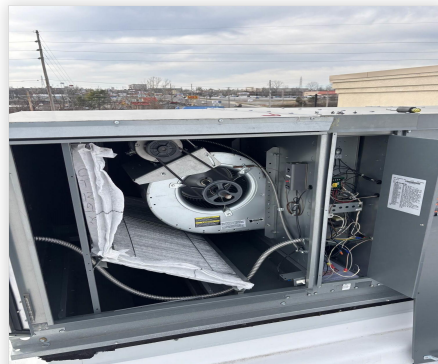
Issue Name : EH1: Amperage
Description : The motor for EH1 is Overramping. The motor sheave has been turned out as far as it can go. Recommend service.
Created By : National TAB **Assigned To :** National TAB - Kalen Kemp
Status : Open
Priority : Urgent **Asset Tag :** EH-1
Originated Date : 12/18/2025 - Kalen Kemp - National TAB

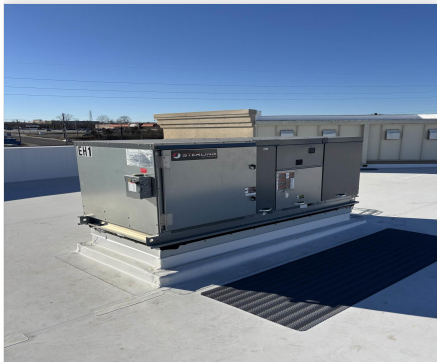
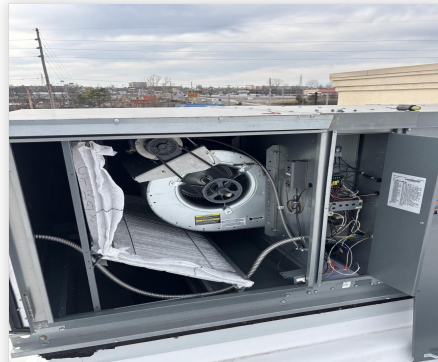
Issue Name : EH1: Fan Sheave
Description : EH1 supply airflow is 36% high. Motor sheave is turned out as far as it will go. Fan sheave will need to be replaced to further reduce airflow.
Created By : National TAB **Assigned To :** National TAB - Kalen Kemp
Status : Open
Priority : Urgent **Asset Tag :** EH-1
Originated Date : 12/18/2025 - Kalen Kemp - National TAB

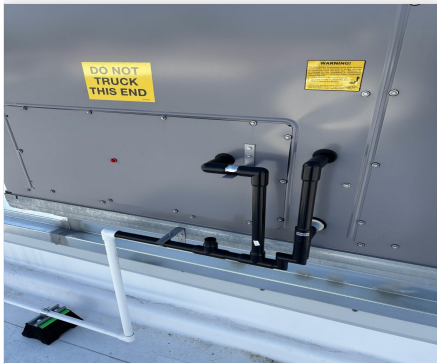
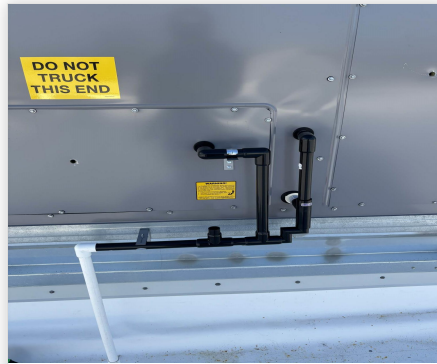
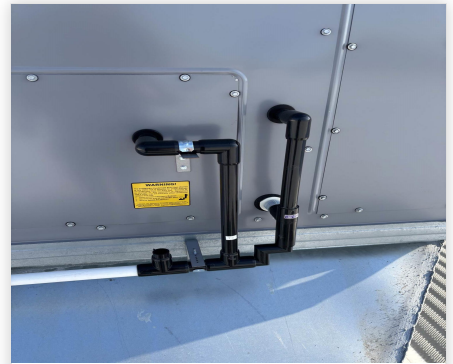
Issue Name : RTU1,2,3: Improper Costguard Supports
Description : The costguard condensate drains are not supported properly on RTU1, RTU2, and RTU3. There is supposed to be a support on the vertical piece on the right.
Created By : National TAB **Assigned To :** National TAB - Kalen Kemp
Status : Open
Priority : Urgent **Asset Tag :**
Originated Date : 12/18/2025 - Kalen Kemp - National TAB

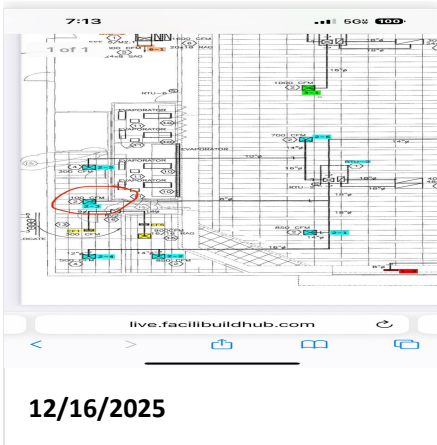
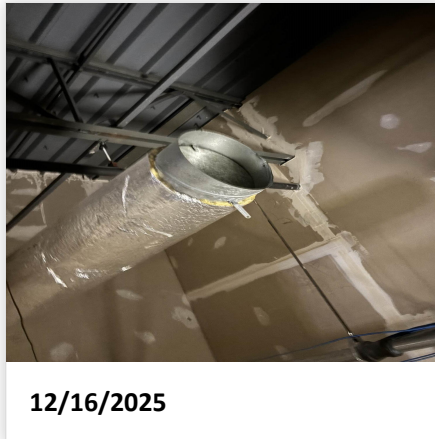
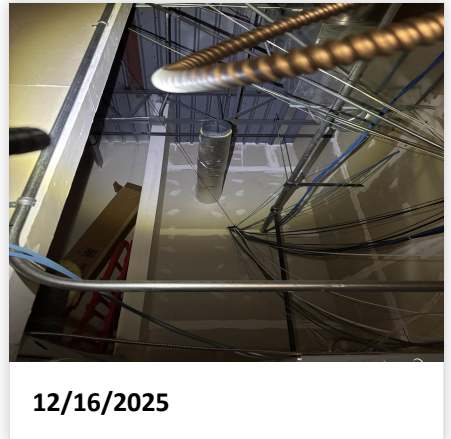
Issue Name : RTU2: Disconnected Duct/Missing Diffuser
Description : The diffuser that serves the hallway near the walk-in cooler and break room is missing. The duct that runs to that diffuser is left open above ceiling. The damper was closed to get a total airflow reading for the rest of the system. Recommend installing diffuser to properly supply air to the space.

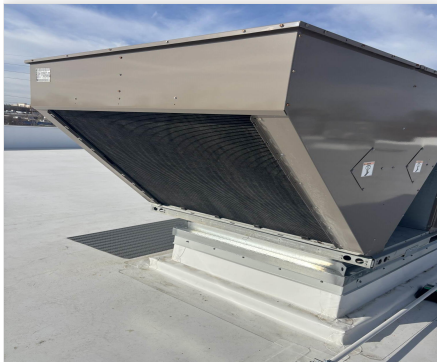
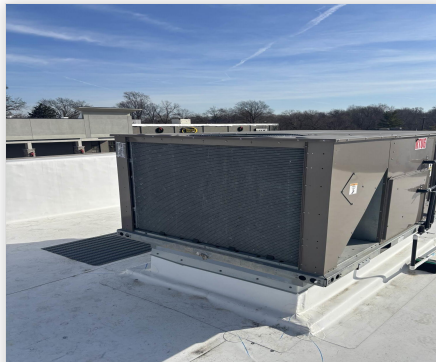
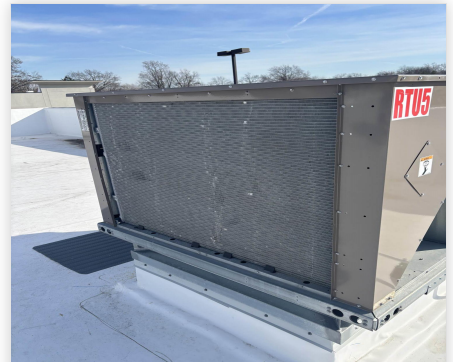
Issue Name : RTU4, 5, 6: Missing Hail Guards
Description : The hail guards for RTU4, 5, and 6 are not installed. Recommend installation to prevent hail damage to condenser coils.
Created By : National TAB **Assigned To :** National TAB - Kalen Kemp
Status : Open
Priority : Medium **Asset Tag :**
Originated Date : 12/18/2025 - Kalen Kemp - National TAB

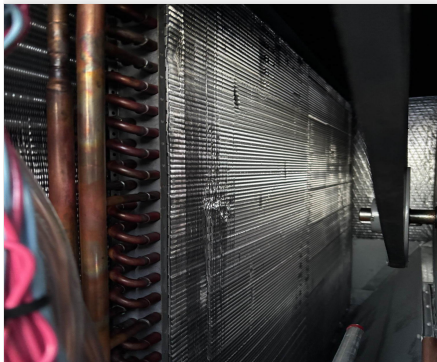
Issue Name : RTU5: Damaged Coil
Description : The evaporator coil inside RTU5 is damaged. This is likely from shipping. Review and assess for repair.
Created By : National TAB **Assigned To :** National TAB - Kalen Kemp
Status : Open
Priority : High **Asset Tag :** RTU-5
Originated Date : 12/18/2025 - Kalen Kemp - National TAB

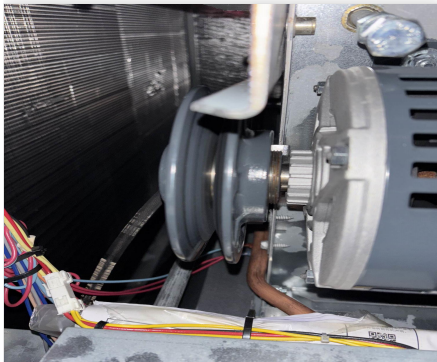
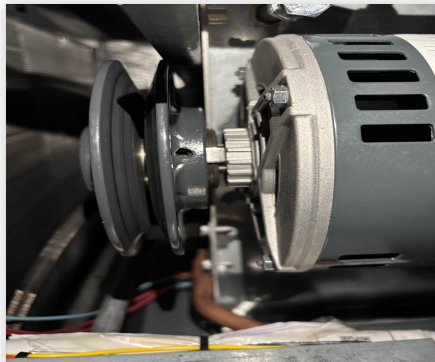
Issue Name : RTU5: Motor/Fan sheave
Description : The airflow for RTU5 is 29% high. Unable to remove lock pin on the motor sheave to adjust the set point. Fan sheave needs to be replaced to reduce airflow.
Created By : National TAB **Assigned To :** National TAB - Kalen Kemp
Status : Open
Priority : Urgent **Asset Tag :** RTU-5
Originated Date : 12/18/2025 - Kalen Kemp - National TAB

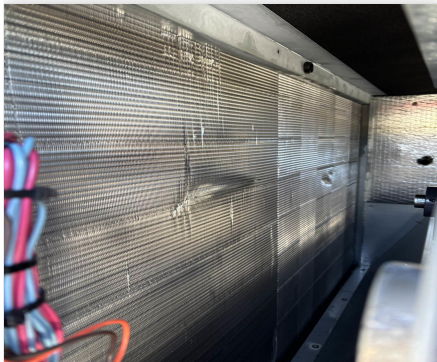
Issue Name : RTU6: Damaged Coil
Description : The evaporator coil inside RTU6 is damaged. This is likely damage from shipping. Review and assess for repair.
Created By : National TAB **Assigned To :** National TAB - Kalen Kemp
Status : Open
Priority : High **Asset Tag :** RTU-6
Originated Date : 12/16/2025 - Kalen Kemp - National TAB

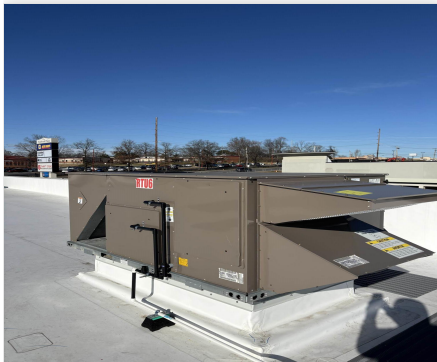
Issue Name : RTU6: Fan Sheave
Description : RTU6 supply airflow is 70% high. Motor sheave is turned out as far as it can go. Fan sheave needs to be replaced to further reduce airflow.
Created By : National TAB **Assigned To :** National TAB - Kalen Kemp
Status : Open
Priority : Urgent **Asset Tag :** RTU-6
Originated Date : 12/18/2025 - Kalen Kemp - National TAB
