Report: REVIVE REPORT
Function: Test, Adjust, & Balance
Date: 10/08/2024
Completed By: National TAB

10-07-24 CULVERS RED WING MN REVIVE

179 Tyler Road

South Red Wing, MN 55066

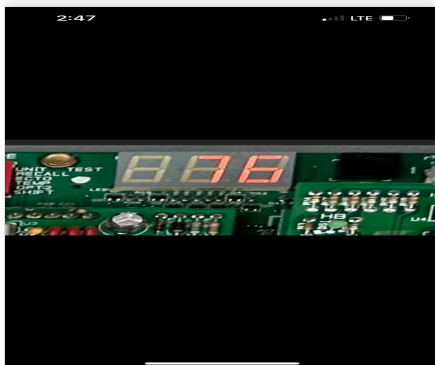
RTU-1 is a non-Humiditrol unit and RTU-2 is a Humiditrol unit. The outside air for RTU-2 was set higher since it has these humidity control capabilities. There is a humidity sensor error on the unit however which means dehumidification may not be working properly. A service company needs to resolve this.

Issue Name : 01: Rtu 2 humidity sensor
Description : Rtu 2 is showing alarm 76 meaning there is an issue with the humidity sensor. A service company should contact Lennox to troubleshoot and replace if necessary. It is critical for dehumidification to function properly due to the high amount of OA required through the RTU's.
Created By : National TAB **Assigned To :** National TAB - Dan Hertenstein
Status : Open
Priority : High **Asset Tag :** RTU2
Originated Date : 10/08/2024 - Gabe Merk - National TAB

1. A service company needs to contact Lennox technical support to troubleshoot the humidity sensor error on RTU-2. (Error 76). It appears that possibly the sensor is damaged. Wiring appeared to be correct but should be verified with Lennox. They also need to verify that all settings are set up correctly for dehumidification. If this is not resolved, there could be comfort issues in the summertime due to the high amount of outside air required through the RTU's.

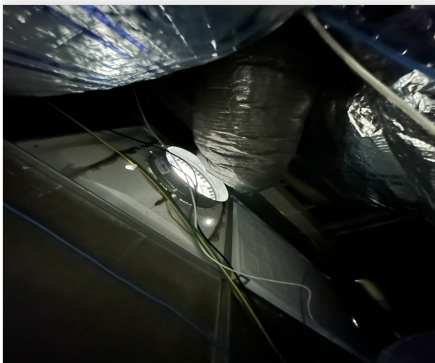
Issue Name : 02: Flex Duct in Kitchen
Description : Flex duct for CD-12 diffuser by dish hood has fallen off and was blowing above the ceiling. This was repaired by NTi while on site. No further action required.
Created By : National TAB **Assigned To :** National TAB - Dan Hertenstein
Status : Closed
Priority : InfoOnly **Asset Tag :**
Originated Date : 10/08/2024 - Gabe Merk - National TAB

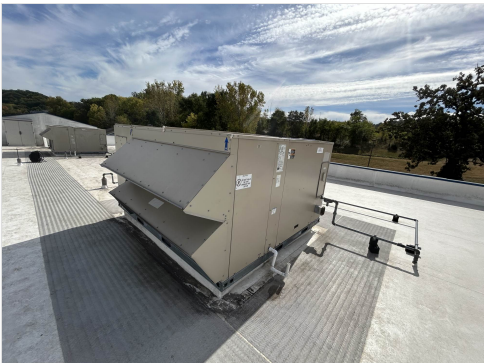
IMG_1491_932175735.jp..

Measured the airflows out on all equipment. Found RTU-1 (Dining) airflow to be initially 4678 CFM out of originally design of 6000 CFM. Went to the roof, and sped up the maximum frequency to get airflow within design. The VFD frequency was also modulating causing building pressure swings. There is no low speed OA damper setpoint so the fan speed was changed to operate at a constant speed.

The outside air dampers for both RTU-1 and RTU-2 were found completely shut. This was the major contributing factor to the negative building pressure. These were opened and set to a minimum amount of outside air.
