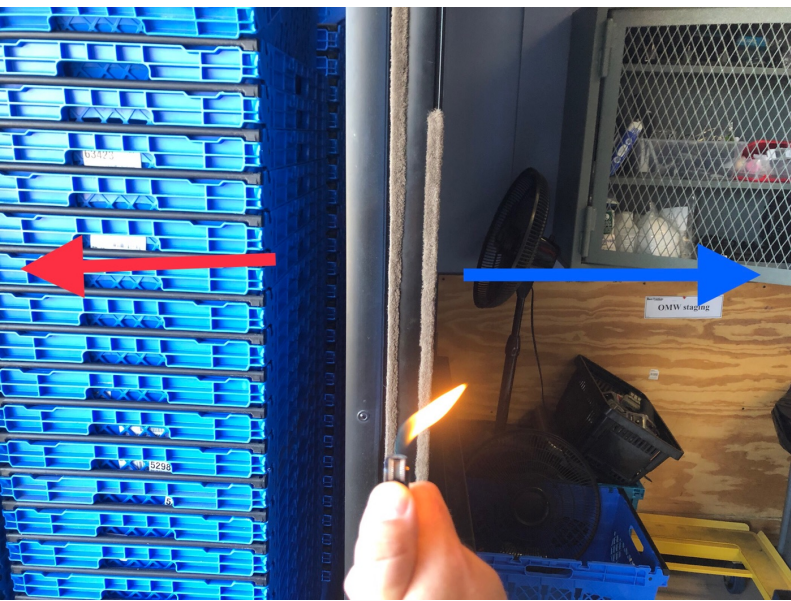
LIGHTER PLACED IN DOOR FRAME OF PICKUP AREA. RED POINTS TO OUTSIDE BLUE POINTS TO INSIDE. FLAME SHOWS THAT OUTSIDE AIR IS INFILTRATING AREA WHEN DOOR IS OPEN.

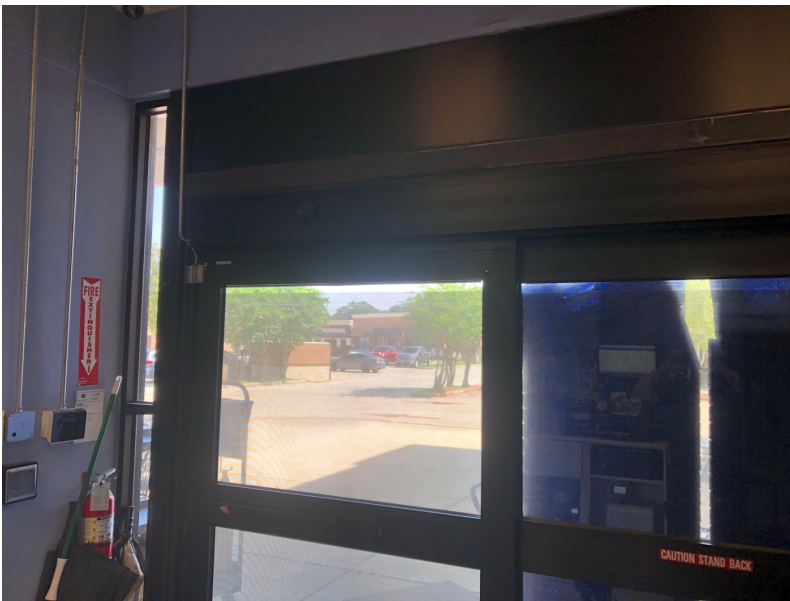
PICKUP DOOR IS MISSING AIR CURTAIN.

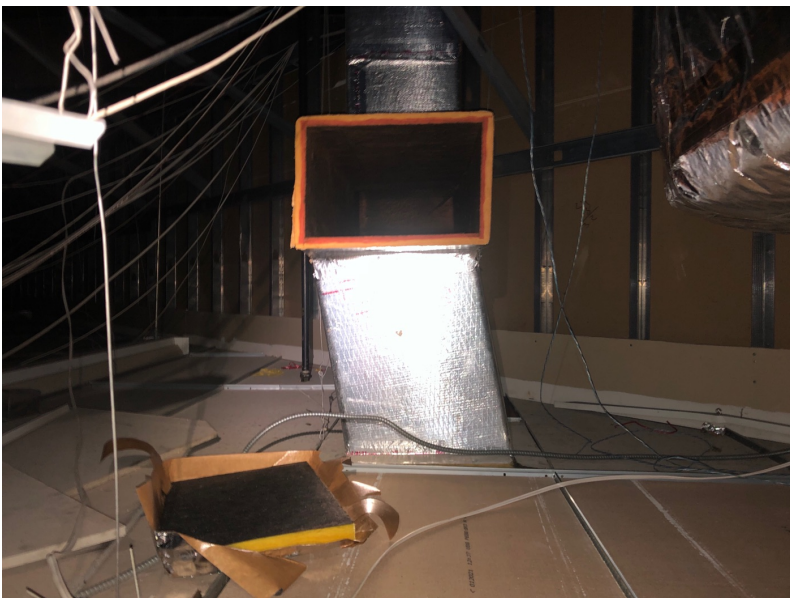
DUCTWORK FOR GRILLE NEAR PICKUP AREA DOOR IS OPEN. LARGE AMOUNTS OF SUPPLY AIR FROM RTU-1 LEAKING INTO CEILING SPACE.
