**Report: Issue Report
Function: Test, Adjust, & Balance
Date: 09/19/2022**

**PROJECT
09-19 CULVERS - LOGANSPOORT, IN**

Project: 09-19 CULVERS - LOGANSPOORT, IN

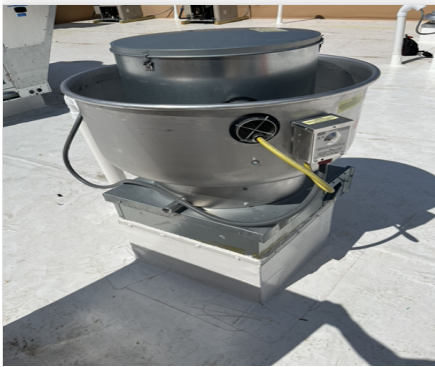
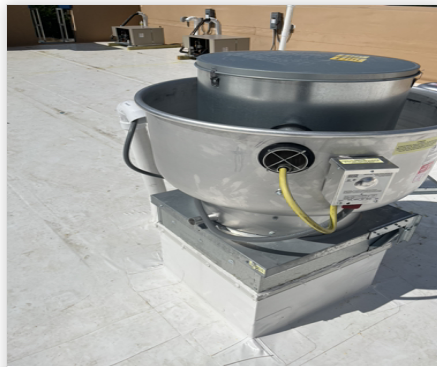
Issue Name : BOTH HOOD EXHAUST GREASE CUPS

Description : The grease cups for both PRV 2 and 3 are in the motor compartment but are not installed.

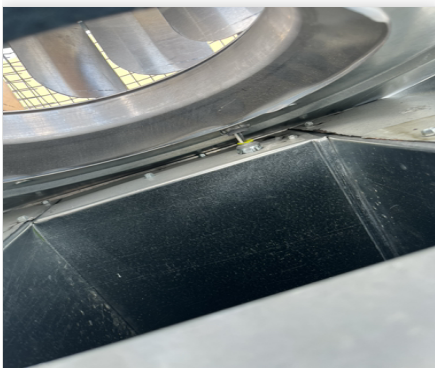
Issue Name : CONDUIT FOR PRV1 is tight.

Description : When you lean the exhaust fan back or try to remove it you can not lift it more then 2-3 inches. Looks like the wires will rip or short out if the fan is pulled back too far. This also may be why backdraft damper is not yet installed.

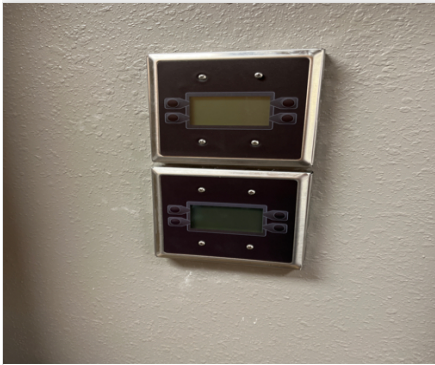
Issue Name : HMI for both RTUS not powered

Description : HMI for RTU1 and RTU2 are missing CAT5 cable and are not powered.

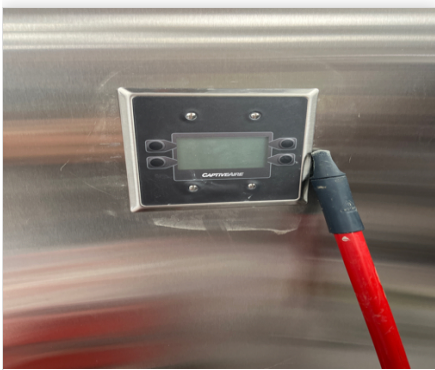
Issue Name : HOOD CONTROL NOT POWERED

Description : The HMI for hoods is not wired and so there is no speed controller for either hood exhaust fan.
