**Report: ISSUES**

**Function: Test, Adjust, & Balance**

**Date: 08/27/2025**

**08-25-25 CHIPOTLE #5270 LOUISVILLE, KY  
(PRESTON CENTER)**

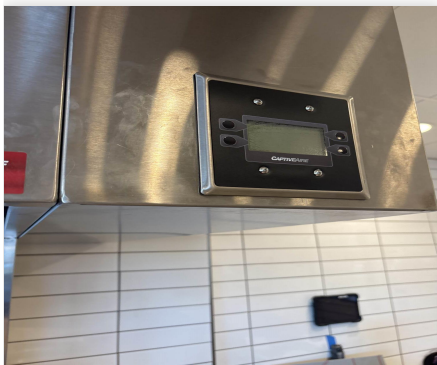
**Issue Name :** HOOD NON-FUNCTIONAL  
**Description :** Manufacturing malfunction causing the hood not to function. Internal solenoid integral to the hood is bad and preventing the HMI and startup of the hood.  
**Created By :** National TAB                      **Assigned To :** National TAB - Dan Hertenstein  
**Status :** Closed  
**Priority :** Urgent                                      **Asset Tag :**  
**Originated Date :** 08/27/2025 - Cavin Van - National TAB

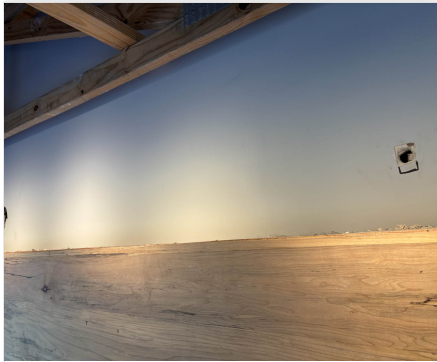
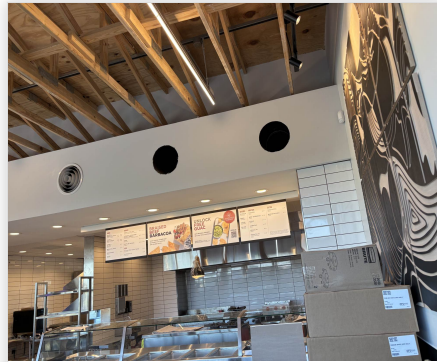
**Issue Name :** Missing Diffusers  
**Description :** Diffusers 2-1 and 2-2 are missing and Diffusers 2-6 and 2-7 need O.B. Dampers.  
**Created By :** National TAB                      **Assigned To :** National TAB - Dan Hertenstein  
**Status :** Closed  
**Priority :** **Urgent**                                      **Asset Tag :**  
**Originated Date :** 08/27/2025 - Cavin Van - National TAB

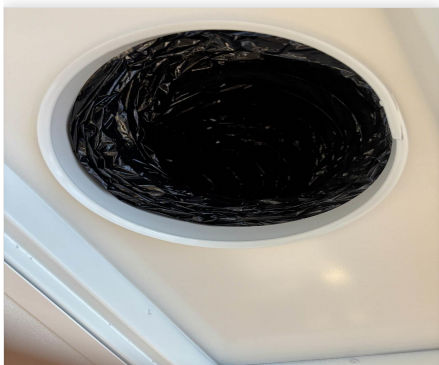
**Issue Name :** Missing O.B. Dampers  
**Description :** All kitchen diffusers are missing O.B. Dampers.  
**Created By :** National TAB                      **Assigned To :** National TAB - Dan Hertenstein  
**Status :** Closed  
**Priority :** Urgent                                      **Asset Tag :**  
**Originated Date :** 08/27/2025 - Cavin Van - National TAB

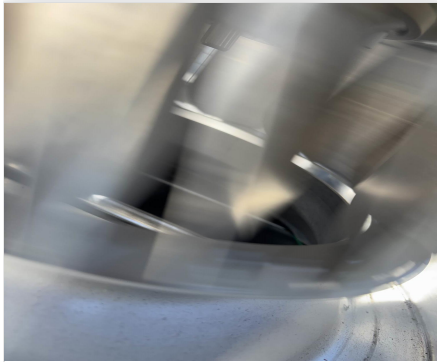
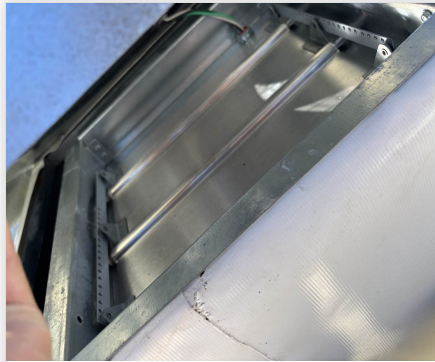
**Issue Name :** RESTROOM BACK DRAFT DAMPER  
**Description :** Restroom back draft damper is too close to the fan causing it to only open up 65%. Recommend lowering backdraft damper.  
**Created By :** National TAB                      **Assigned To :** National TAB - Dan Hertenstein  
**Status :** Open  
**Priority :** High                                      **Asset Tag :**  
**Originated Date :** 08/27/2025 - Cavin Van - National TAB
