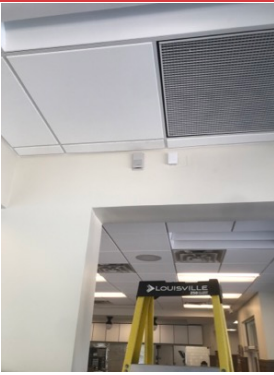
### **ISSUE 1**

SENSORS WERE MOVED DUE TO METAL POLE FROM OLD PLAYGROUND BEING INSIDE IN THE WALL WHERE SENSORS WERE TO BE LOCATED ON PRINTS PER MECHANICAL

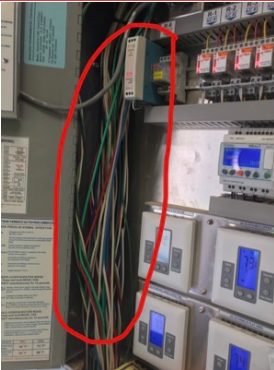
### **ISSUE 2**

HIGH VOLTAGE WIRING COVER NEEDS TO BE INSTALLED IN T-500 PANEL

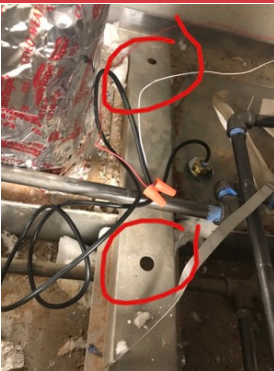
### **ISSUE 3**

HOOD1L NOT ALL SUPPORT POINTS HAVE 0.50" THREADED ROD RAN TO THEM, BUT BACK OF HOOD IS SCREWED TO WALL. WHICH IS USUALLY ACCEPTABLE BY CFA STANDARDS

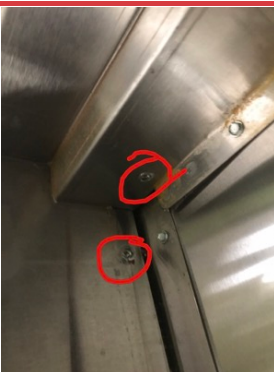
### **ISSUE 4**

HOOD2 GUSSET BRACKET SCREWS NEED TO BE INSTALLED

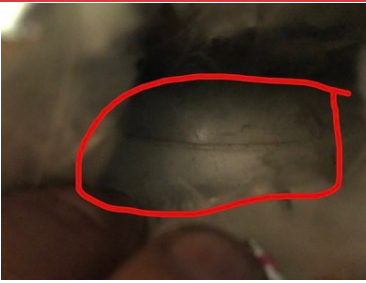
**ISSUE 5**

AC2 MASTIC IS NOT INSTALLED AT RIGID CONNECTIONS FROM HARD DUCT TO DIFFUSER TOP

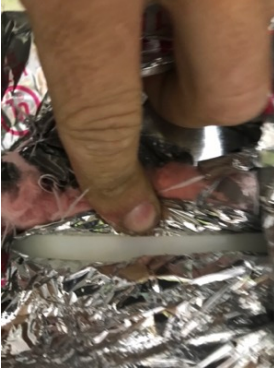
**ISSUE 6**

AC1 DRAWBAND IS INSTALLED ON FLEX INNER CORE, BUT NOT DRAWBAND AND TAPE.

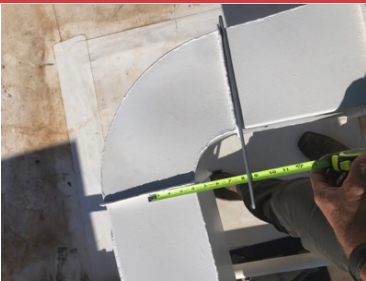
**ISSUE 7**

EF1 & EF2 GREASE DUCT DOES NOT HAVE LONG RADIUS TURNS INSTALLED.

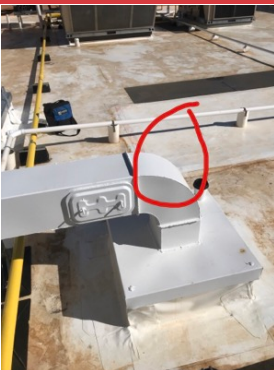
**ISSUE 8**

EF1 & EF2 BOTH HAVE TWO GREASE CLEANOUT DOORS PER LOCATED IN DIFFERENT LOCATIONS THEN SHOWN ON PRINTS.

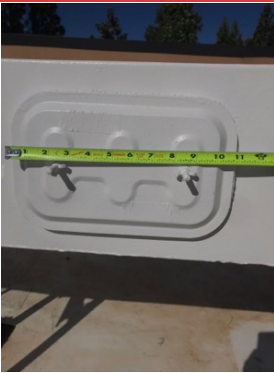
**ISSUE 9**

EF1 & EF2 GREASE CLEANOUT DOOR SIZES DO NOT MEET SIZES SPECS LISTED IN PRINTS FOR ALL DOORS.

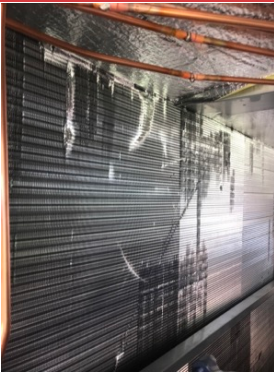
**ISSUE 10**

AC2 HAS SOME DAMAGE TO EVAP. COIL.

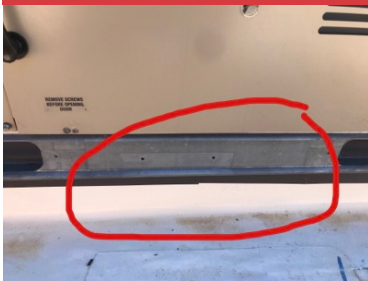
**ISSUE 11**

HURRICANE CLIPS ARE NOT INSTALLED ON AC1

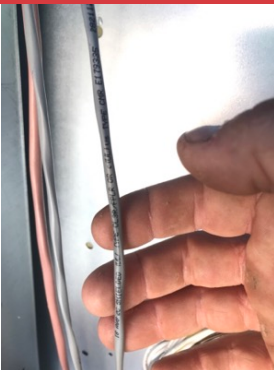
**ISSUE 12**

AC1, AC2, AC3, AC4 HUMIDITY SENSOR WIRING IS NOT BELDEN BRAND

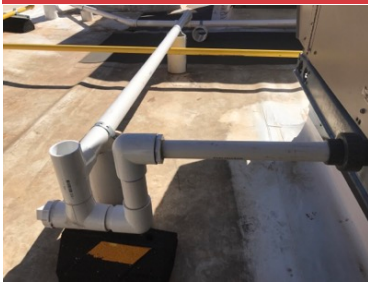
**ISSUE 13**

AC1 CONDENSATE LINE SIZE AFTER P-TRAP DOES NOT MEET SIZE LISTED ON PRINTS, CONDENSATE LINE IS 1.0" PRINTS CALL FOR 1.5" LINE.

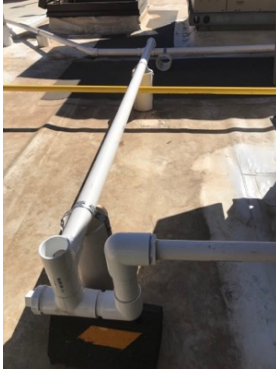
**ISSUE 14**

AC2 CONDENSATE LINE DOES NOT HAVE A UNION INSTALLED ON BOTH SIDES OF THE P-TRAP

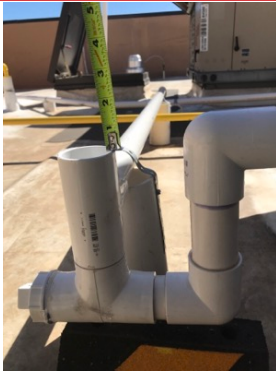
**ISSUE 15**

AC2 CONDENSATE LINE DOES NOT HAVE A 2" FALL

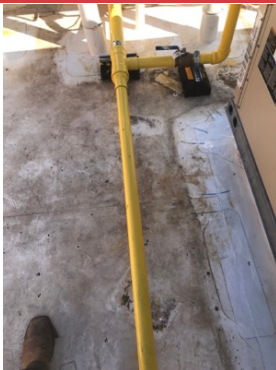
**ISSUE 16**

GAS PIPING IS PAINTED YELLOW, WHICH IS USUALLY AN ACCEPTABLE COLOR BY CFA STANDARDS.

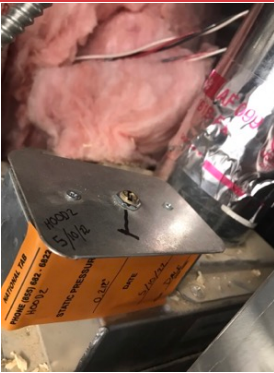
**ISSUE 17**

HOOD2 CAPTURE JET DOES NOT REACH DESIGN PRESSURE WITH FAN RUNNING AT MAX SPEED. FAN IS FACTORY INSTALLED. HOOD SMOKE CAPTURE WAS 100%.

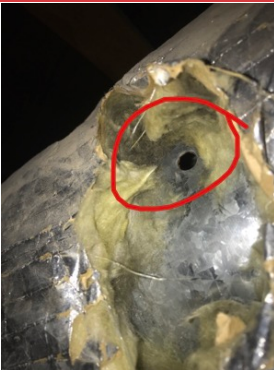
**ISSUE 18**

AC1 SGRD7 DAMPER IS BROKEN DUCTWORK UNABLE TO BALANCE SUPPLY GRILL TO DESIGN CFM.

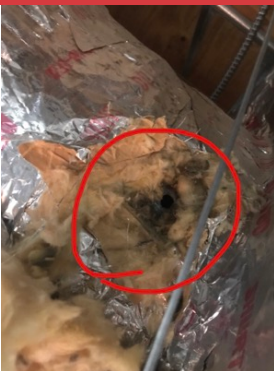
**ISSUE 19**

AC3 SGRD12 DAMPER IS BROKE UNABLE TO BALANCE SUPPLY GRILL TO DESIGN CFM.

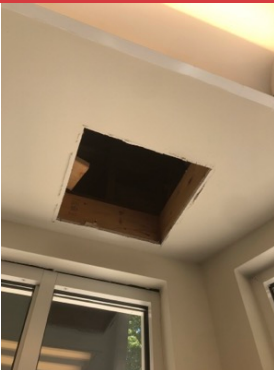
**ISSUE 20**

AC3 RETURN GRILL EGRD1 NO EXISTING DUCTWORK IS RUN TO THIS GRILL. APPEARS THE GRILL NEVER HAD DUCT RUN TO IT FROM THE LAST BUILD/ REMODEL.

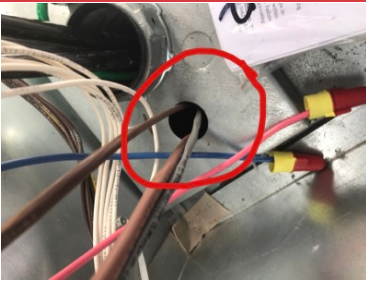
**ISSUE 21**

AC2 GROMMETS NEED TO BE PLACED AROUND LOW VOLTAGE WIRE CUT OUT.

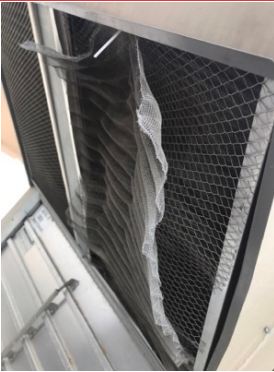
**ISSUE 23**

AC1 PRE-FILTER IS DAMAGED AND RECOMMENDED BEING REPLACED THIS IS A EXISTING UNIT.

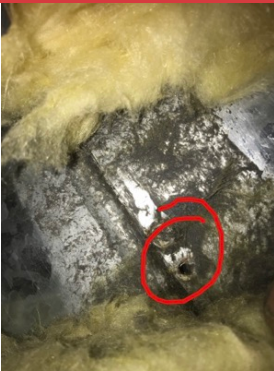
**ISSUE 24**

AC1 SGRD7 THAT SERVES THEM MENS RR. DAMPER IS BROKEN UNABLE TO BALANCE GRILL TO DESIGN CFM.

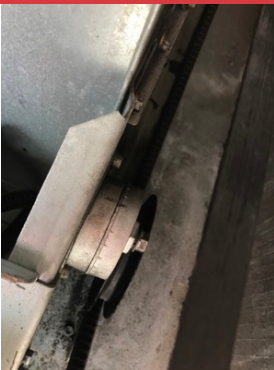
**ISSUE 25**

AC3 BELT NEEDS TO BE RESIZED IN ORDER TO ACHIEVE PROPER TENSION "3RD TICK MARK" UNABLE TO LOCATE BELT IN THE LOCAL AREA BEFORE HAVING TO LEAVE JOB SITE.

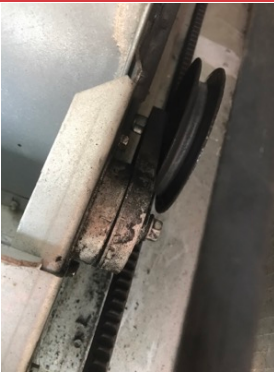
**ISSUE 26**  
EXISTING UNIT

AC1 BELT TENSIONER IS SEIZED AND WILL NOT ALLOW THE TENSIONER TO BE ADJUSTED

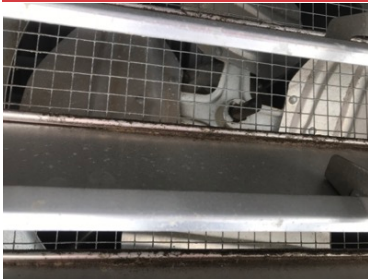
**ISSUE 27**  
EXISTING UNIT

AC4 & AC1 POWER EXHAUST FANS ARE NOT OPERATIONAL. THESE ARE EXISTING UNITS

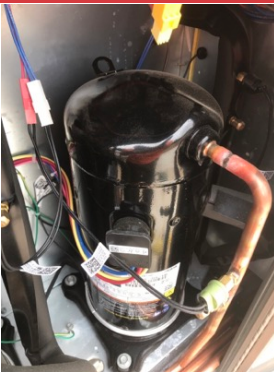
**ISSUE 28**  
AC2 COMPRESSOR 4 FREEZE STAT HAS TRIPPED THE ALARM NOW ALLOW THIS COMPRESSOR TO RUN.

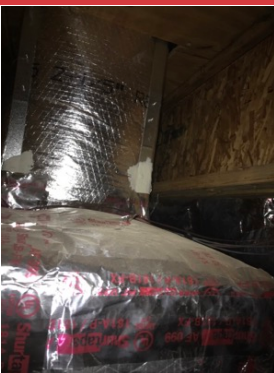
**ISSUE 29**  
AC2 RETURN MAIN DROP DUCTWORK DOES NOT SPAN OUT AT THE BOTTOM BUT MAKES A "L" SHAPE. THIS IS DIFFERENT THEN WHAT IS CALLED FOR IN THE PRINTS. UNIT WAS BALANCED AND ALL GRILLS WERE BALANCED TO DESIGN CFM.
