Report: TAB Survey
Function: Test, Adjust, & Balance
Date: 12/10/2025
Completed By: National TAB

PROJECT
12-08-25 CHILIS HAMILTON, NJ (TAB SURVEY)

125 Marketplace Boulevard

Hamilton , NJ 08691

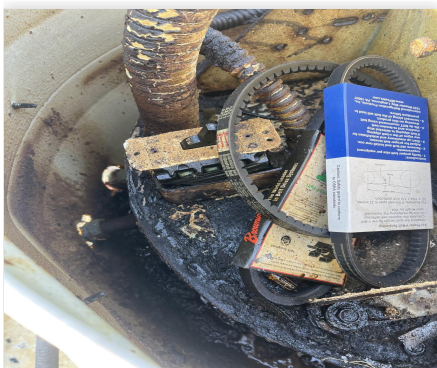
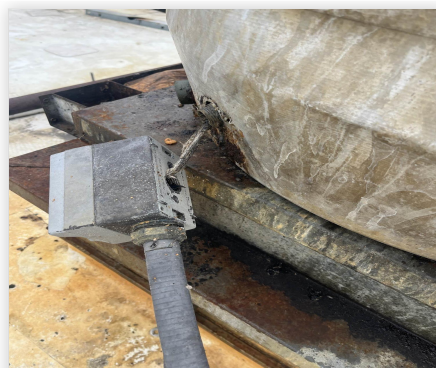
Issue Name : EF-1 recommend refurb/replacement
Description : Fan is electrically not sound, junction box is hanging on by wires and internal fan disconnect is not secured. Fan will likely short out if not repaired.
Created By : National TAB **Assigned To :** National TAB - Dan Hertenstein
Status : Open
Priority : Low **Asset Tag :**
Originated Date : 12/10/2025 - Tyler Youells - National TAB

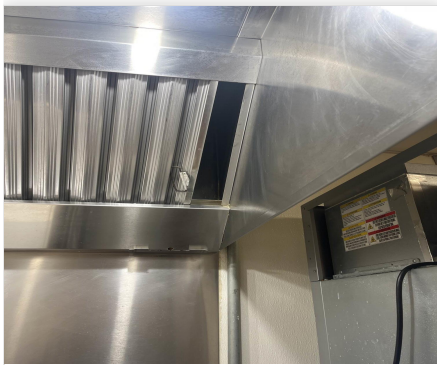
Issue Name : HOOD-4 Gap in filters
Description : Hood-4 has a 3-4" gap on the end of the filters, piece of blanking metal seems to have gone missing. Recommend reinstalling and closing the gap.
Created By : National TAB **Assigned To :** National TAB - Dan Hertenstein
Status : Open
Priority : Low **Asset Tag :**
Originated Date : 12/10/2025 - Tyler Youells - National TAB

THERE IS A LARGE GAP IN HOOD-4 FILTERS ON THE RIGHT SIDE, BLANK OFF PLATE LOOKS MISSING AND RECOMMEND SEALING SPACE.

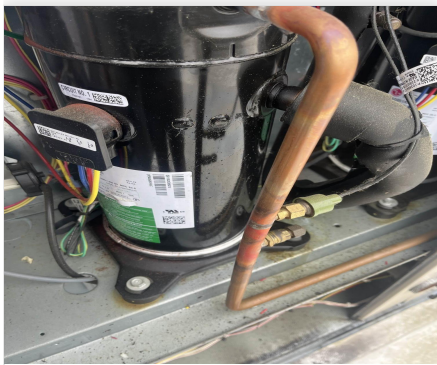
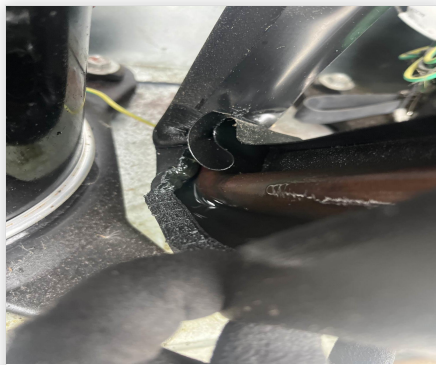
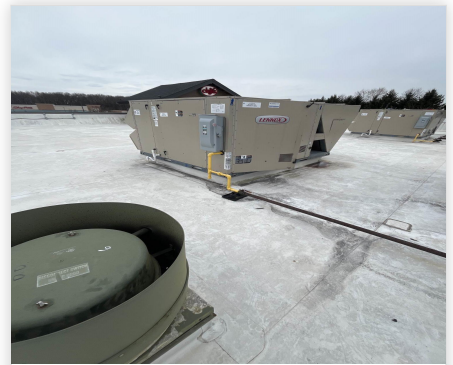
Issue Name : RTU-2 Dining: Cooling issue
Description : Cooling is not activating in a forced component test. Compressor 1 has oil dripping from piping probably locking the unit out of cooling.
Created By : National TAB **Assigned To :** National TAB - Dan Hertenstein
Status : Open
Priority : High **Asset Tag :**
Originated Date : 12/10/2025 - Tyler Youells - National TAB

RTU-2 Dining is not staging cooling, a compressor looks to have a large leak ad oil dripping.

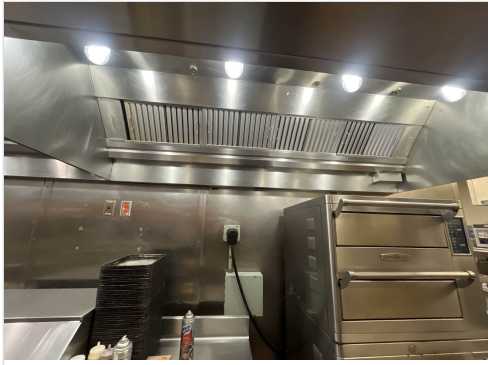
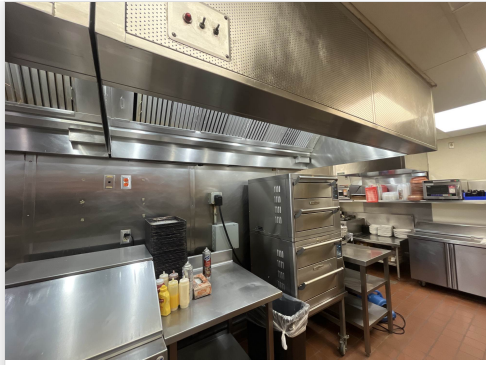
Asset: HD2

[1] SUPPLY READINGS INCONCLUSIVE DUE TO CLOGGED PSP PLENUM AND CROSS DRAFT FROM 4-WAY DIFFUSERS ON FRONT OF THE HOODS.
