Report: TAB Survey
Function: Test, Adjust, & Balance
Date: 12/10/2025
Completed By: National TAB

PROJECT
12-08-25 CHILIS HAMILTON, NJ (TAB SURVEY)

Project: 12-08-25 CHILIS HAMILTON, NJ (TAB SURVEY)

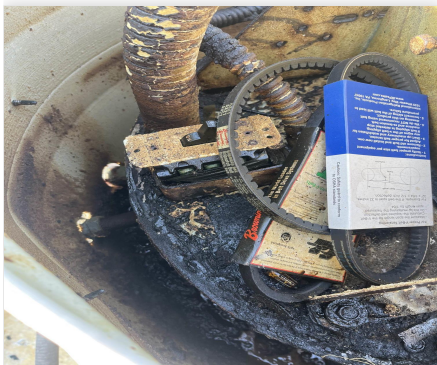
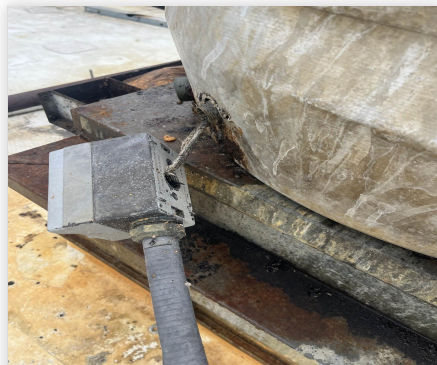
Issue Name : EF-1 recommend refurb/replacement
Description : Fan is electrically not sound, junction box is hanging on by wires and internal fan disconnect is not secured. Fan will likely short out if not repaired.
Created By : National TAB **Assigned To :** National TAB - Dan Hertenstein
Status : Open
Priority : Low **Asset Tag :**
Originated Date : 12/10/2025 - Tyler Youells - National TAB

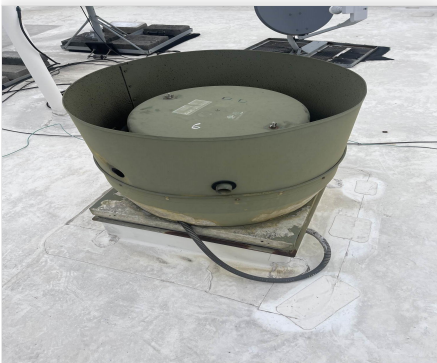
Issue Name : EF-6 Dish not operable
Description : Ef-6 serving the dish exhaust is not operating. Fan is seized, motor was humming and tripping on thermal overload. Disconnect switch turned off for safety.
Created By : National TAB **Assigned To :** National TAB - Dan Hertenstein
Status : Open
Priority : Urgent **Asset Tag :**
Originated Date : 12/10/2025 - Tyler Youells - National TAB

[1] EF-7 RESTROOM HAS A LITTLE BEARING NOISE, RECOMMEND ASSESSING HEALTH. EF-6 DISHWASHER IS NOT OPERABLE MOTOR IS SEIZED AND MAKING A LOUD HUMMING NOISE.

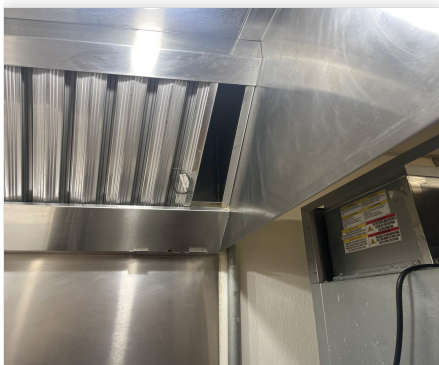
Issue Name : HOOD-4 Gap in filters
Description : Hood-4 has a 3-4" gap on the end of the filters, piece of blanking metal seems to have gone missing. Recommend reinstalling and closing the gap.
Created By : National TAB **Assigned To :** National TAB - Dan Hertenstein
Status : Open
Priority : Low **Asset Tag :**
Originated Date : 12/10/2025 - Tyler Youells - National TAB

THERE IS A LARGE GAP IN HOOD-4 FILTERS ON THE RIGHT SIDE, BLANK OFF PLATE LOOKS MISSING AND RECOMMEND SEALING SPACE.

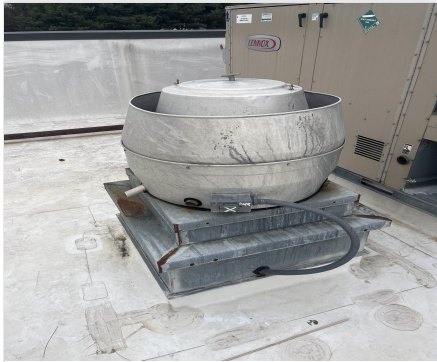
Issue Name : INFO- EF5
Description : Recommend removing and capping. Fan serves a hood that is no longer needed. Fan turned to the off position.
Created By : National TAB **Assigned To :** National TAB - Dan Hertenstein
Status : Open
Priority : InfoOnly **Asset Tag :**
Originated Date : 12/10/2025 - Tyler Youells - National TAB

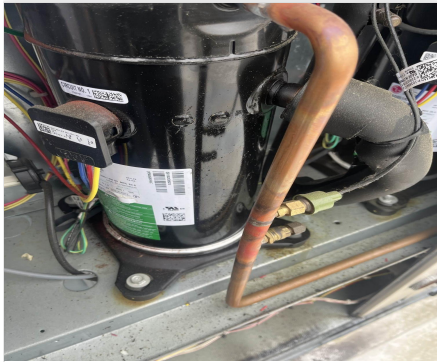
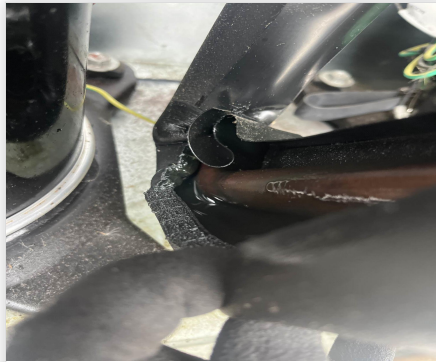
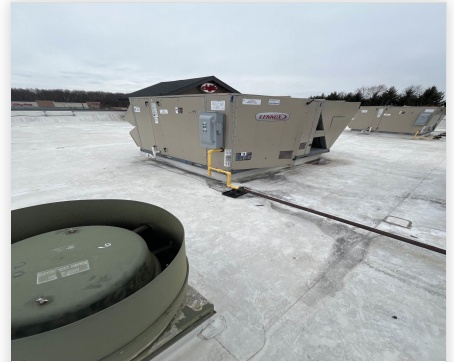
Issue Name : RTU-2 Dining: Cooling issue
Description : Cooling is not activating in a forced component test. Compressor 1 has oil dripping from piping probably locking the unit out of cooling.
Created By : National TAB **Assigned To :** National TAB - Dan Hertenstein
Status : Open
Priority : High **Asset Tag :**
Originated Date : 12/10/2025 - Tyler Youells - National TAB

RTU-2 Dining is not staging cooling, a compressor looks to have a large leak ad oil dripping.

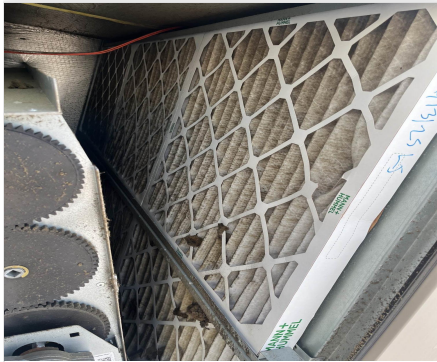
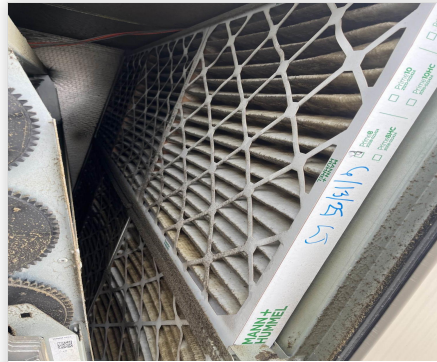
Issue Name : RTU-Filters
Description : RTU filters are all due for replacement. Dated 6 months ago. Recommend changing filters every 3 months for restaurant applications
Created By : National TAB **Assigned To :** National TAB - Dan Hertenstein
Status : Open
Priority : Medium **Asset Tag :**
Originated Date : 12/10/2025 - Tyler Youells - National TAB

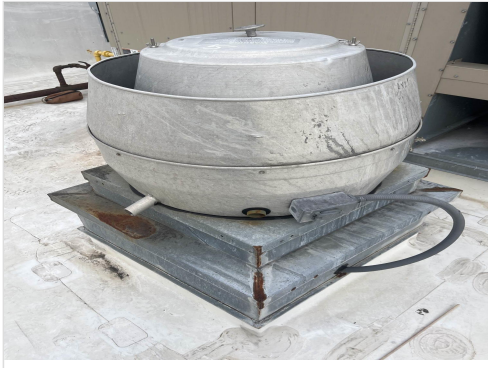
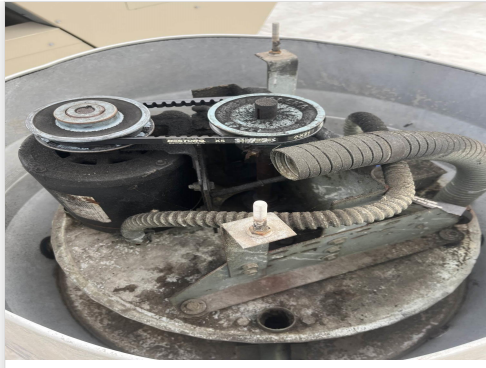
Asset: EF5

[1] FAN NOT NEEDED FAN TURBED OFF AT THE DISCONNECT

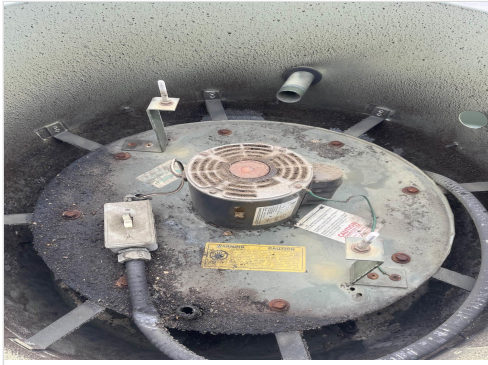
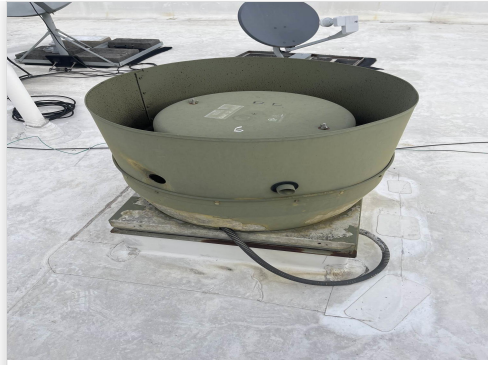
Asset: EF6

[1] FAN IS NOT FUNCTIONAL, MOTOR IS SIEZED AND MAKING A HUMMING NOISE, TRIPPING ON THERMAL OVERLOAD. TURNED DISCONNECT OFF FOR SAFETY

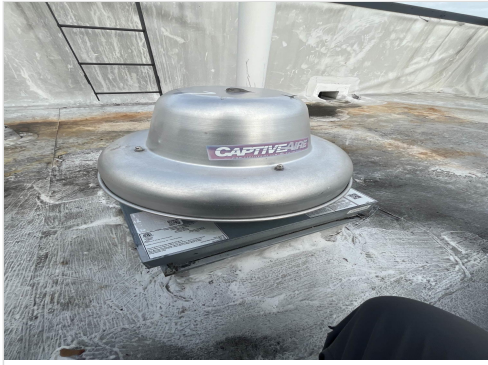
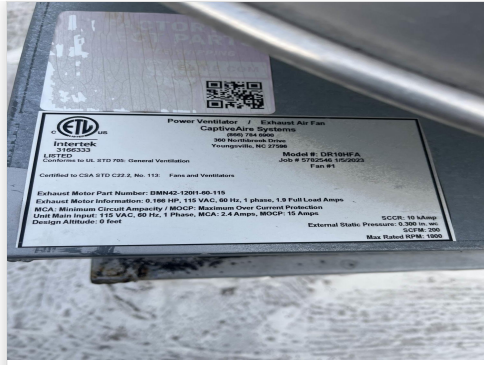
Asset: EF7

[1] RECOMMENDED FLOW FOR THE EF IS 525CFM BASED ON NUMBER OF TOILETS. FAN INSTALLED IS DESIGNED FOR 200CFM.

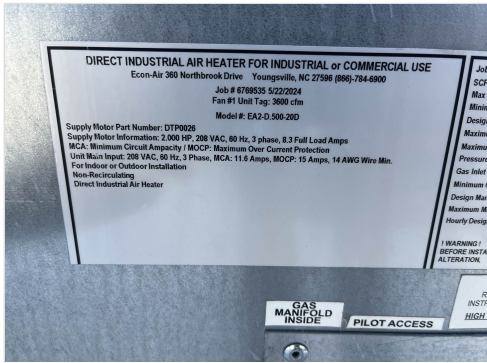
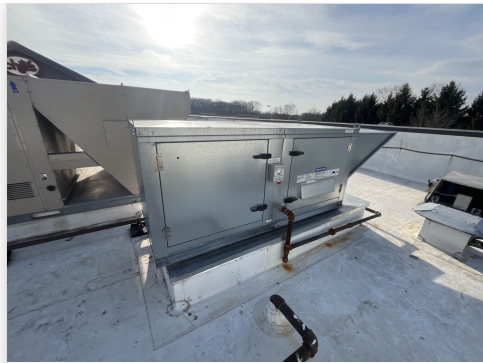
Asset: MAU1

[1] MUA DISCHARGE PRESSURE IS EXTREMELY HIGH. Discharge plenums are clogged.

[1] DISCHARGE PRESSURE 1.9". Ductwork/outlets are restricted and flow cannot be increased. Unit label shows design cfm of 3600.

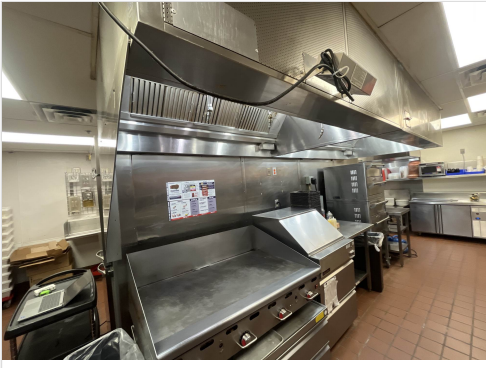
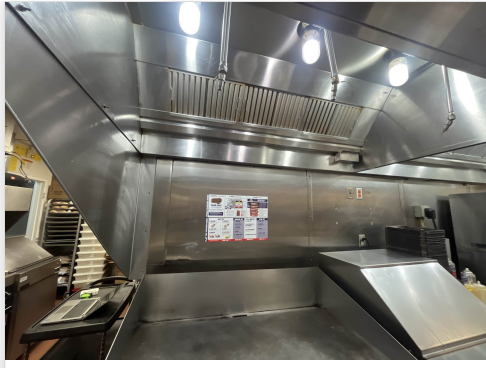
Asset: HD1

[1] SUPPLY READING INCONCLUSIVE DUE TO CLOGGED PSP PLENUM AND CROSS DRAFT FROM 4-WAY DIFFUSERS IN FRONT OF THE HOOD.

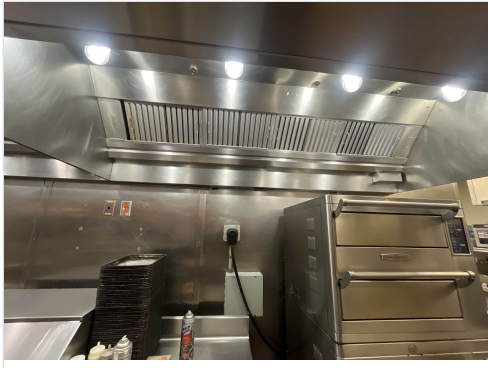
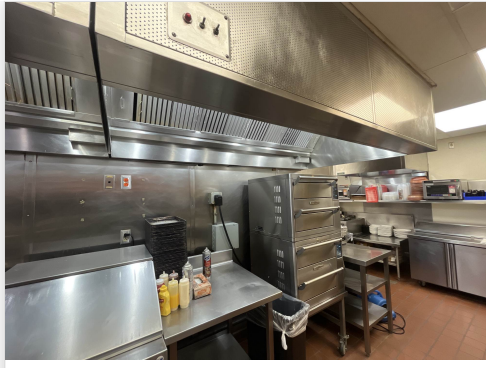
Asset: HD2

[1] SUPPLY READINGS INCONCLUSIVE DUE TO CLOGGED PSP PLENUM AND CROSS DRAFT FROM 4-WAY DIFFUSERS ON FRONT OF THE HOODS.

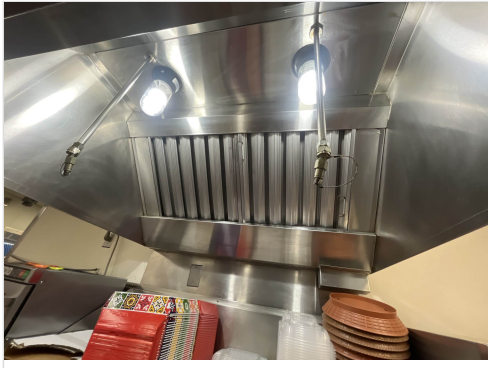
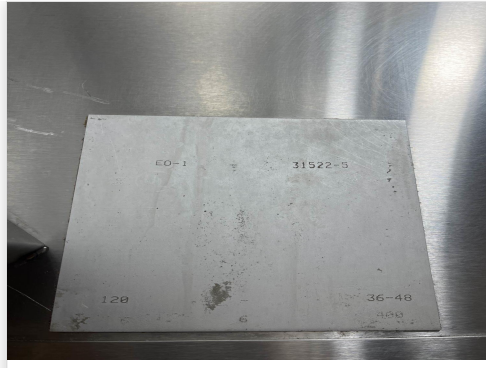
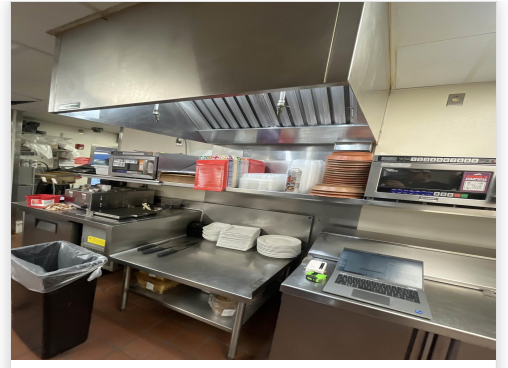
Asset: HD5

- [1] COOKING EQUIPMENT NO LONGER PRESENT, AREA UNDER THE HOOD LOOKS TO BE FOR PREP ONLY
- [2] FAN TURNED OFF TO REDUCE BUILDING EXHAUST FLOW SINCE HOOD IS NOT NEEDED
