**Report: TAB Report**  
**Function: Test, Adjust, & Balance**  
**Date: 10/23/2025**  
**Completed By: National TAB**

**PROJECT**  
**01-19-26 QT #1431 TOLLESON, AZ**

9101 W MCDOWELL RD

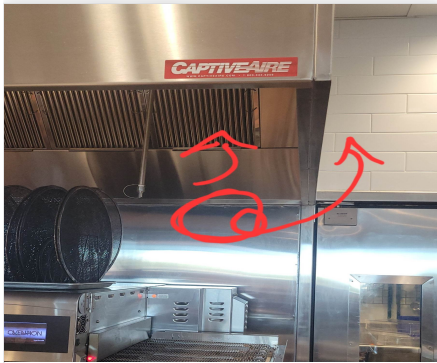
**Issue Name :** OVEN FAN PUSHES SMOKE OUT OF HOOD  
**Description :** Picture shows surface smoke air flow. About half is exhausted while the other half is swirled and pushed out of the hood. The fan on the side of the pizza oven is what is pushing it out. Quarter end panel needs to be installed  
**Created By :** National TAB                      **Assigned To :** National TAB - Dan Hertenstein  
**Status :** Open  
**Priority :** Low    **Asset Tag :** HD1  
**Originated Date :** 02/14/2026 - Christine Weale - National TAB

Quarter panel not installed.
