**Report: TAB Report**  
**Function: Test, Adjust, & Balance**  
**Date: 10/23/2025**  
**Completed By: National TAB**

**PROJECT**  
**01-19-26 QT #1431 TOLLESON, AZ**

QUIKTRIP  
4705 SOUTH 129TH EAST AVENUE  
TULSA, OK 74134

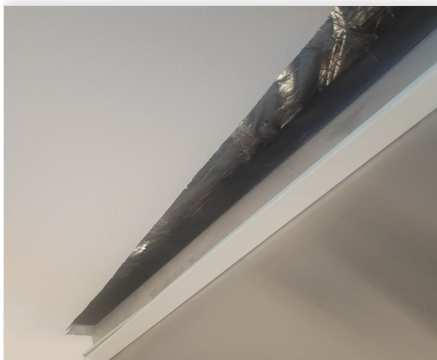
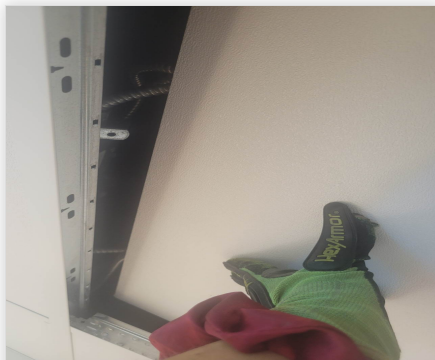
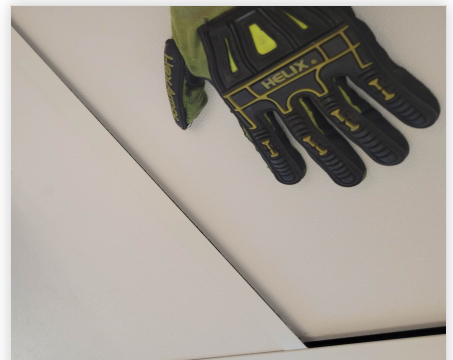
**Issue Name :** INACCESSIBLE KITCHEN DAMPERS  
**Description :** Ceiling tiles can't be raised at all. Pics show 3 different tiles I tried to raise and how far I was able to move them. QT #0497 and plenty of others don't have this issue. Recommend either: light canisters need to be moved, duct plenum needs to be raised, or grille-facing dampers need to be used instead. MC should make sure dampers are accessible.  
**Created By :** National TAB      **Assigned To :** National TAB - Dan Hertenstein  
**Status :** Open  
**Priority :** High      **Asset Tag :** RT-3  
**Originated Date :** 01/20/2026 - Christine Weale - National TAB

DAMPERS COMPLETELY INACCESSIBLE, SEE 'REMARKS'. LEFT UNIT ON LOW SIDE SINCE SGRD1 & 2 ARE ALREADY SO HIGH.

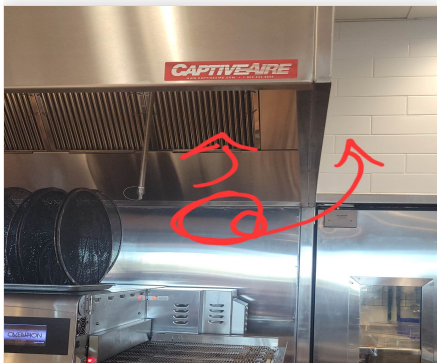
**Issue Name :** OVEN FAN PUSHES SMOKE OUT OF HOOD  
**Description :** Picture shows surface smoke air flow. About half is exhausted while the other half is swirled and pushed out of the hood. The fan on the side of the pizza oven is what is pushing it out.  
**Created By :** National TAB                      **Assigned To :** National TAB - Dan Hertenstein  
**Status :** Open  
**Priority :** Low                                      **Asset Tag :** HD1  
**Originated Date :** 02/14/2026 - Christine Weale - National TAB

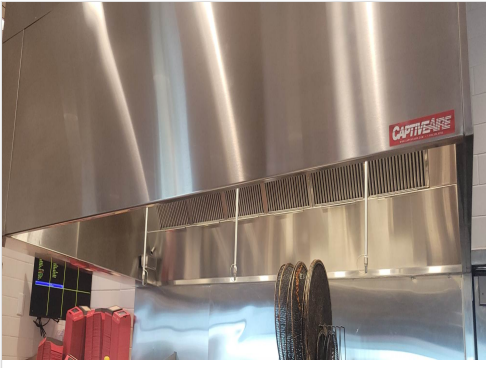
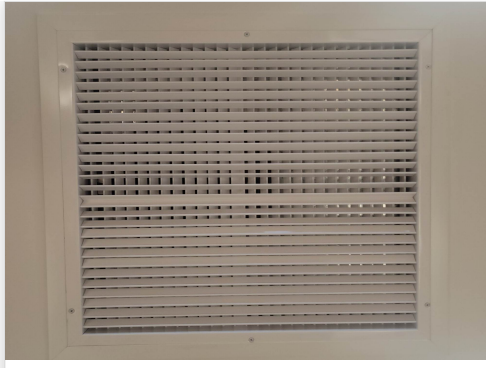
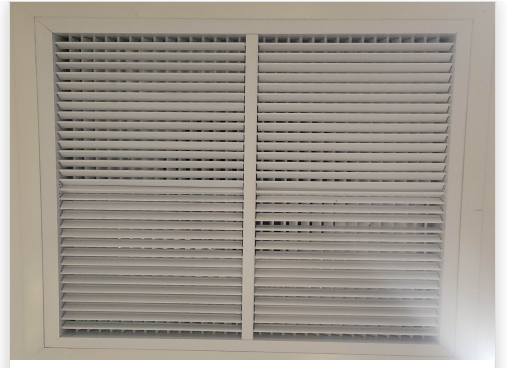
PICS OF GRILLE SHOW BEFORE AND AFTER. WHEN SET TO MSET DEPICTION, SMOKE LOSS WAS EXTREMELY HIGH MID-HOOD. HAD TO SET GRILLES ALMOST COMPLETELY OPPOSED TO HOOD TO OBTAIN 98% CAPTURE.
