Report: TAB Report
Function: Test, Adjust, & Balance
Date: 03/13/2026
Completed By: National TAB

PROJECT
01-19-26 QT #1431 TOLLESON, AZ

Project: 01-19-26 QT #1431 TOLLESON, AZ

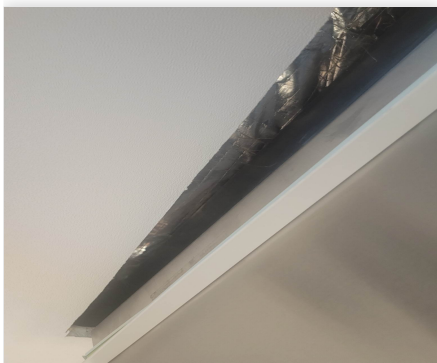
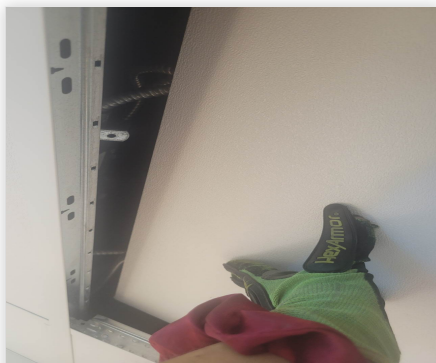
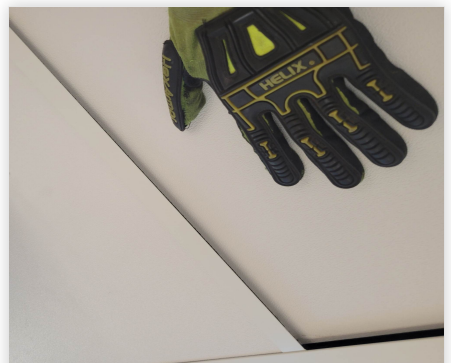
Issue Name : INACCESSIBLE KITCHEN DAMPERS
Description : Ceiling tiles can't be raised at all. Pics show 3 different tiles I tried to raise and how far I was able to move them. QT #0497 and plenty of others don't have this issue. Recommend either: light canisters need to be moved, duct plenum needs to be raised, or grille-facing dampers need to be used instead. MC should make sure dampers are accessible.
Created By : National TAB **Assigned To :** National TAB - Dan Hertenstein
Status : Open
Priority : High **Asset Tag :** RT-3
Originated Date : 01/20/2026 - Christine Weale - National TAB

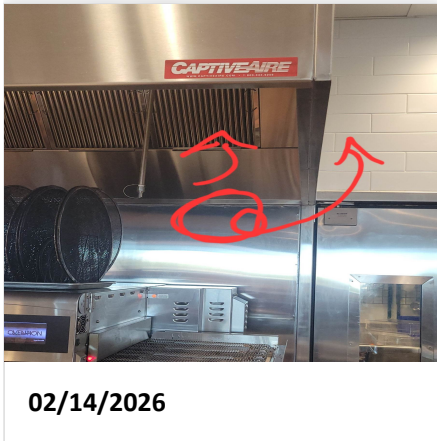
Issue Name : OVEN FAN PUSHES SMOKE OUT OF HOOD
Description : Picture shows surface smoke air flow. About half is exhausted while the other half is swirled and pushed out of the hood. The fan on the side of the pizza oven is what is pushing it out. Quarter end panel needs to be installed
Created By : National TAB **Assigned To :** National TAB - Dan Hertenstein
Status : Open
Priority : Low **Asset Tag :** HD1
Originated Date : 02/14/2026 - Christine Weale - National TAB

Quarter panel not installed.

100 - unless dual-oven on, fan blows smoke out, then 90

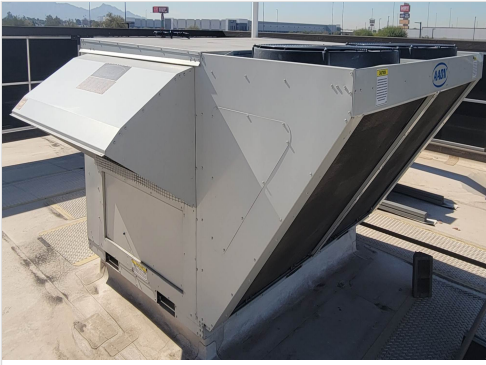
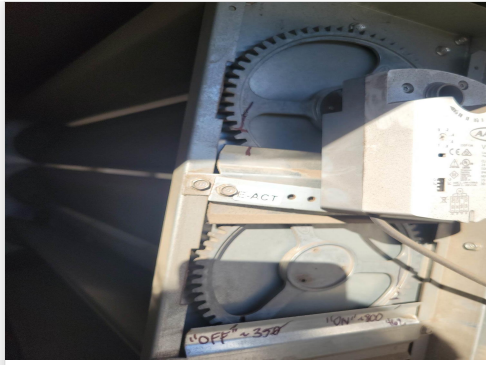
Asset: RT-3

DAMPERS COMPLETELY INACCESSIBLE, SEE 'REMARKS'. LEFT UNIT ON LOW SIDE SINCE SGRD1 & 2 ARE ALREADY SO HIGH.

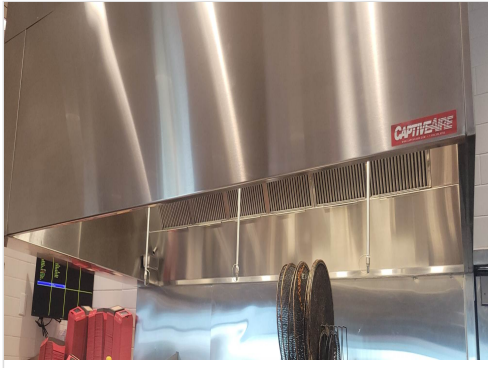
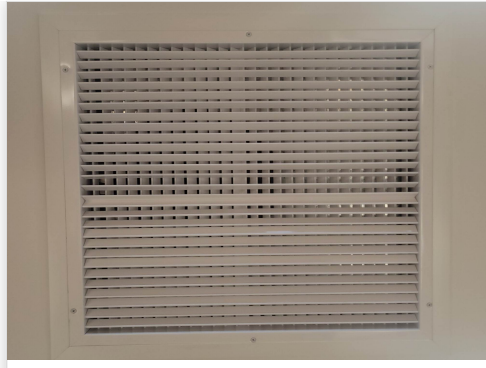
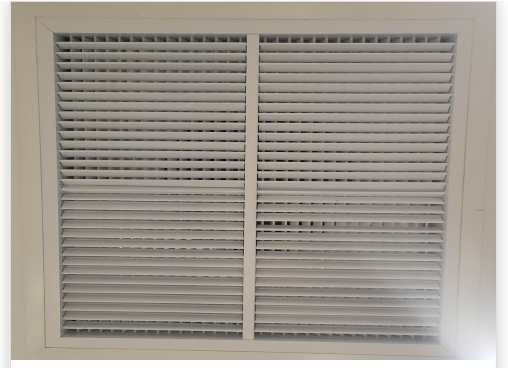
Asset: HD1

PICS OF GRILLE SHOW BEFORE AND AFTER. WHEN SET TO MSET DEPICTION, SMOKE LOSS WAS EXTREMELY HIGH MID-HOOD. HAD TO SET GRILLES ALMOST COMPLETELY OPPOSED TO HOOD TO OBTAIN 98% CAPTURE.
