Report: TAB Report
Function: Test, Adjust, & Balance
Date: 06/09/2025
Completed By: National TAB

PROJECT
06-02-25 NIKE #214 PEARL, MS

Project: 06-02-25 NIKE #214 PEARL, MS

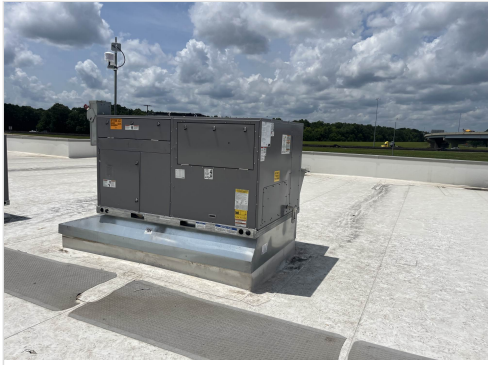
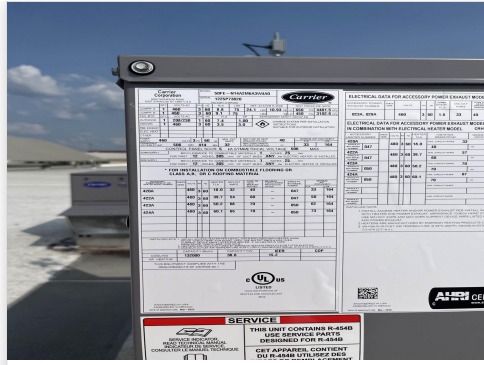
Asset: RTU3

Test Data		
	Design	Actual
SF CFM	4000	3971
SF RPM	-	1931
RA CFM	3100	3104
OA CFM	900	867
RL Voltage	-	486/483/483
RL Amperage	-	3.2/3.4/3.7
SF Rotation	-	CORRECT
SF System SetPt	-	85%
RA Damper Position	-	67%
Min OA Damper Position	-	33%
Min OA Damper Type	-	ECONOMIZER

Performance Data		
	Design	Actual
MA Plenum SP	-	-0.74"
Fan Suction SP	-	-1.37"
Fan Discharge SP	-	0.65"
Total ESP	.90"	1.39"
Fan Total SP	-	2.02"

Notes:
LOW SPEED DAMPER 49%.
