Report: TAB Report
Function: Test, Adjust, & Balance
Date: 06/09/2025
Completed By: National TAB

PROJECT
06-02-25 NIKE #214 PEARL, MS

Comfort Systems USA Strategic Accounts
2655 Fortune Circle West, Suite E

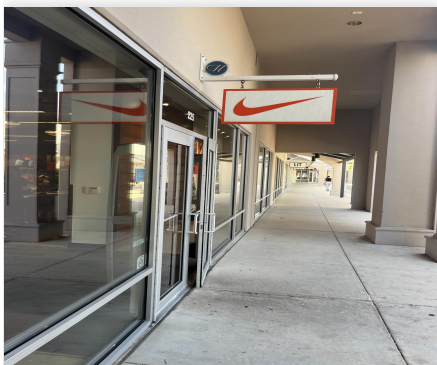
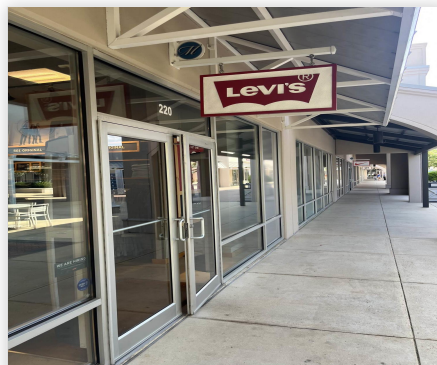
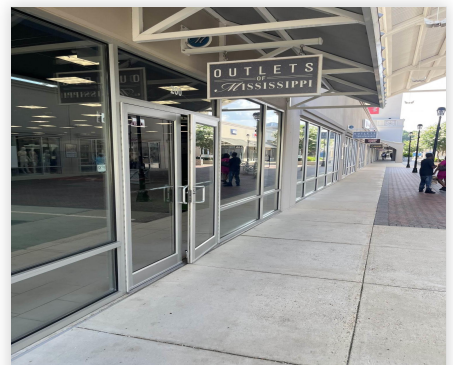
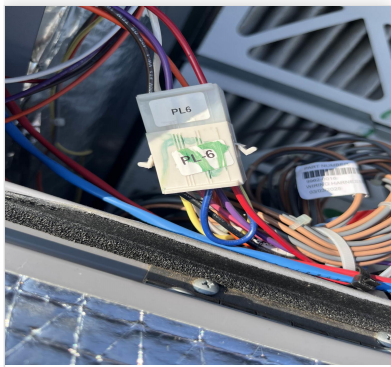
Issue Name : High Building Pressure
Description : The building pressure was found to be very high, in excess of +0.1". This is enough to hold the doors a few inches open. Under further investigation the majority of this pressure is coming from the adjacent suites in the strip mall, as even with the Nike RTU outside air dampers closed there was 0.08" of static pressure.
Created By : National TAB **Assigned To :** National TAB - Will Turnbough
Status : Open
Priority : Urgent **Asset Tag :**
Originated Date : 06/09/2025 - Stephen Tassinaro - National TAB

0.1" - SEE ISSUES ABOVE.

YES BUT BUILDING PRESSURE IS EXTREME. SUSPECTED THAT THE NIKE SPACE IS BEING PRESSURIZED BY THE ADJACENT SPACES IN THE STRIP MALL.

- **06/09/2025 National TAB - Stephen Tassinaro**
 - To minimize the negative effects of the high building pressure, the economizers were unplugged (except for RTU-4 as it brings in very little OA). The economizers were balanced and are setup within the System Vu controllers so that once the building pressure issue can be resolved, these can simply be plugged back in and will open to the design setpoints.

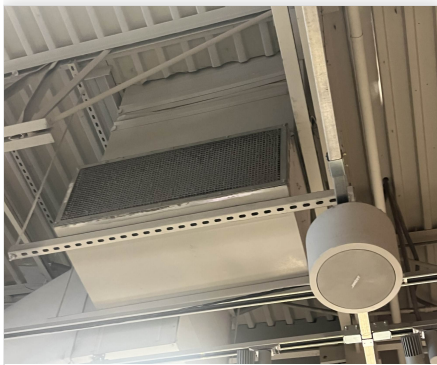
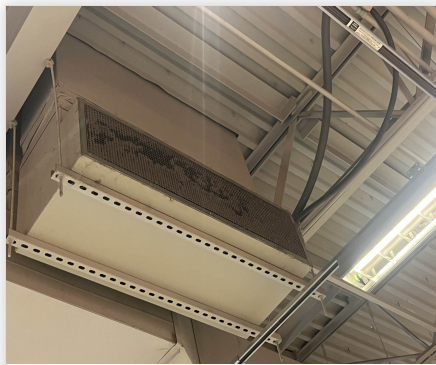
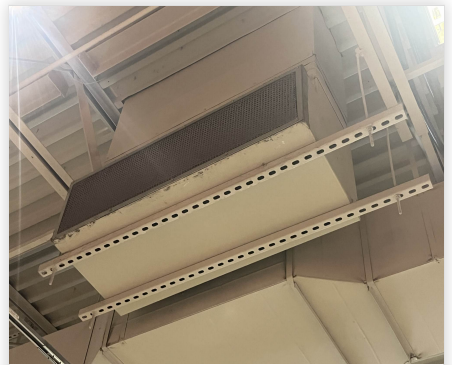
Issue Name : Return Grilles Dirty - All
Description : All return grilles were found to be dirty within the space. Cleaning recommended.
Created By : National TAB **Assigned To :** National TAB - Will Turnbough
Status : Open
Priority : Medium **Asset Tag :**
Originated Date : 06/09/2025 - Stephen Tassinaro - National TAB

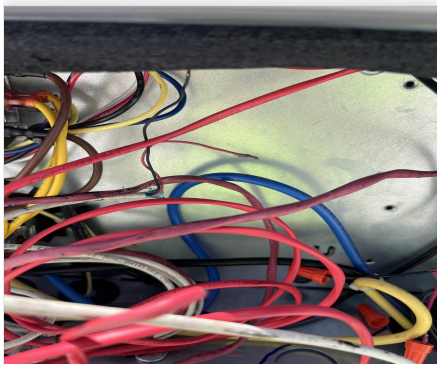
Issue Name : RTU 1 - Unterminated Wires
Description : There are several unterminated low voltage wires inside of RTU-1. Recommend further inspection to make sure non are live or critical.
Created By : National TAB **Assigned To :** National TAB - Will Turnbough
Status : Open
Priority : Medium **Asset Tag :**
Originated Date : 06/09/2025 - Stephen Tassinaro - National TAB

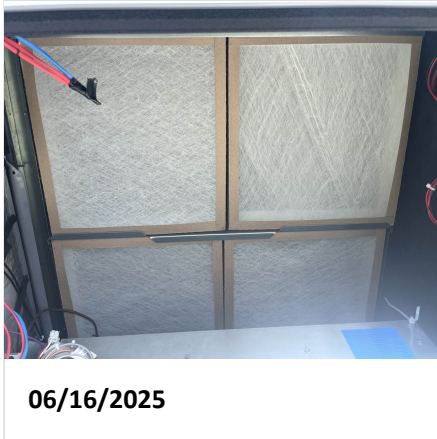
Issue Name : RTU 5 - Construction Filters
Description : Recommend replacing the factory provided construction filters with MERV 8 or greater filters in RTU-5.
Created By : National TAB **Assigned To :** National TAB - Will Turnbough
Status : Open
Priority : Low **Asset Tag :**
Originated Date : 06/09/2025 - Stephen Tassinaro - National TAB

| General | |
|---|---|
| Unit Filters Clean | CONSTRUCTION FILTERS |

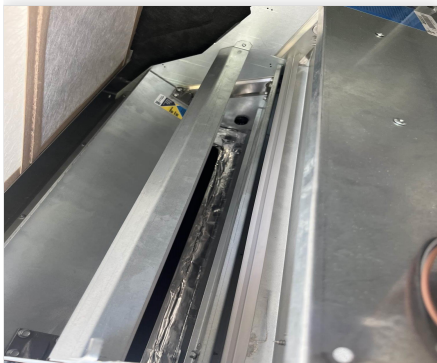
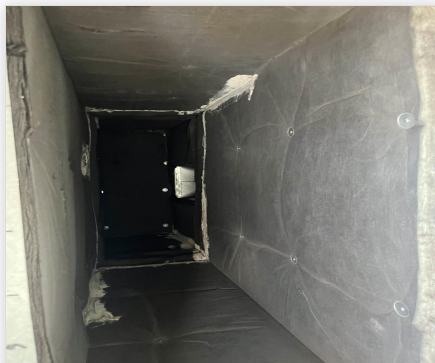
Issue Name : RTU 5 - High Static Pressures
Description : The static pressures within RTU 5 are higher than expected. Airflow was validated twice to ensure fan speed is set accurately. Mixed air compartment does appear to be somewhat restrictive with only small gaps between the return air damper leading to the return drop.
Created By : National TAB **Assigned To :** National TAB - Will Turnbough
Status : Open
Priority : High **Asset Tag :**
Originated Date : 06/09/2025 - Stephen Tassinaro - National TAB

Notes:
 LOW SPEED DAMPER 44%. / STATIC PRESSURES HIGH ON THIS UNIT DURING HIGH SPEED OPERATION. AIRFLOW VALIDATED TWICE TO ENSURE THIS WAS NOT AN ERROR. SEE ASSOCIATED ISSUE IN BEGINNING OF REPORT.

- **06/09/2025 National TAB - Stephen Tassinaro**
 - The supply drop did not appear to be restrictive. It is recommended to have the supply ductwork/diffusers inspected for restrictions. Due to time restrictions and the space being occupied, NTi was not able to identify the restriction.

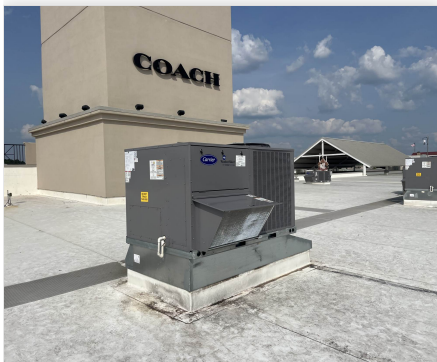
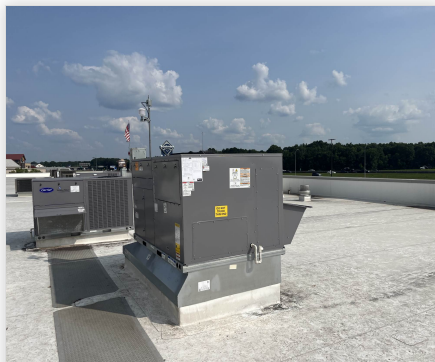
Issue Name : RTU-2 and RTU-3 Operating at FLA
Description : RTU-2 and RTU-3 are at the limit of FLA. Fan would have to be slowed down below design to see a notable reduction in amperage draw. During NTi technician's testing the amperage draw did not go down until fan speeds were set below 75%. However design airflow required at least 85% fan speed for both of these units.
Created By : National TAB **Assigned To :** National TAB - Will Turnbough
Status : Open
Priority : InfoOnly **Asset Tag :**
Originated Date : 06/09/2025 - Stephen Tassinaro - National TAB

RTU-2 AND RTU-3 AT FLA. AMPERAGE DRAW DID NOT REDUCE UNTIL FANS WERE SET AT 75% OR LOWER.
