PlanGrid Task Report - Oct 14, 2024

L04730_Homestead FSU (FL)

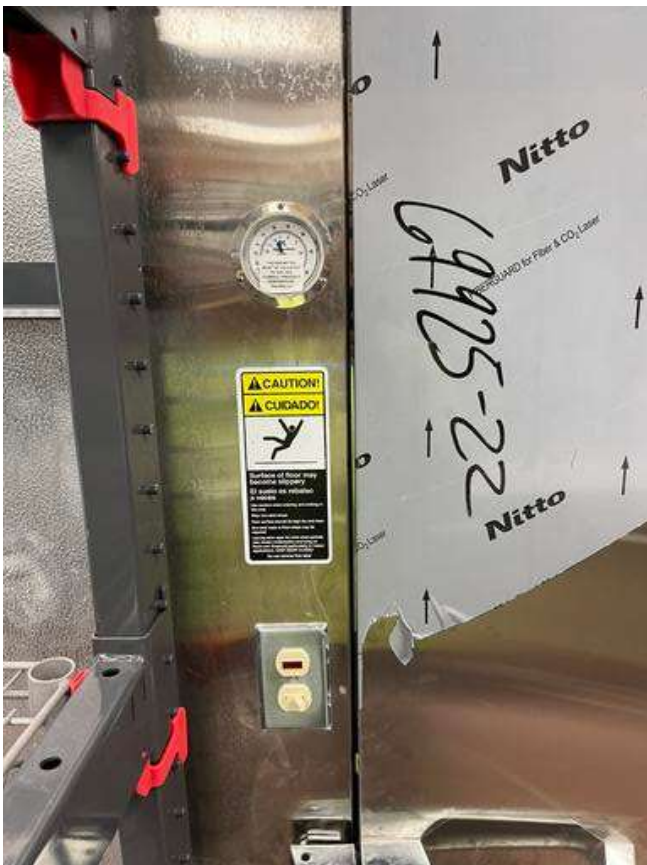
IMG_4101

WIF/WIC are not yet operational to confirm temperatures are per spec.

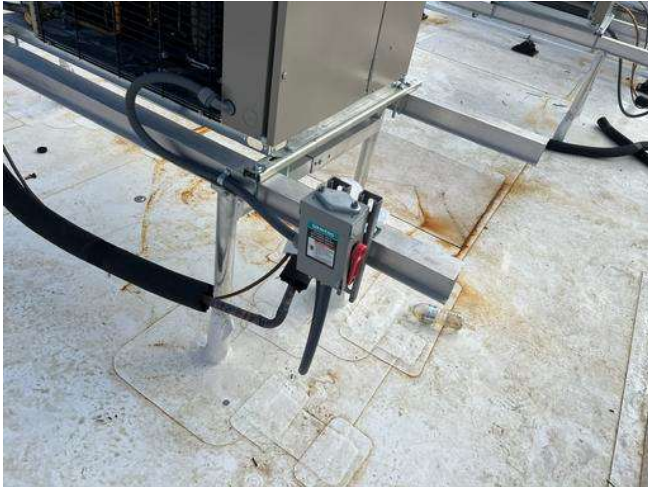
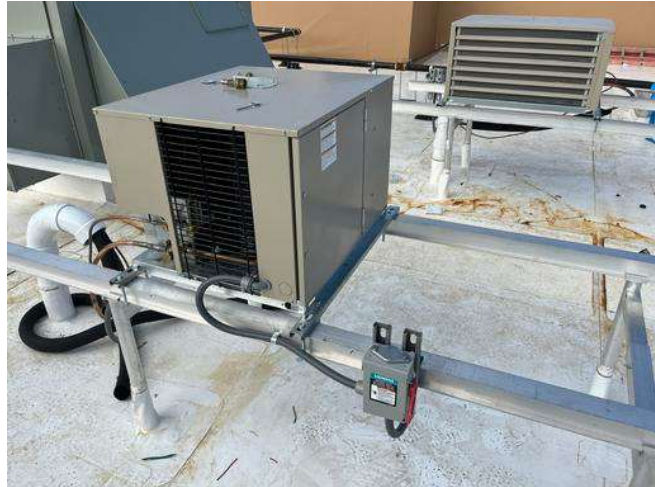
Description
Electrical disconnects are
not properly labeled.

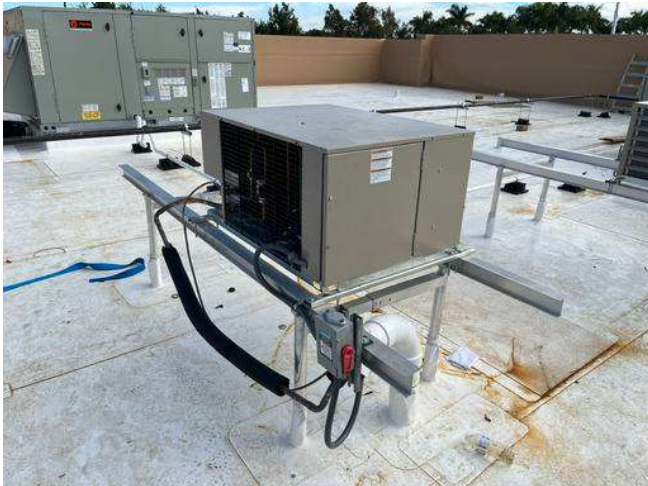
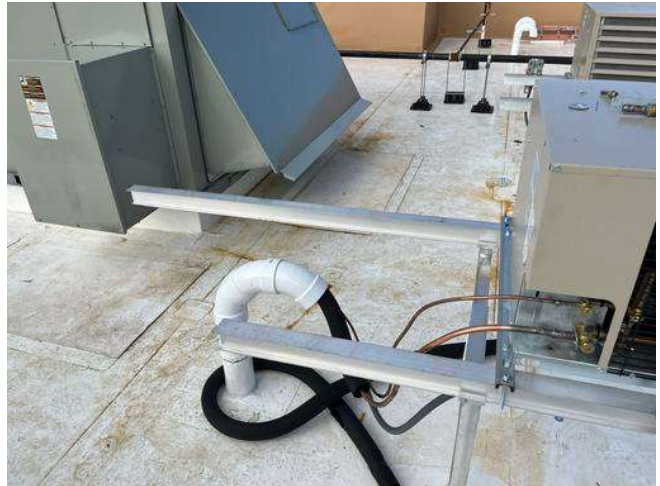
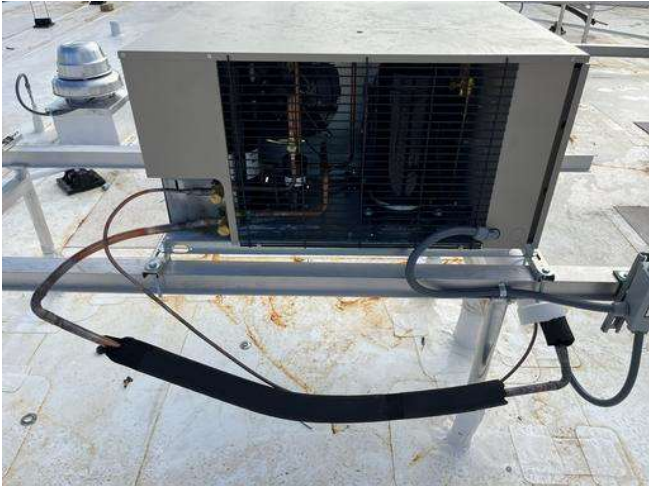
Line sets contain excessive lengths (loop traps), are not routed properly, or are not properly insulated/secured.

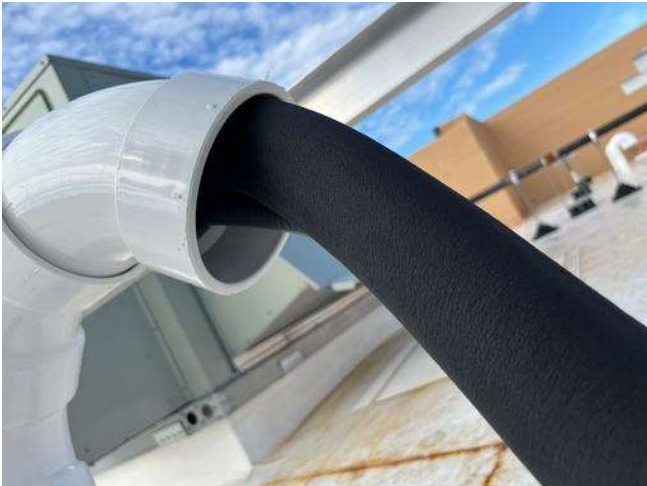
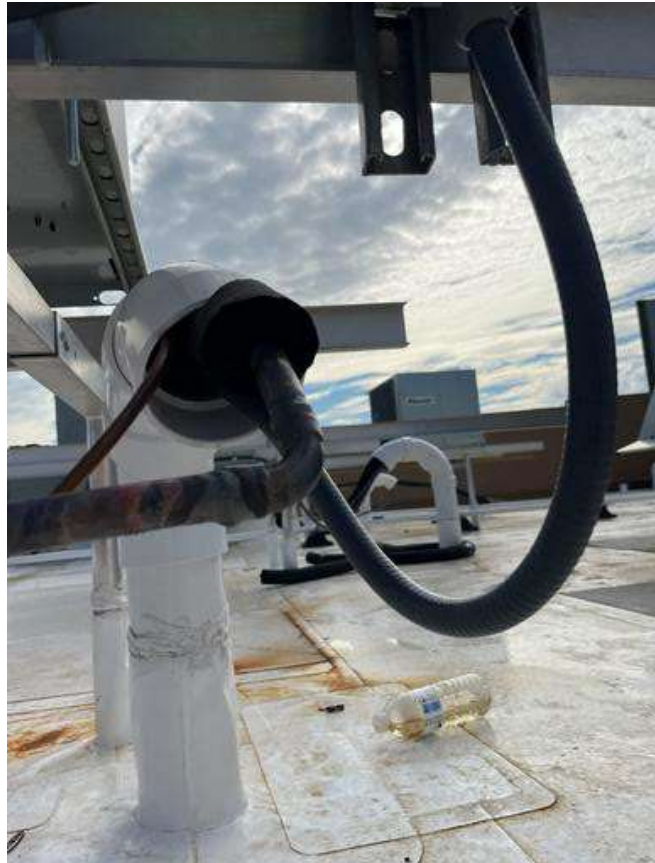
PVC pipe chase risers are not sealed with spray foam to prevent weather/pest infiltration.

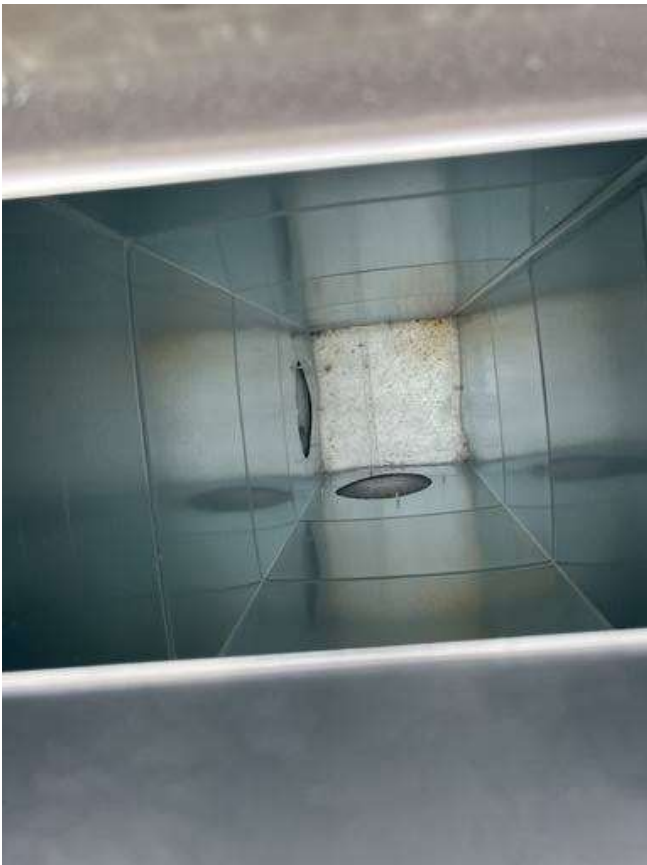
IMG_4086

Restroom exhaust rectangular duct riser not correctly lined per specification.

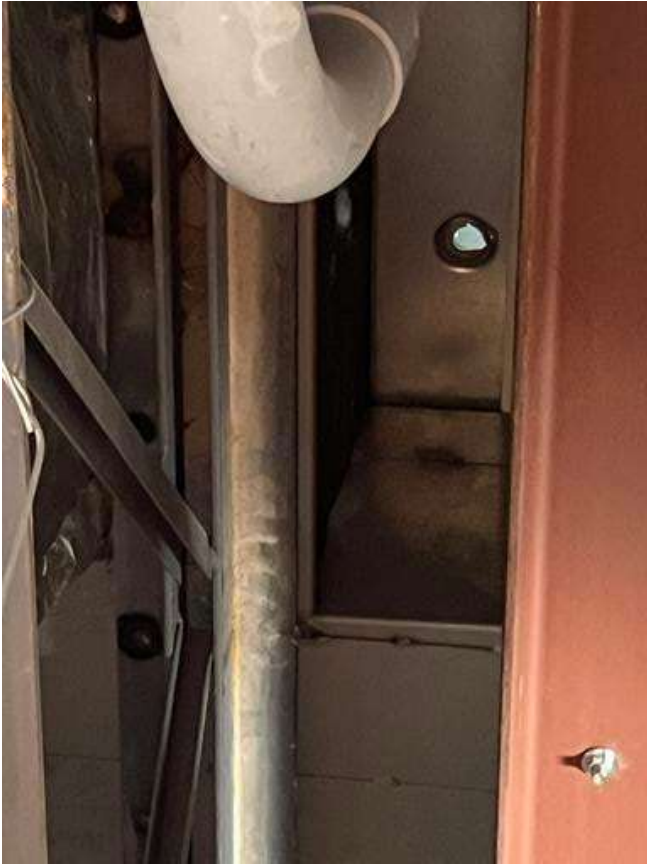
IMG_4050

There is a hole into the RTU-1 curb visible from the ceiling in the kitchen. This will need to be permanently sealed. As there have been multiple leaks found it is recommended to thoroughly inspect all curbs and all drops for leakage.

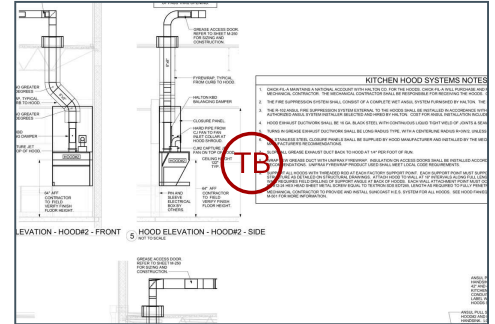
Sheet
M-301

Grease duct is not wrapped with UNIFRAX FYREWRAP as per mechanical plans.

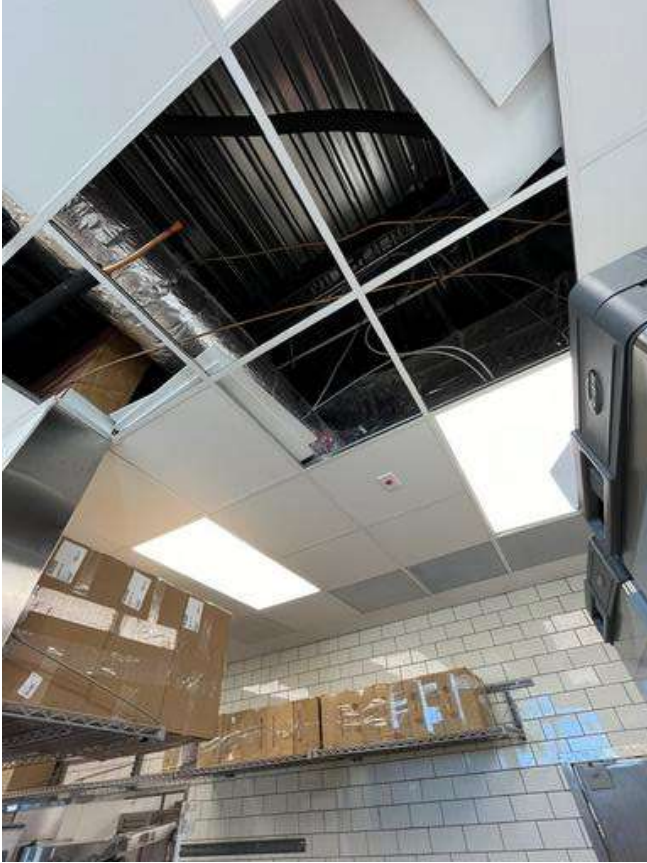
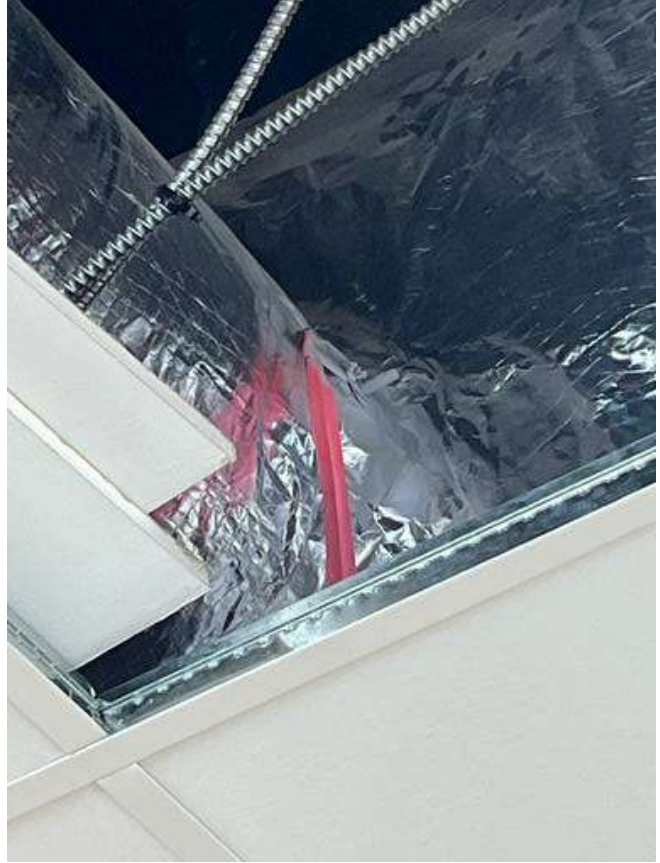
RTU 2 Diffuser 4 damper is rattling and moving around. The diffuser has been set to design and handle locked down, but the damper shaft & blade continue to oscillate. Damper will need to be serviced or replaced. Recommend setting damper to full open once resolved.

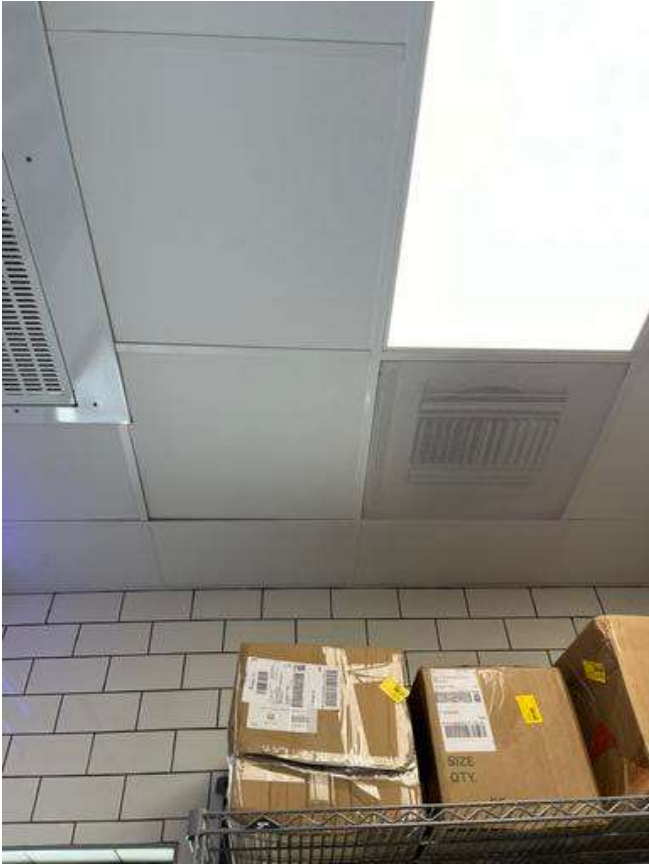
IMG_4030

RTU 2 Diffuser 7 is outputting design airflow but making a noticeable rattling noise. Damper is adjusted to design and locked down, there is no movement on the damper shaft. Recommend MC investigate inside of ductwork to resolve the noise, without adjusting the damper.

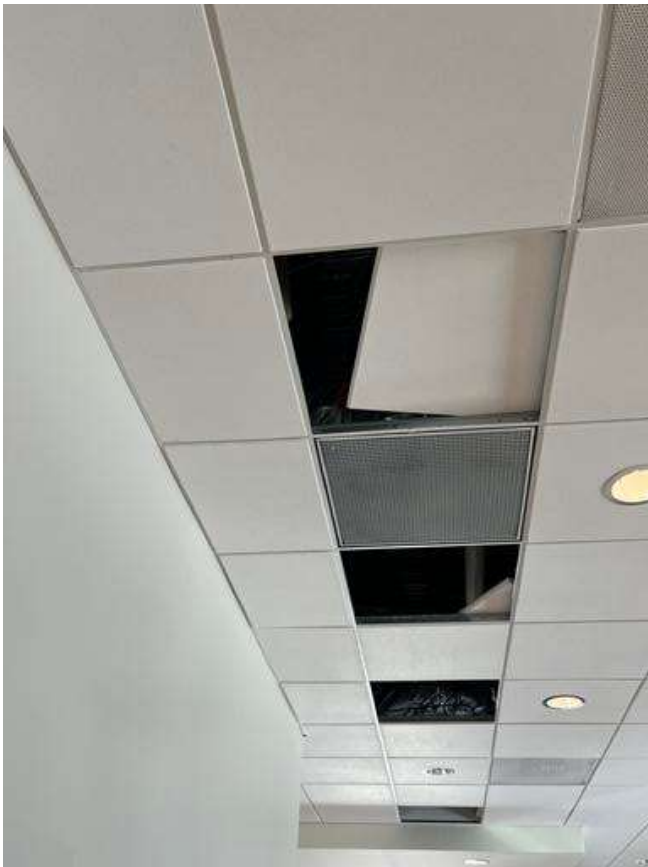
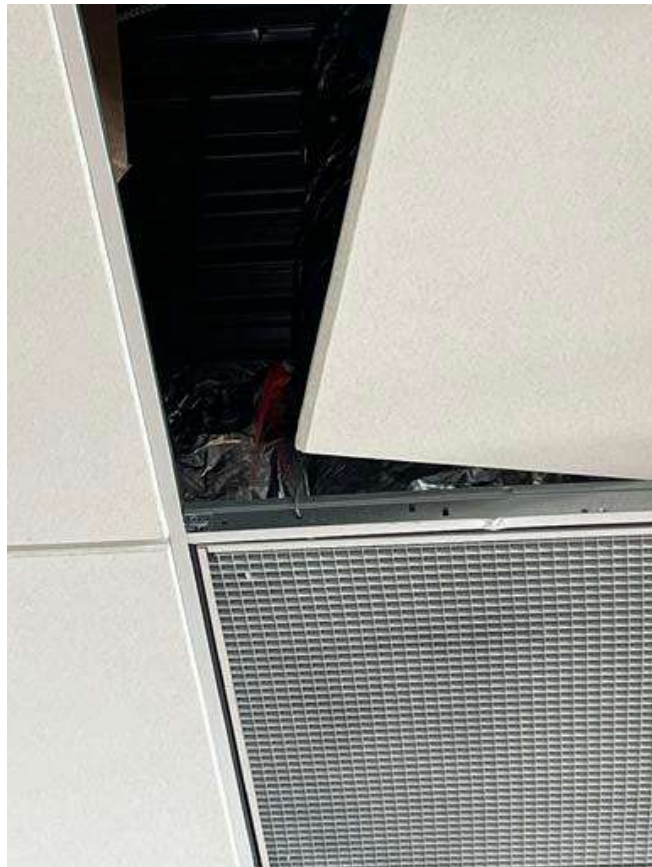
Description
Return damper is bound in partially closed position. This will need to be freed and opened.

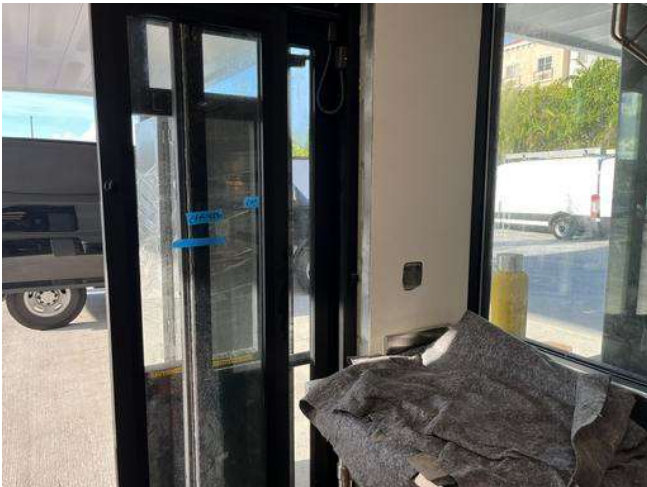
IMG_3990

Air curtain remote switches are not installed or do not control curtain functions properly between modes (fan on / auto, heat on / off) at time of TAB inspection.

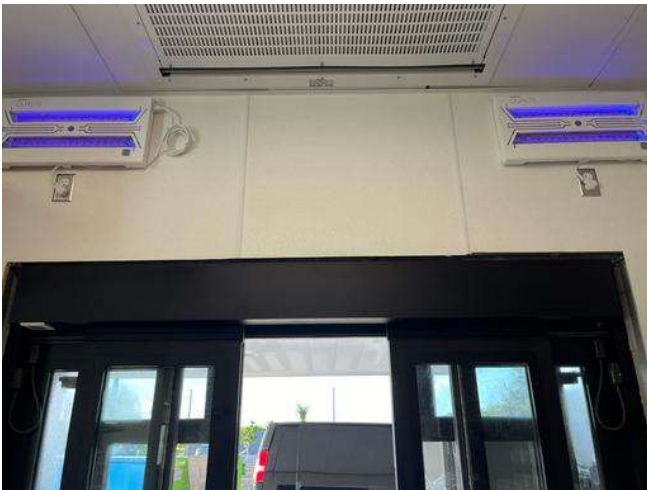
IMG_3991

Diverter box not installed.

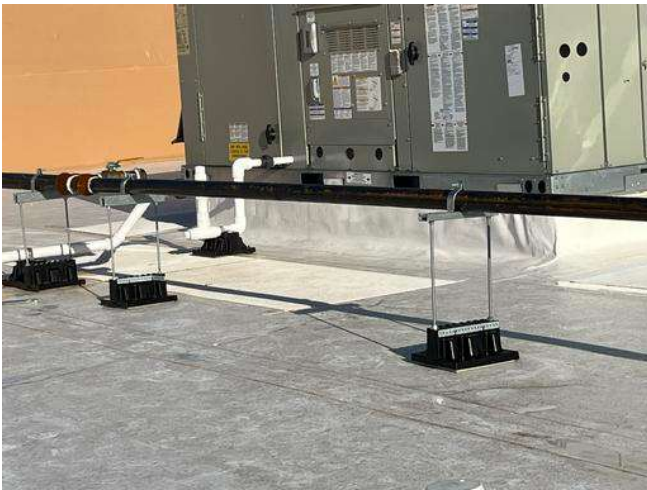
IMG_3998

Equipment gas piping is not complete. Ensure that piping is painted once completed.

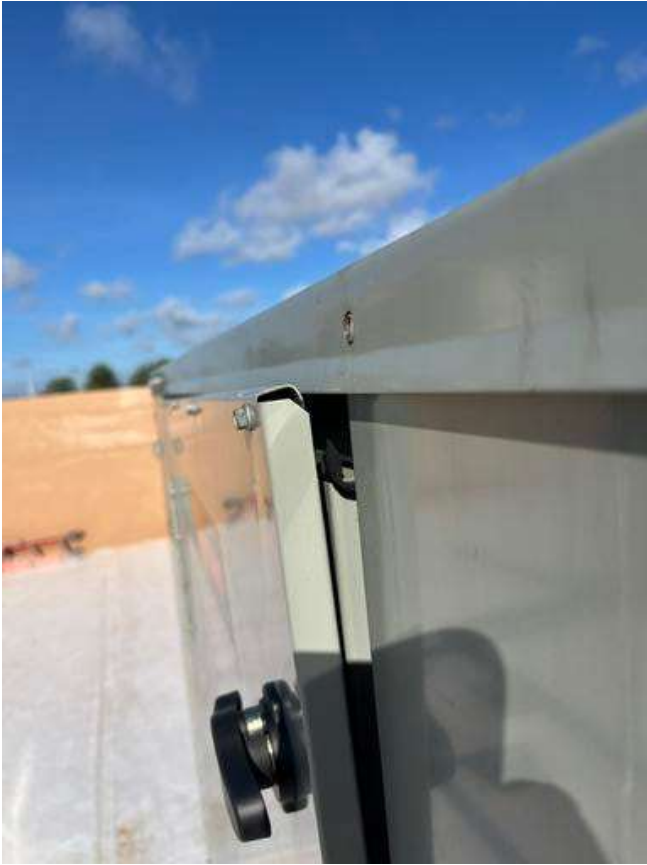
IMG_4006

The final filter & economizer access door on RTU 3 gets caught on the top panel of the RTU. This makes it impossible to open or close the door without prying. Recommend re-aligning door.

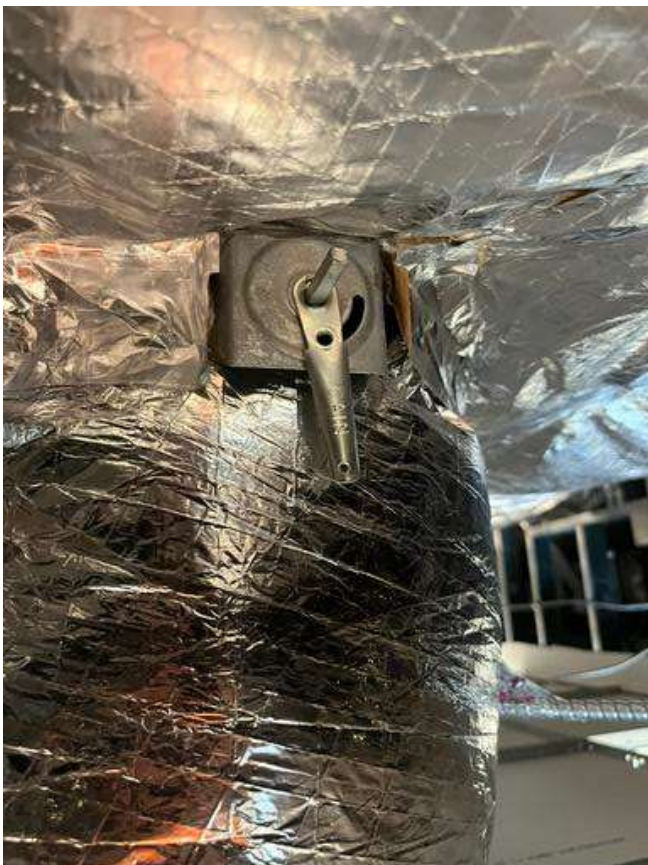
Description
SGRD3-5 Damper handle is missing hardware to lock the damper position in place.

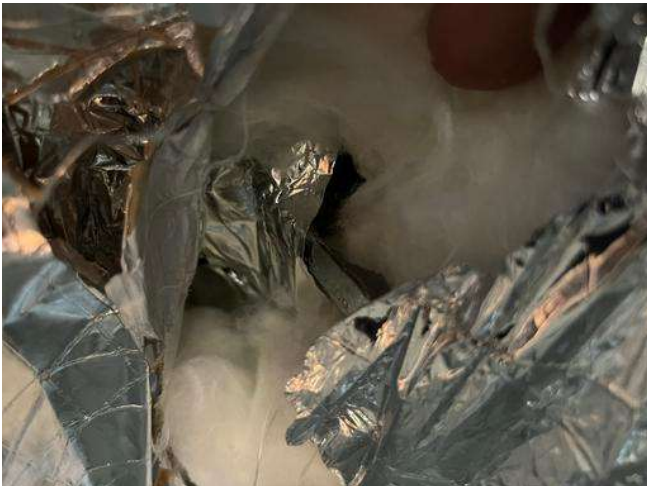
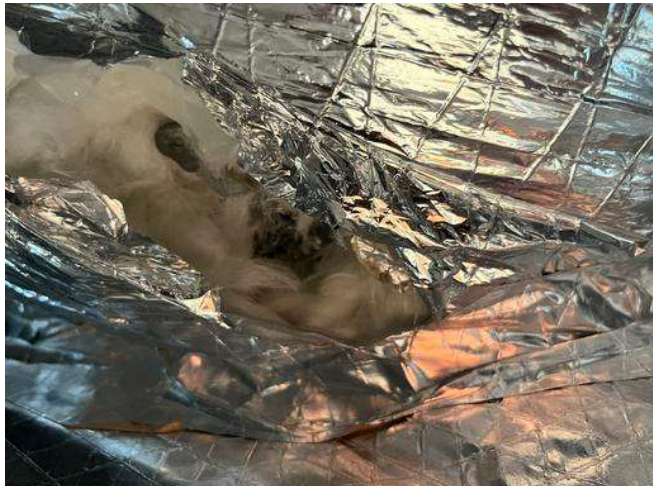
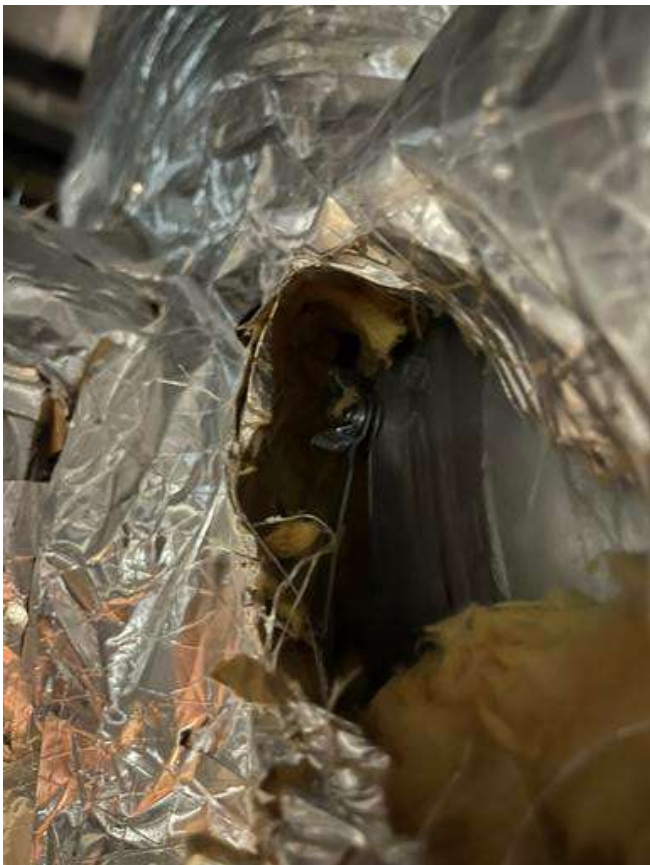
Dampers observed on RTU 1 & 3 Return of wrong type with incorrect standoff. Contact national account provider for replacements. 1 incorrect damper on RTU 1 and 2 incorrect dampers on RTU 3.

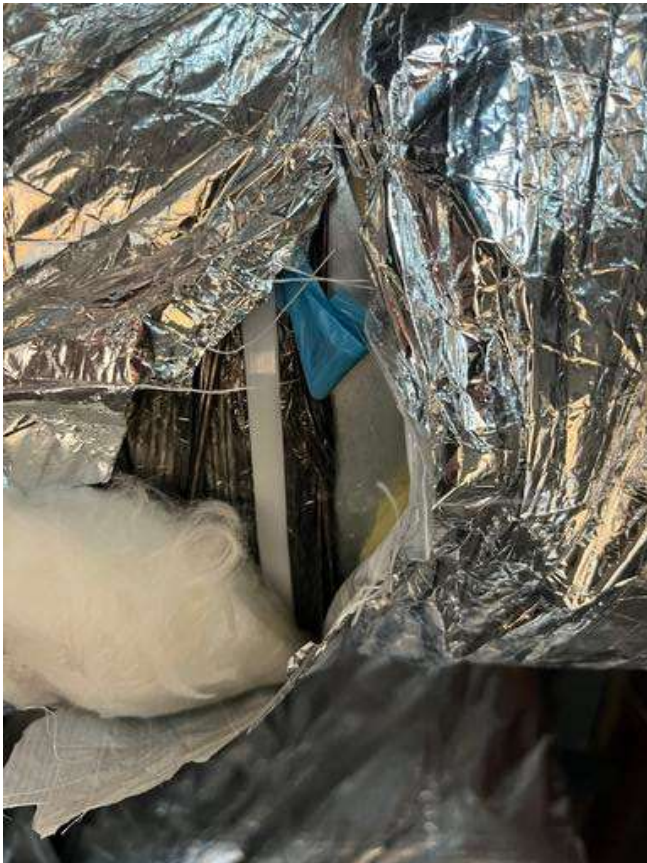
Ensure flex inner core is taped and banded, along with tape or banding on outer insulation jacket. Inner cores are not taped, only banded.

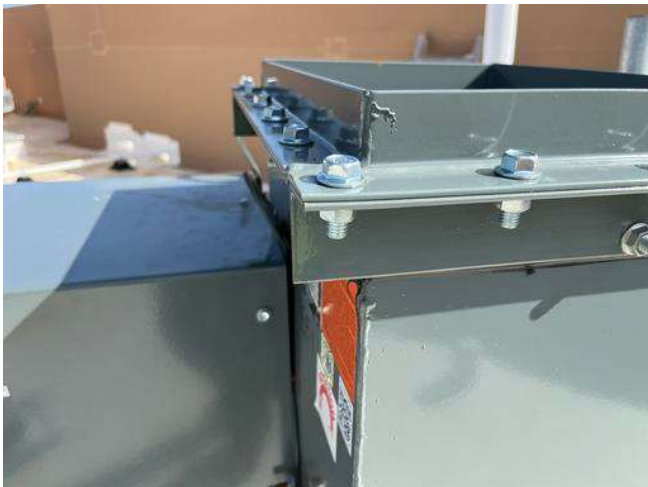
IMG_3974

Exhaust fan discharge nozzle is not constructed to kitchen hood exhaust fan detail or is not welded to discharge flange.

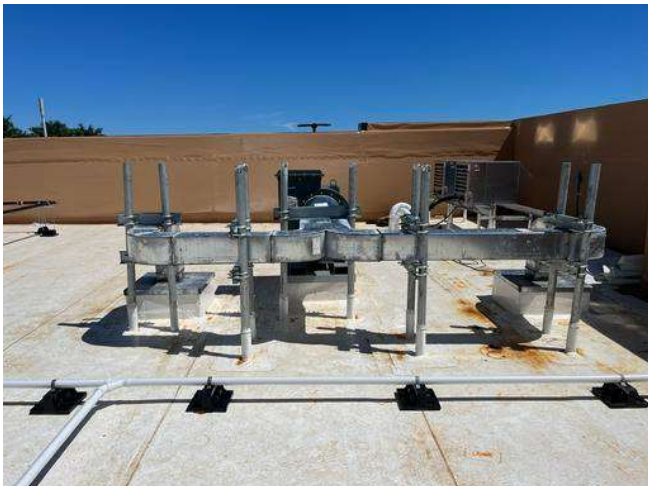
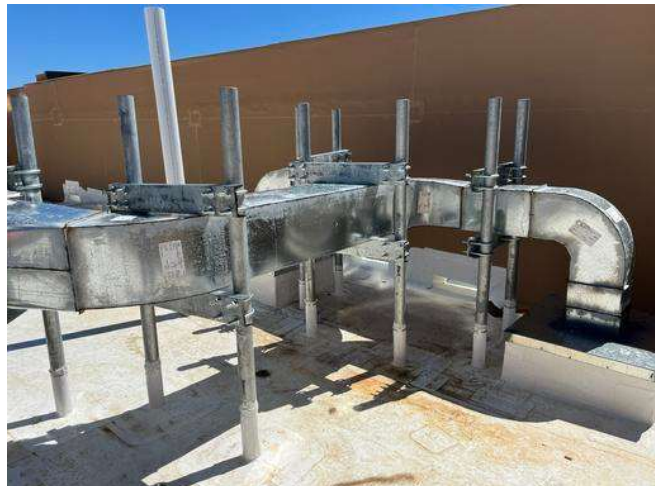
Miro brand duct supports not used. Supports are now making good contact with the grease duct to support it.

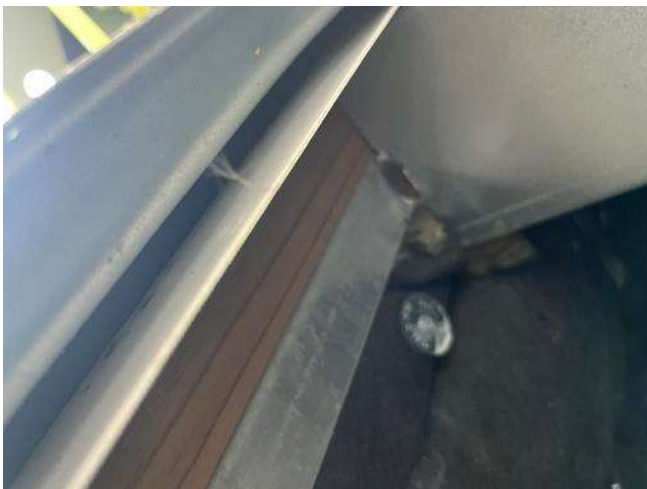
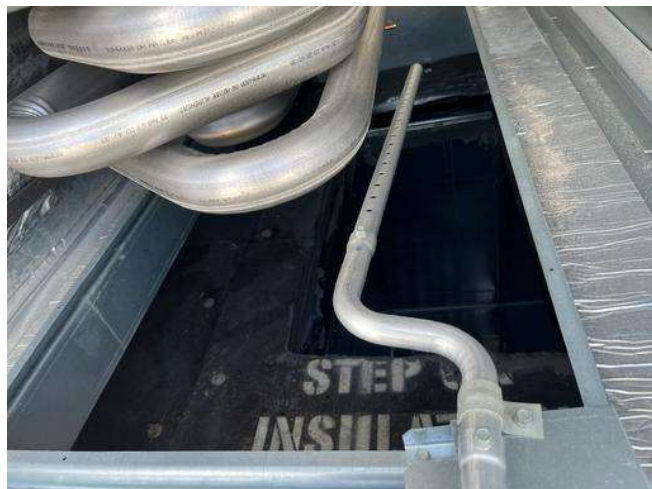
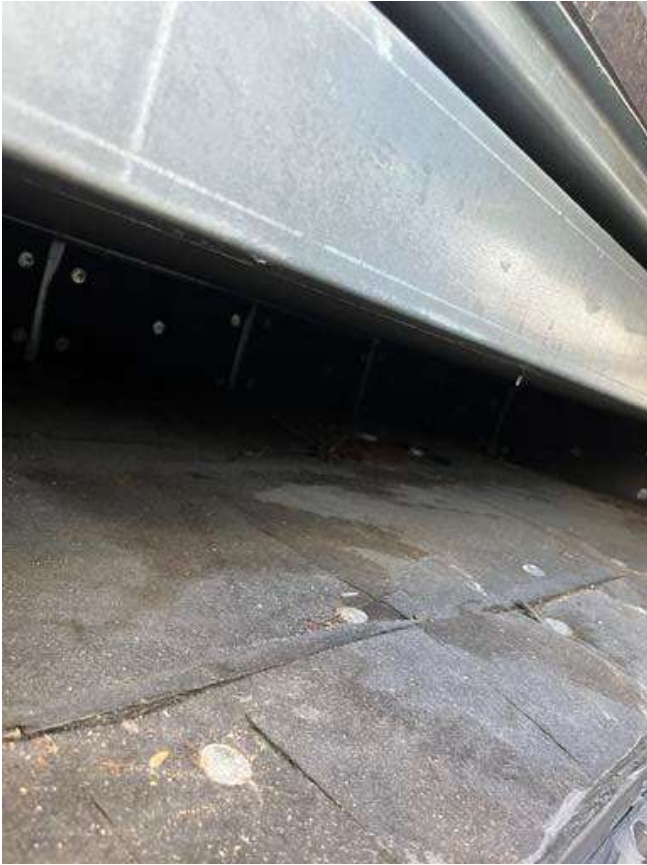
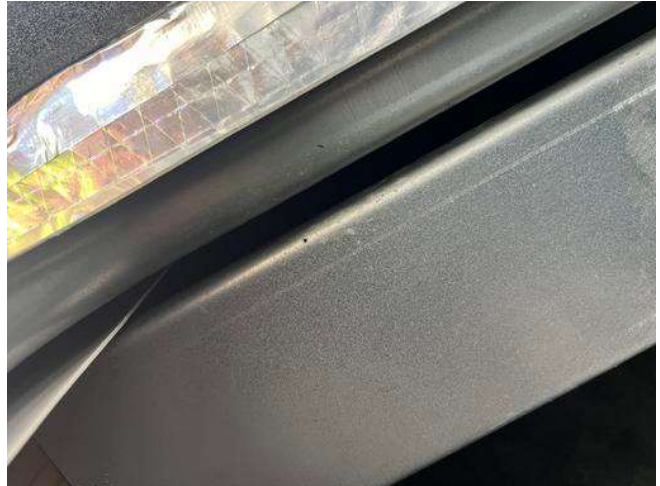
The mechanical plans call for standard 14" curbs to be used. Instead plenum curbs have been installed. If the units can be reset (and resealed) to resolve the leakage issues, CFA and the ME will need to approve this change.

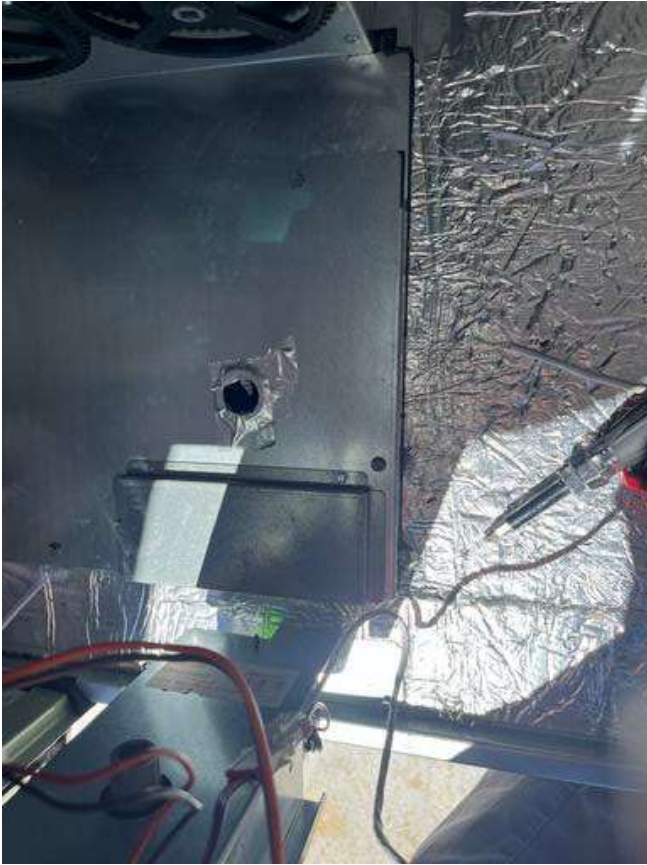
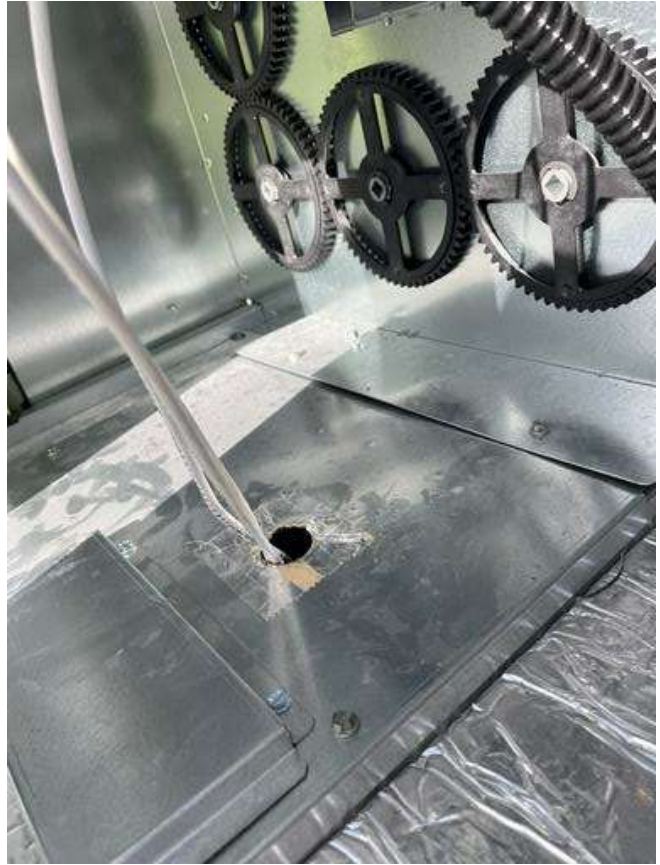
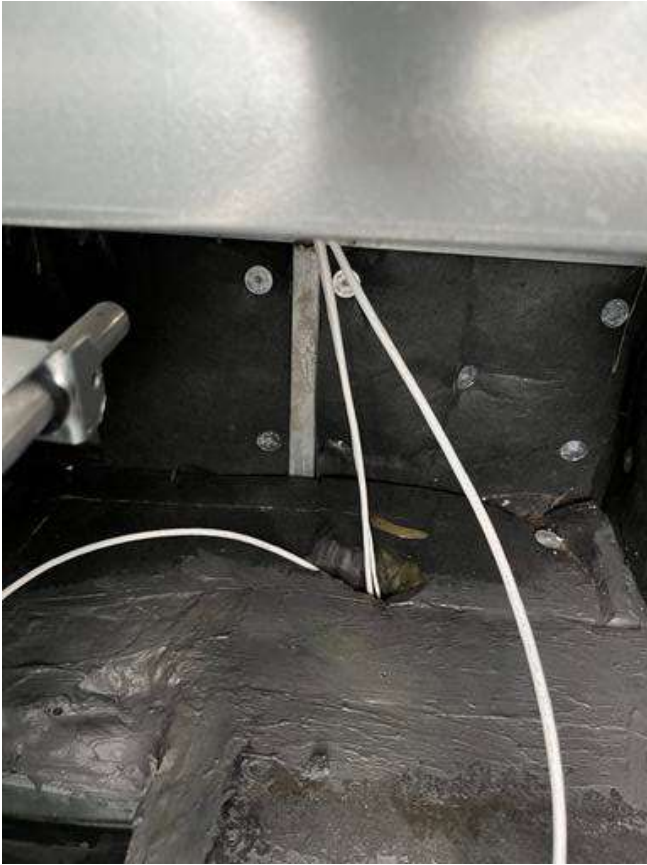
The low voltage wires are ran through the return drops. It is not recommended to run any wires through any of the ductwork.

Wires removed. Ensure all previously drilled holes are permanently sealed.

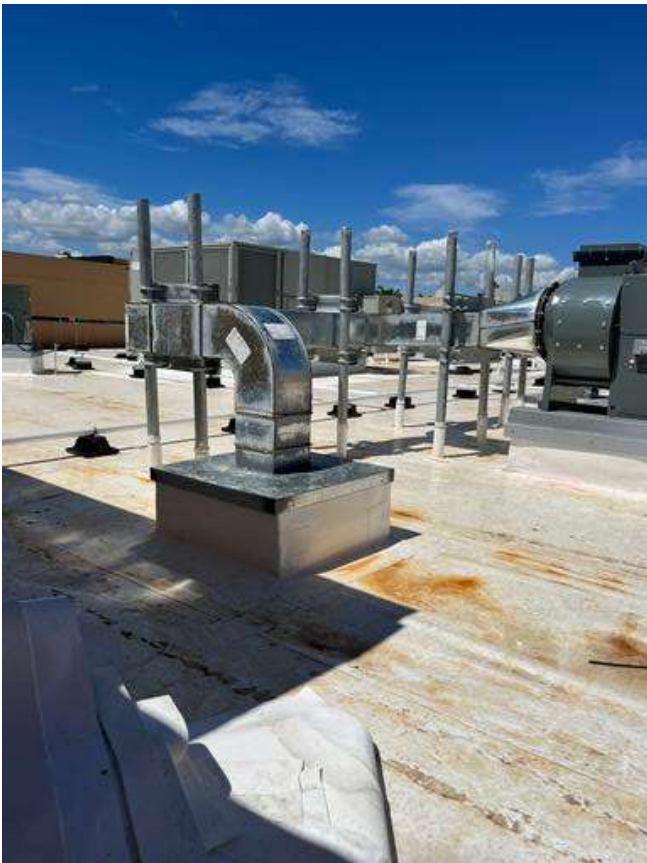
20241002_134647_photo

Access doors are missing or not constructed properly in grease ductwork.

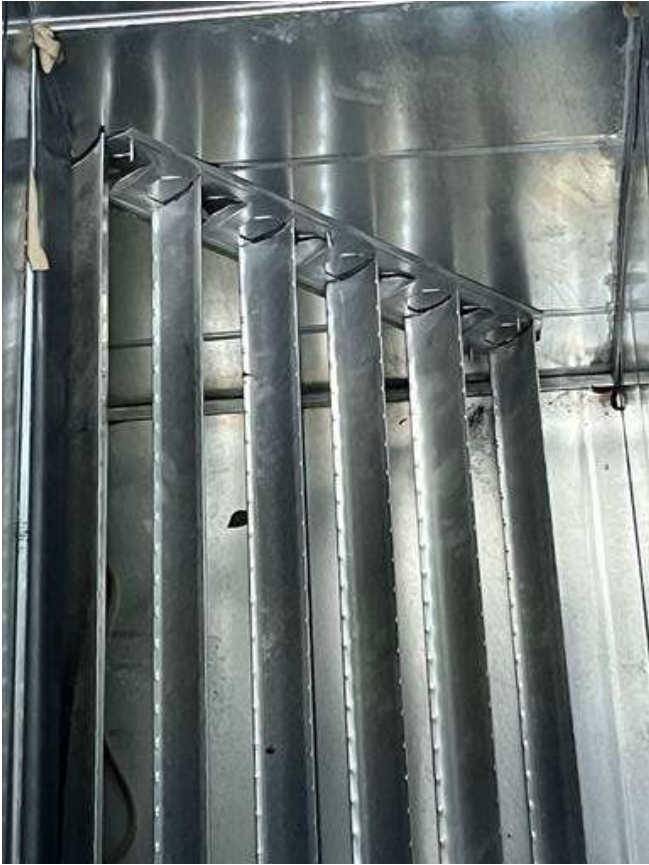
IMG_3978

Double thickness turning vanes are present in the system. Per specification only single thickness are to be installed in 90 degree turns where any dimension is greater than 12". Duct is not designed to accommodate the static drop across double thickness vanes. Remove and replace. Unable to balance system until corrected.

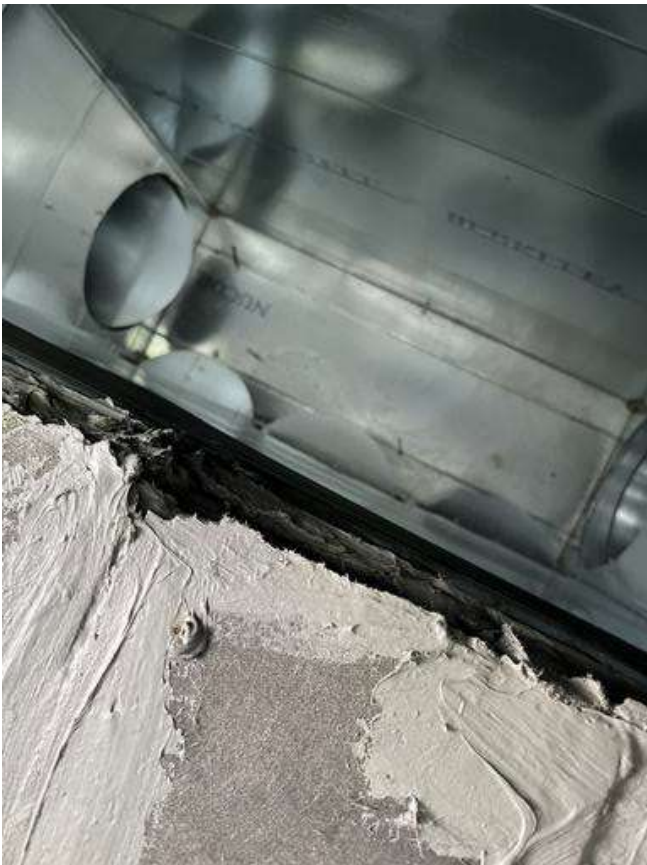
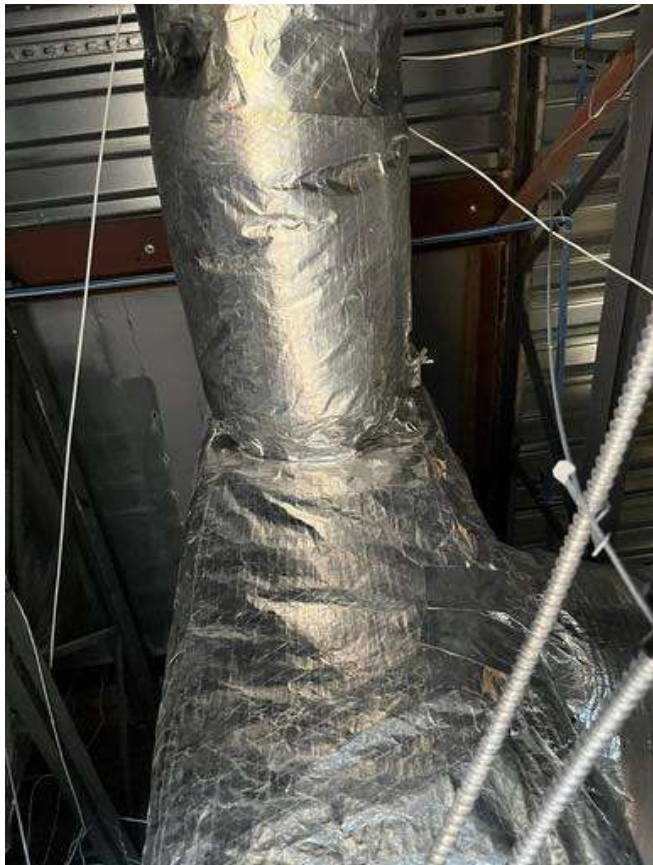
RTUs 1 & 3 Returns -
Dampers to be installed
parallel to airflow. On vertical
ducts position damper on
bottom only (6 o'clock).

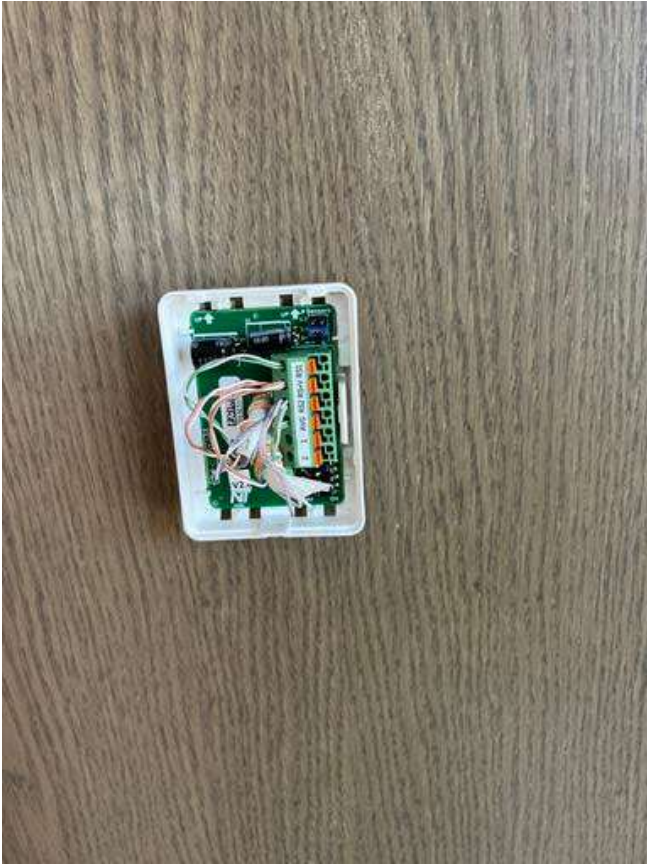
IMG_3957

(Averaging) Sensors not communicating properly, check for correct terminations, correct dip switch / jumper settings, and shorts to ground. RTU 3 (Dining) - Sensor #2, #3 and #4 not communicating.

MC diagnosed a broken wire between two of the sensors, as there is no continuity. MC working to replace wire.

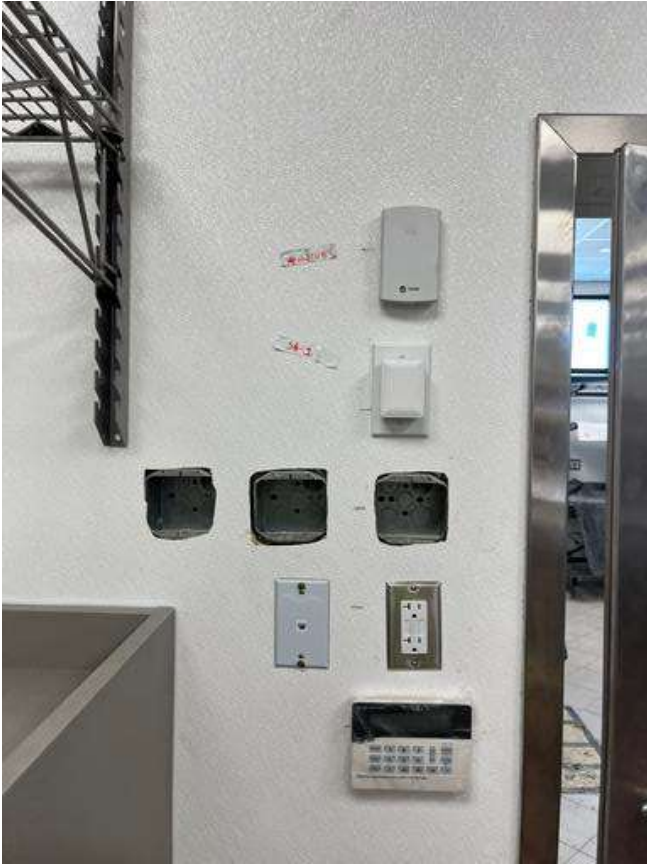
IMG_3961

Label all sensors, humidistats, thermostats, smoke annunciators and remote space mounted OADs, MODs, VFD's for which piece of equipment they serve.

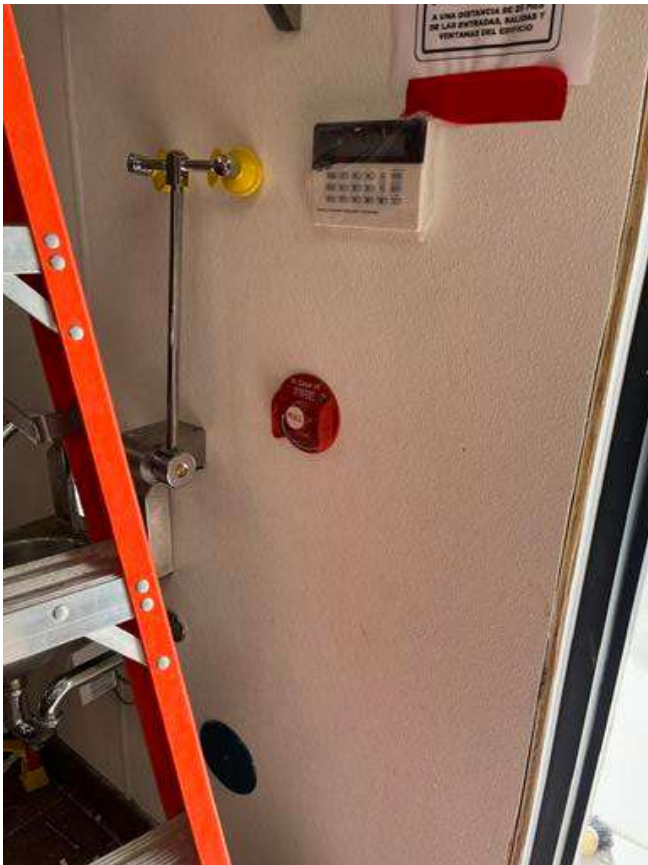
IMG_3962

Label all ansul pull stations for which hoods they serve.

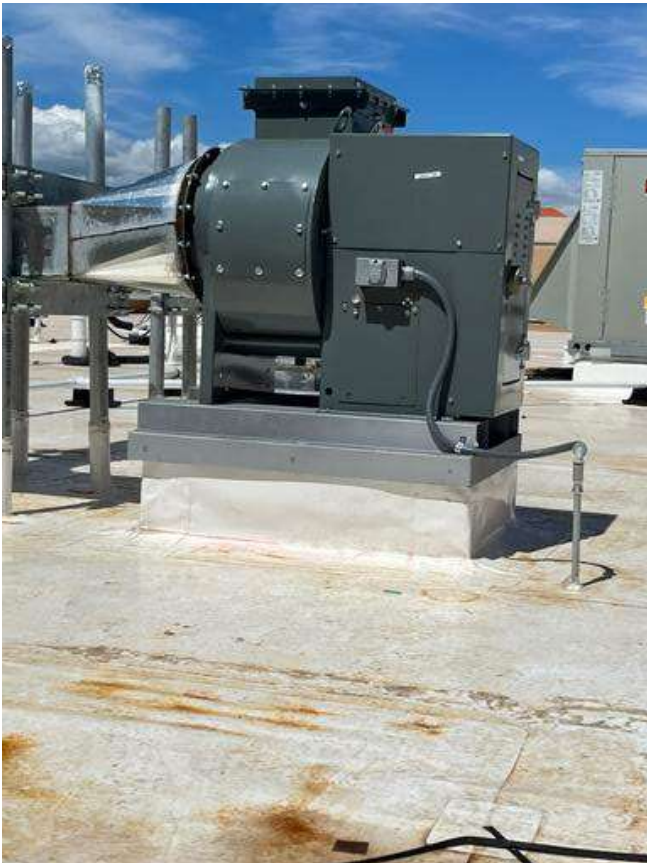
20241002_134735_photo

Exhaust fan drain is not properly installed, pitched, or routed to center of drip guard per detail. If gas piping is used, will need to be painted for rust protection.

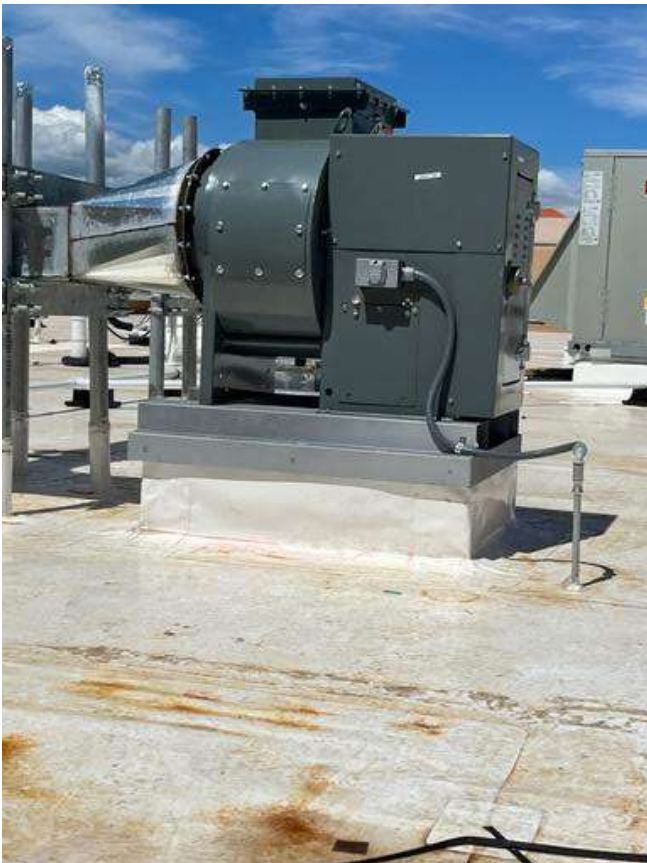
Exhaust fan G2 Drip Guard is not installed correctly or is missing.

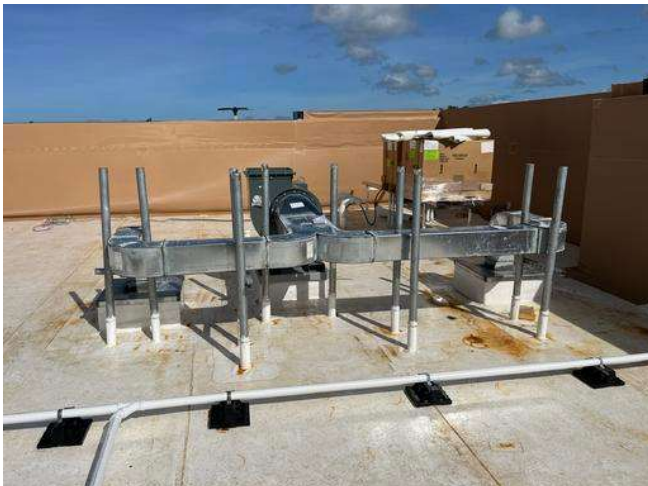
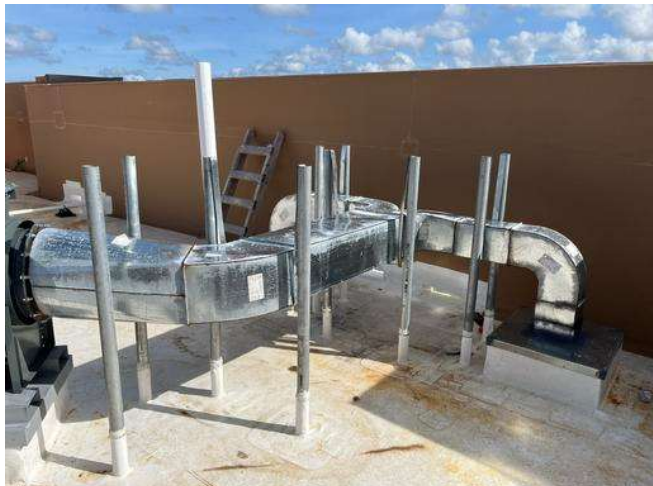
Exposed grease exhaust duct is to be painted per specification on kitchen hood exhaust fan detail.

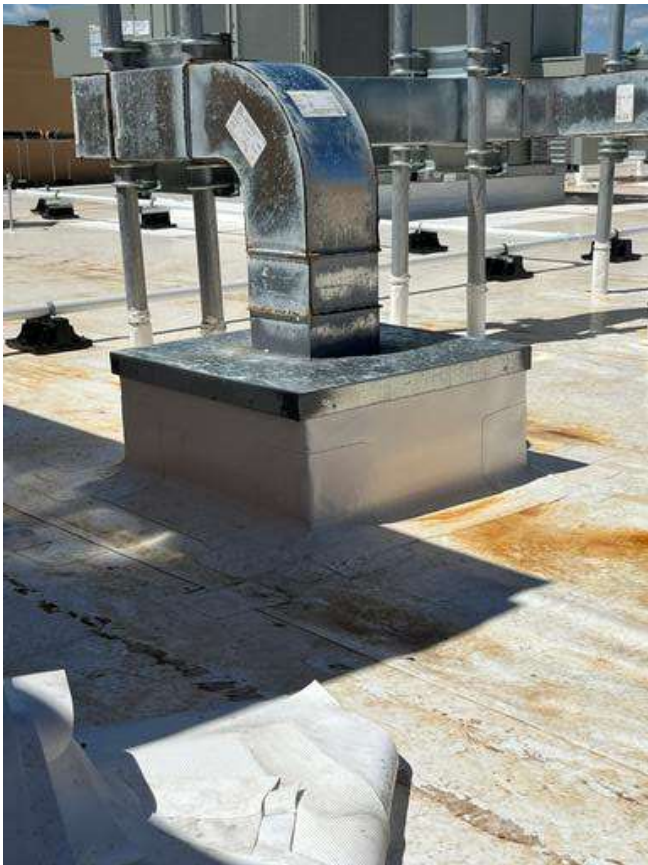
20241002_134821_photo

Grease duct curb cap is to be screwed at all corners along with a full perimeter weld between curb cap and duct.
