PlanGrid Task Report - Oct 14, 2024

L04730_Homestead FSU (FL)

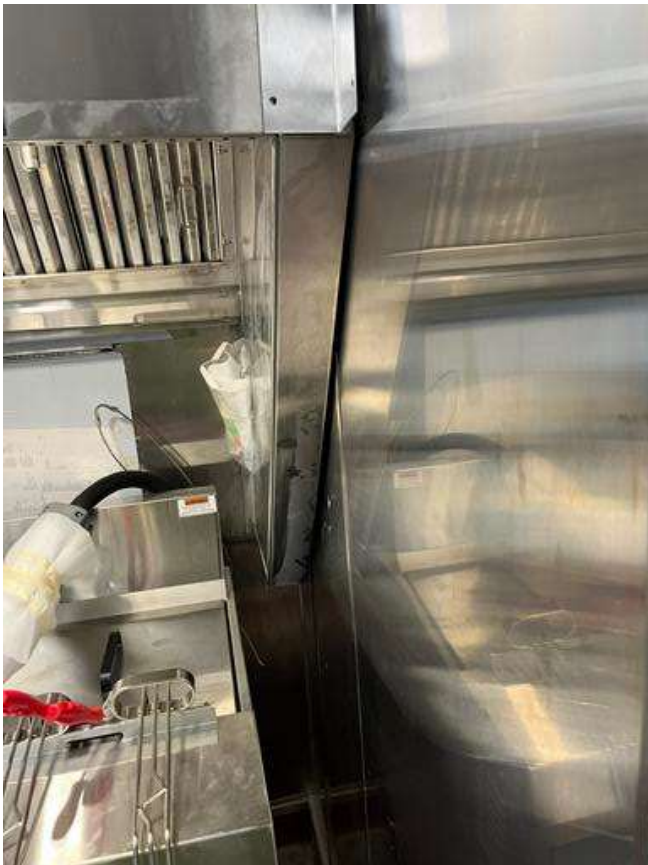
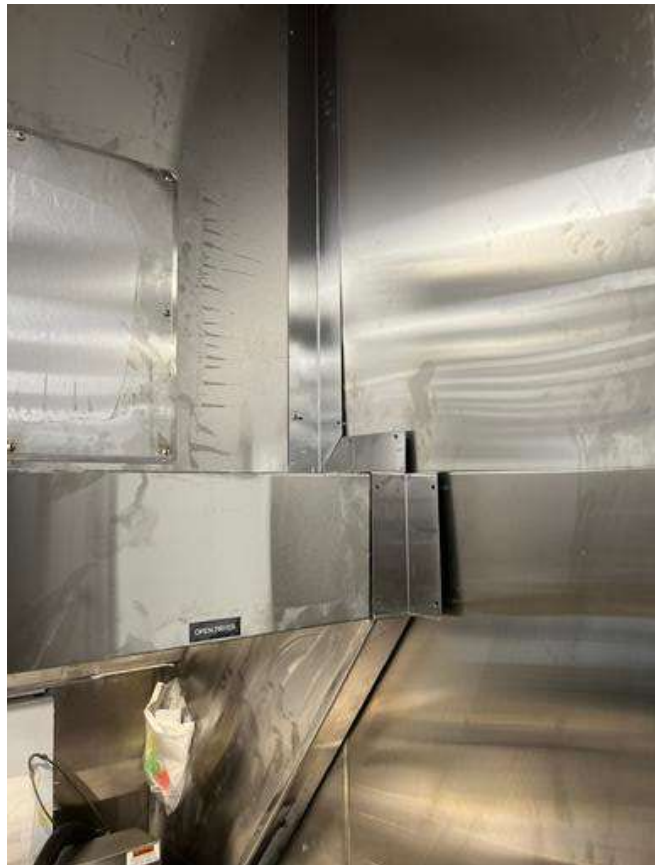
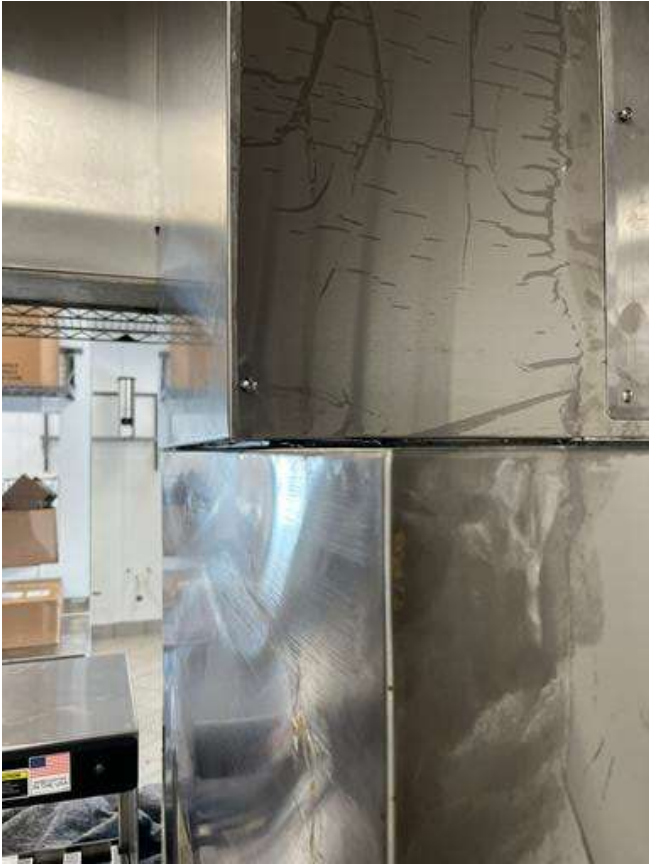
Hood 2 shroud
misalignment. See Pictures.
Also not mounted flush to
side wall.

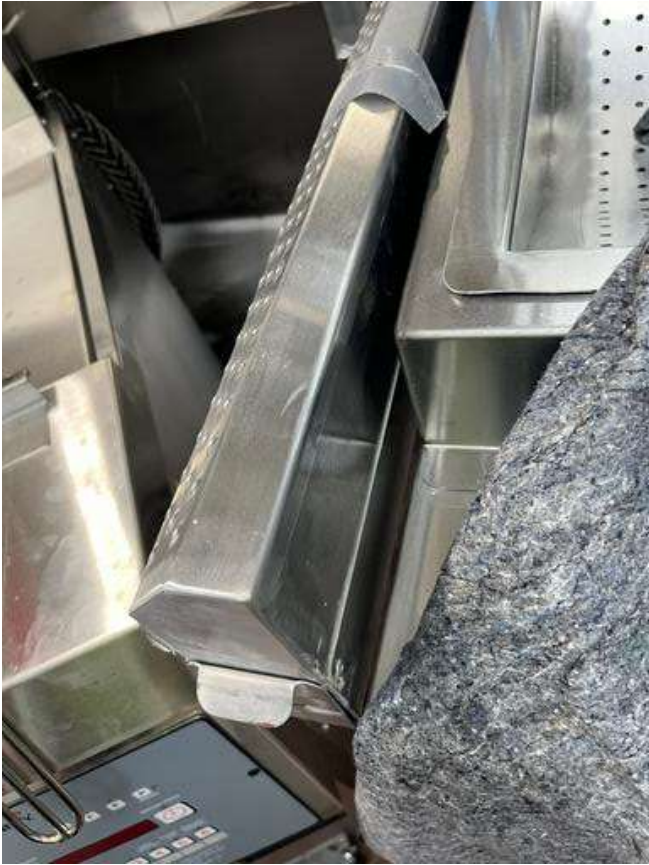
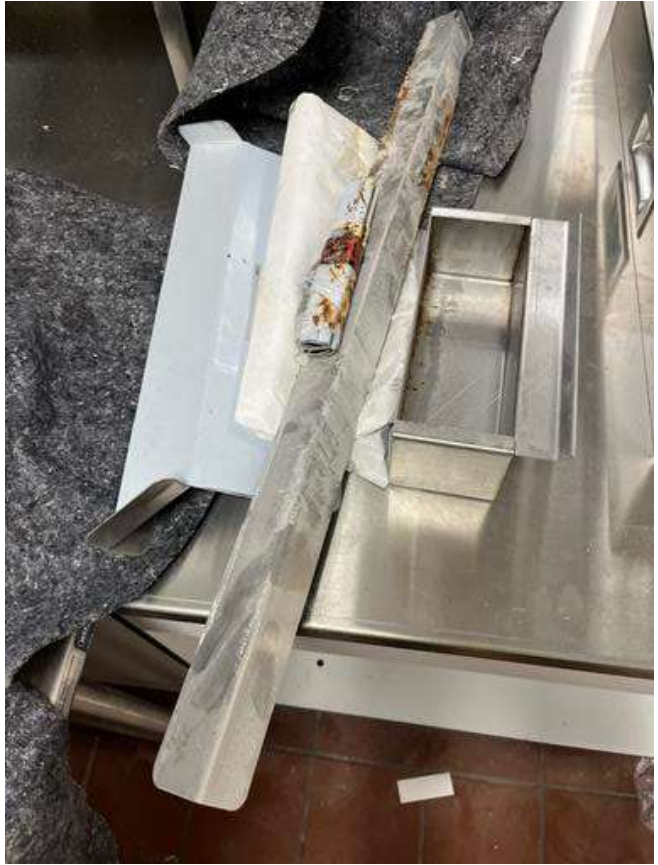
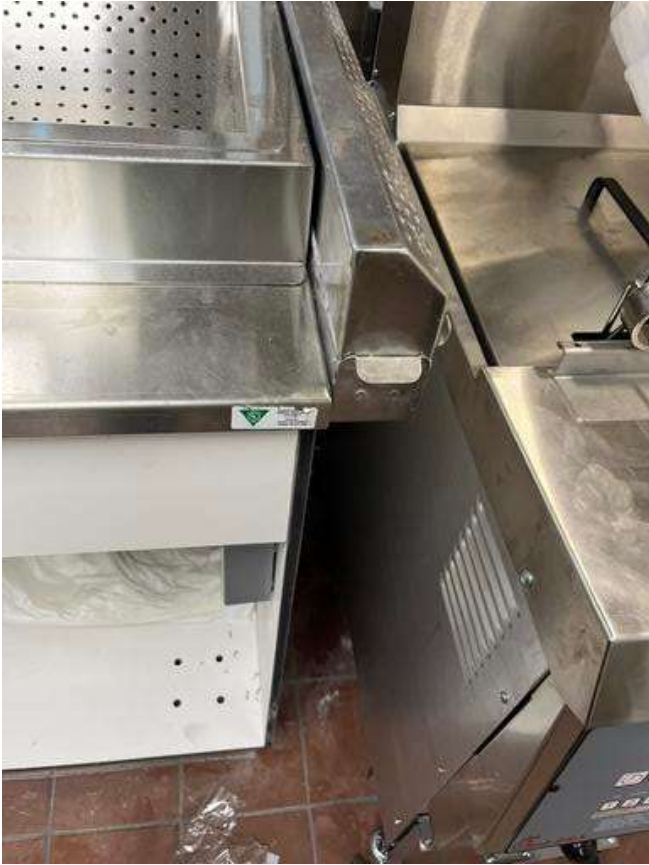
The Halton supplied angle bracket that connects the integral sidejet arm to the counter is missing or not installed correctly. Secure bracket to arm and bracket to counter underneath removeable fry dump via stainless steel rivets.

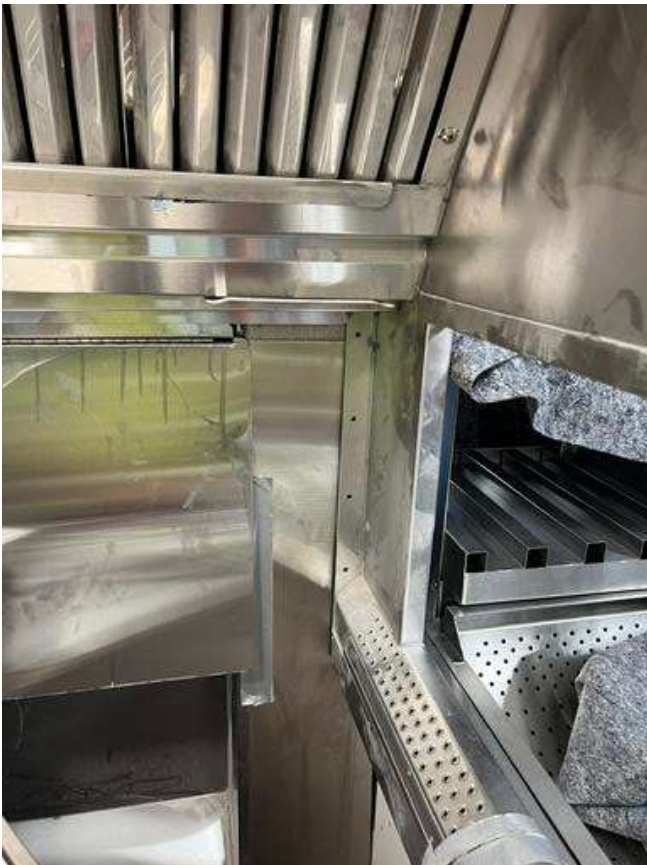
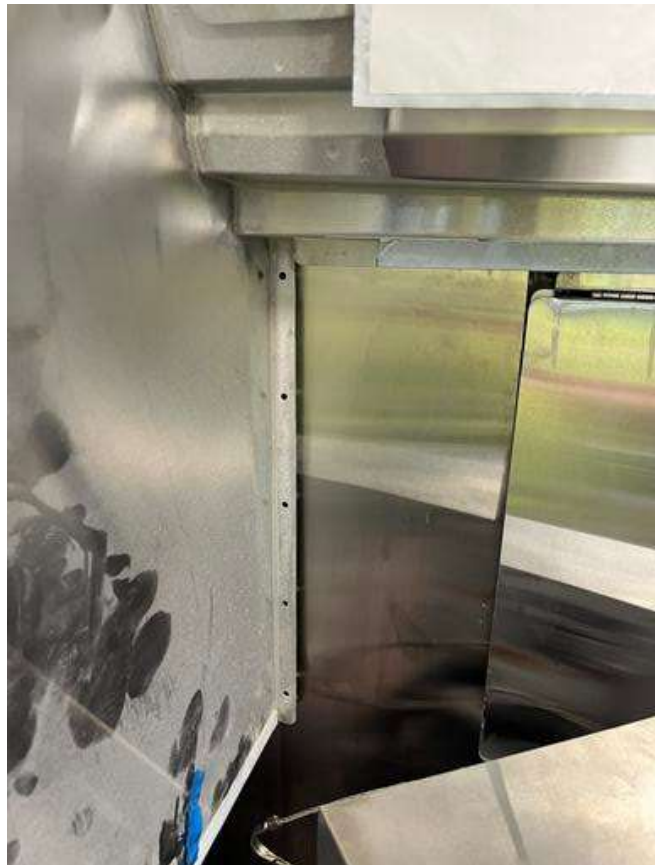
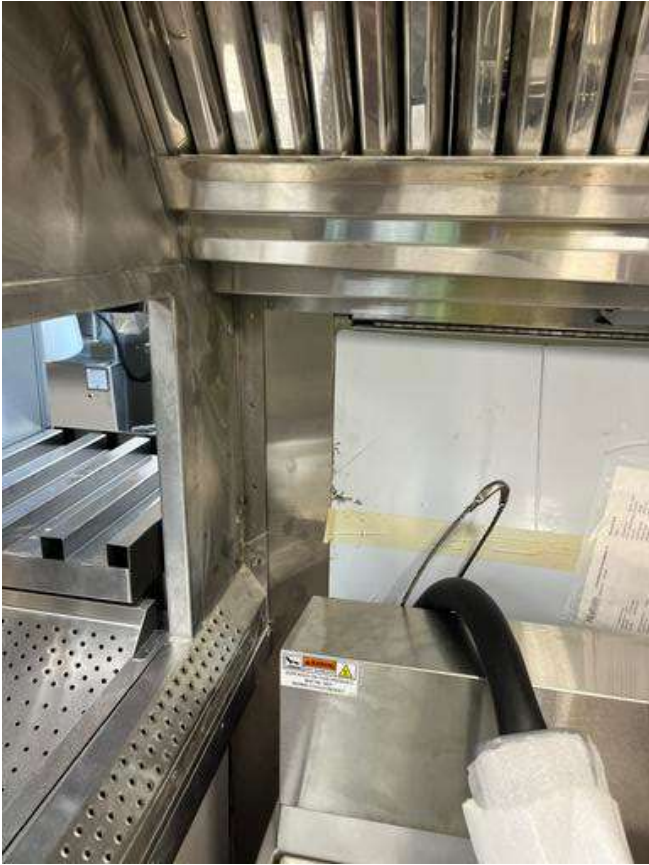
Hoods are to be secured to back panes via pre-punch holes with stainless steel screws.

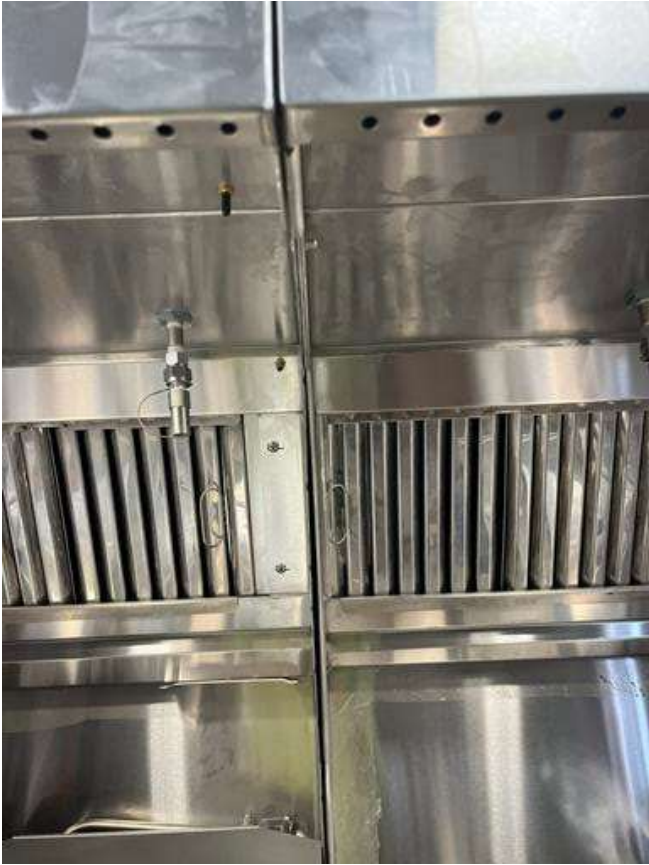
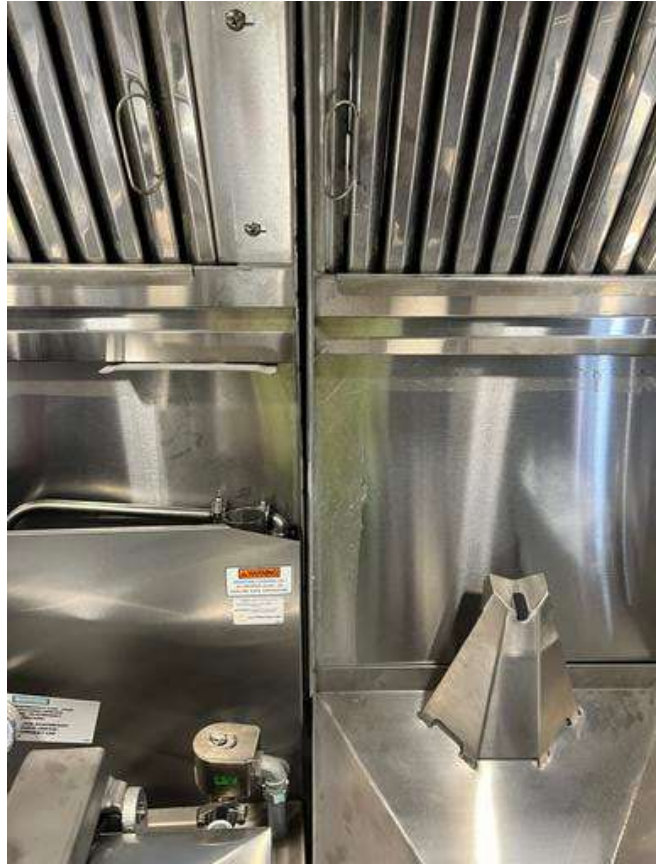
Hoods 1L/1R are missing bolting hardware and / or the splice brackets that are to be installed at their midpoint connection seams. Splice bracket is not correctly installed.
