Report: TAB Report
Function: Test, Adjust, & Balance
Date: 10/17/2023

**10-02-23 WALGREENS #3870 - HOUSTON,
TX**

4995 HWY 6N

HOUSTON, TX

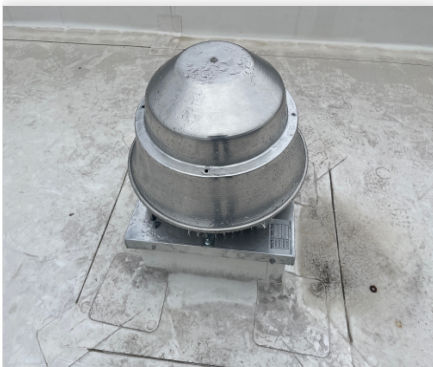
EF-4
10/03/2023

Issue Name : EF-4 (Office) is not operational
Description : EF-4 is not operating and could not be tested.
Created By : National TAB **Assigned To :** National TAB - Will Turnbough
Status : Open
Originated Date : 10/03/2023 - Wesley John - National TAB

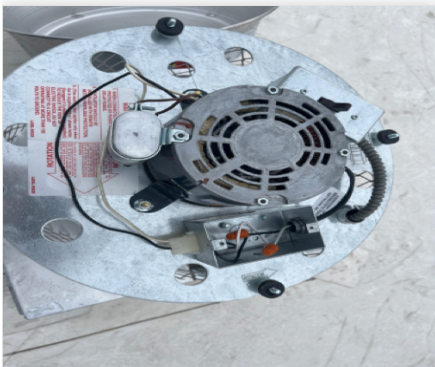
SPEED_CONTROLLER
10/03/2023

Issue Name : EF-4 (Office) Speed Controller
Description : EF-4 is missing speed controller. Recommend installing.
Created By : National TAB **Assigned To :** National TAB - Will Turnbough
Status : Open
Originated Date : 10/03/2023 - Wesley John - National TAB

CEILING MOUNTED EFs ARE SINGLE SPEED. ROOFTOP EXHAUST FANS ARE MISSING SPEED CONTROLLERS. (SEE ISSUE DATA)

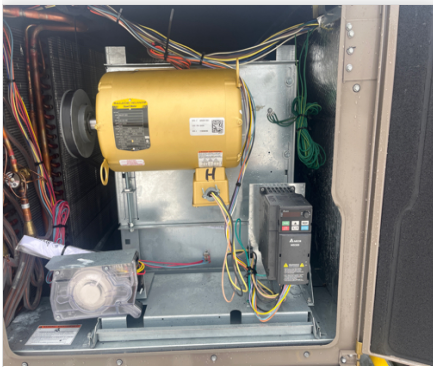
RTU-2(1)
10/03/2023

Issue Name : RTU-2 cd2 Alarm on VFD
Description : RTU-2 flow was measured initially. Amperage was over FLA. Opened motor compartment. Drive is now under cd2 alarm and will not drive motor. Unable to complete testing on RTU-2.
Created By : National TAB **Assigned To :** National TAB - Will Turnbough
Status : Open
Originated Date : 10/03/2023 - Wesley John - National TAB

RTU-2 VFD HAS ALARM THAT WILL NOT CLEAR. SEE ISSUES LIST.

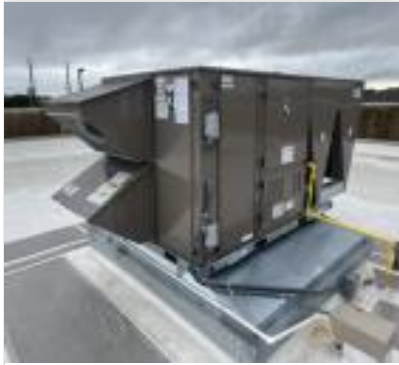
RTU-2(1)
10/10/2023

RTU-2 UNABLE TO BE SET DUE TO ALARM ON DRIVE.

RTU-2 DRIVE IS NOT OPERATIONAL.

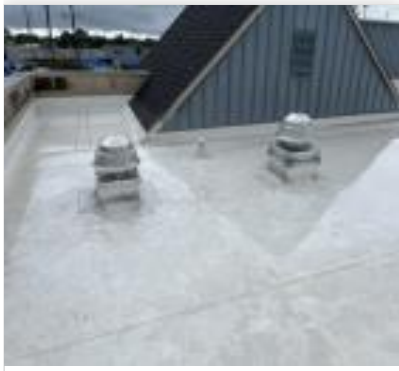
EF-4and5
10/10/2023

EF-4&5 NOT RUNNING. FAN ROTATION CANNOT BE VERIFIED. EF-1 THROUGH EF-3 ARE ROTATING CORRECTLY.

EF-4&5 INDETERMINATE.

CANNOT DETERMINE CONTROLS FOR EF-4&5.
