**Report: TAB Report**

**Function: Test, Adjust, & Balance**

**07-14-25 WAWA #7211 MASON, OH**

Project: 07-14-25 WAWA #7211 MASON, OH

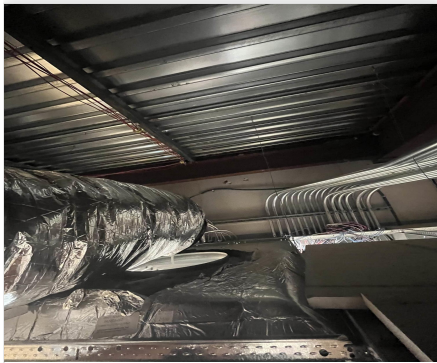
**Issue Name :** Diffuser 1-11 duct detached at diffuser  
**Description :** Diffuser 1-11 “electrical room” duct is detached at the diffuser, I was able to have someone hold it in place temporarily to balance it but will need to be properly secured. Duct is laying flat across the diffuser collar.  
**Created By :** National TAB                      **Assigned To :** National TAB - Brianna Biggs  
**Status :** Open  
**Priority :** Urgent                                      **Asset Tag :**  
**Originated Date :** 07/16/2025 - Dylan Crisman - National TAB

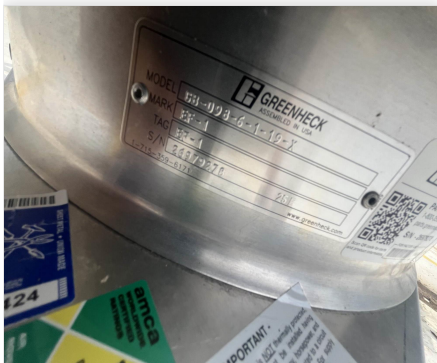
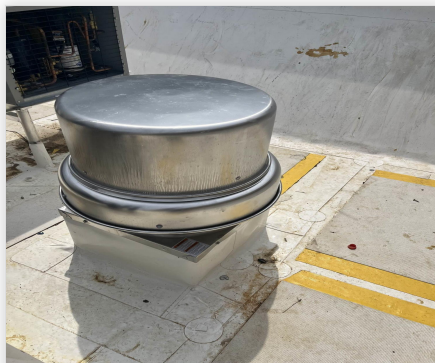
**Issue Name :** EF-1 high on flow  
**Description :** EF-1 is high on flow at 452/375 CFM. Motor sheave is reduced as much as is possible, unable to decrease airflow any further. Recommend possible pulley change.  
**Created By :** National TAB                      **Assigned To :** National TAB - Dylan Crisman  
**Status :** Open  
**Priority :** High                                      **Asset Tag :**  
**Originated Date :** 07/16/2025 - Dylan Crisman - National TAB

Test Data		
	Design	Actual
CFM	375	452
Fan Rotation	-	CCW
Suction ESP	-	-0.34"
Discharge ESP	-	ATM
Total ESP	-	0.34"

Asset									
Asset Name	Location	Type	Size	DESIGN CFM	AK	CFM(1)	CFM(2)	FINAL CFM	% to design
EGRD1	MENS RESTROOM	EG-1	8"	225	1.0	254	239	239	106.2
EGRD2	WOMENS RESTROOM	EG-1	8"	150	1.0	227	213	213	142.0
Total				375		481	452	452	120.53%

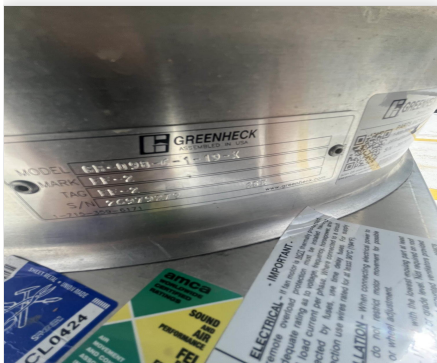
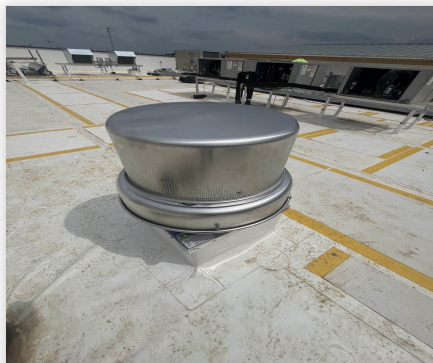
**Issue Name :** EF-2 not operational  
**Description :** EF-2 fan is misaligned, when running fan wheel rubs against housing, could not balance in its current condition. Mechanical shut it down and a replacement fan has been ordered to correct this issue.  
**Created By :** National TAB                      **Assigned To :** National TAB - Dylan Crisman  
**Status :** Open  
**Priority :** Urgent                                      **Asset Tag :**  
**Originated Date :** 07/16/2025 - Dylan Crisman - National TAB

Could not be balanced at time of TAB due to fan being misaligned and needing replacement. Replacement has been ordered.

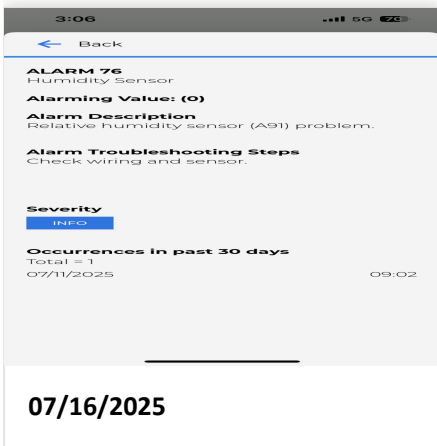
**Issue Name :** RTU-1/RTU-3 alarm  
**Description :** RTU-1/RTU-3 have an alarm for humidity sensor, recommend checking wiring to make sure this is landed properly at sensor and at unit.  
**Created By :** National TAB                      **Assigned To :** National TAB - Dylan Crisman  
**Status :** Open  
**Priority :** High                                      **Asset Tag :**  
**Originated Date :** 07/16/2025 - Dylan Crisman - National TAB

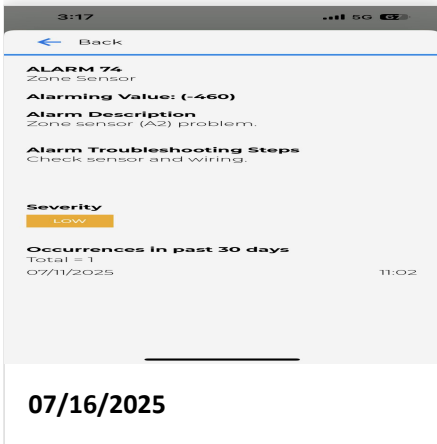
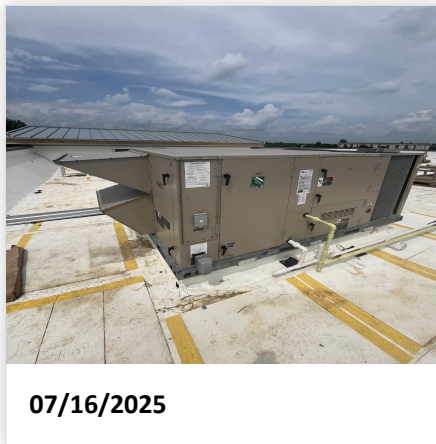
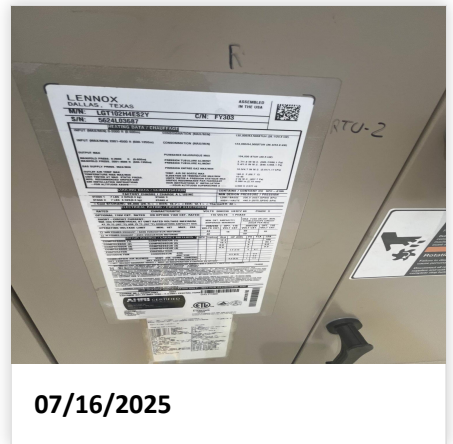
**Issue Name :** RTU-2 alarm  
**Description :** RTU-2 has an alarm for “zone sensor” Recommend checking wiring to ensure it is landed properly at sensor as well as at unit.  
**Created By :** National TAB                      **Assigned To :** National TAB - Dylan Crisman  
**Status :** Open  
**Priority :** High                                      **Asset Tag :**  
**Originated Date :** 07/16/2025 - Dylan Crisman - National TAB
